Extensive Restorations of Arched Stone Bridges: the Examples of Plaka Bridge in Greece and Stari Most in Bosnia and Herzegovina

Vasileios K. Tzoumas¹

¹ Ministry of Infrastructure and Transport Directorate of Road Infrastructure, Athens, Greece
PhD Candidate at the National Technical University of Athens, Greece
vas.k.tzoumas@gmail.com

Keywords: Arched Stone Bridge, Masonry Structure, Monument, Procedure-Framework, Restoration.

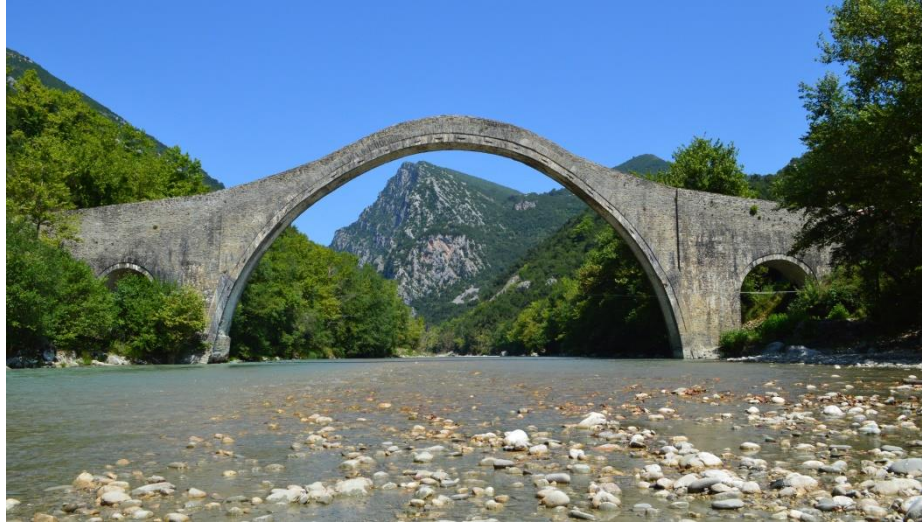
Fig. 1. Plaka Bridge (downstream view), August 2014.

Both bridges suffered significant losses for different reasons. Plaka Bridge (Fig.1) collapsed in a significant part (Fig.2), on February 1, 2015, after heavy rainfalls in the area.

After the initial failed attempt in 1863, the bridge was rebuilt in 1866 by the Tzoumerkioti master builder from Pramanta, Kostas Bekas [12], and was preserved until 2015 (Fig.1). The bridge worked beneficially for the people of Tzoumerka, since it was a vital necessity for the commercial communication of the region with Arta, from the time of its construction until 1881, the year in which most villages in the region gained their freedom from the Turkish yoke, after their annexation to the Greek State [12, 13], according to the Treaty of Berlin.

It consists of the central arch (Fig.1 and Fig. 11) that has a free opening of about 40m, a height of about 20m and two false-arches, the eastern arch with an opening of 6.6m and the western arch with an opening of 5.2m. The total length at the level of the parapets is 72m. Its width is 4.5m on the eastern and 5.0m on the western pedestal, decreasing progressively towards the piers, remaining constant only along the central arch, which is 3.7m wide at its bottom.

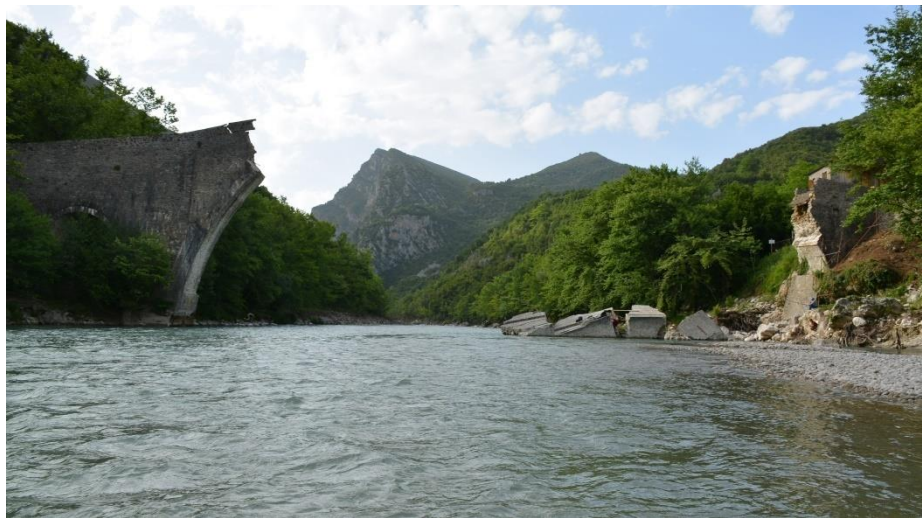
Fig. 2. Plaka Bridge (downstream view), May 2015.(Image source: © Ch. Giannelos)

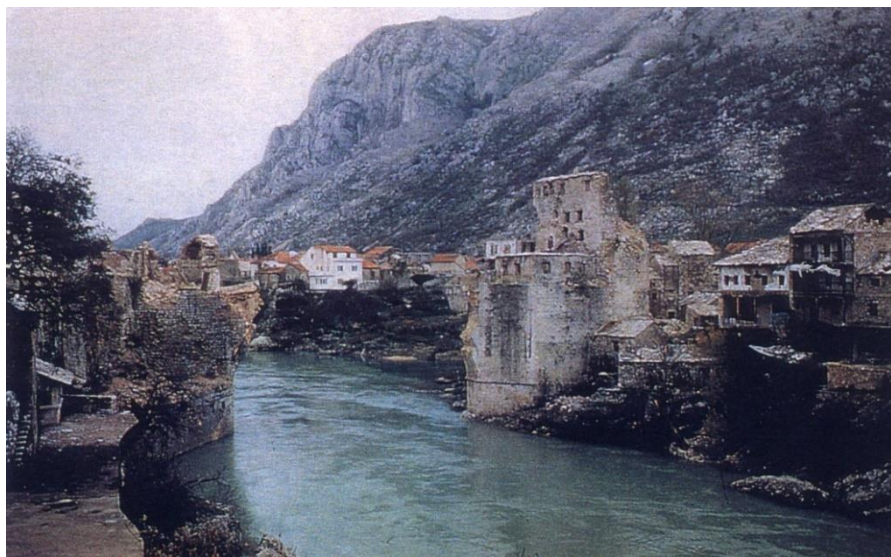
Fig. 4. The surviving abutments of Stari Most after the bombardment, December 1993. (Image source: © A. Pašić)

Stari Most (Fig. 3) was destroyed on November 9, 1993 (Fig. 4) due to bombardment by Croatian forces, during the war in Yugoslavia.

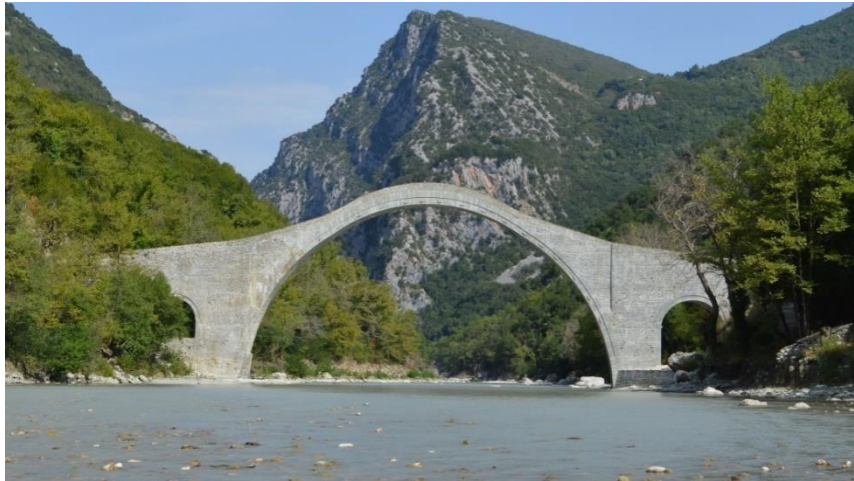
Fig.11.Plaka Bridge after restoration (downstream view), August 2021.

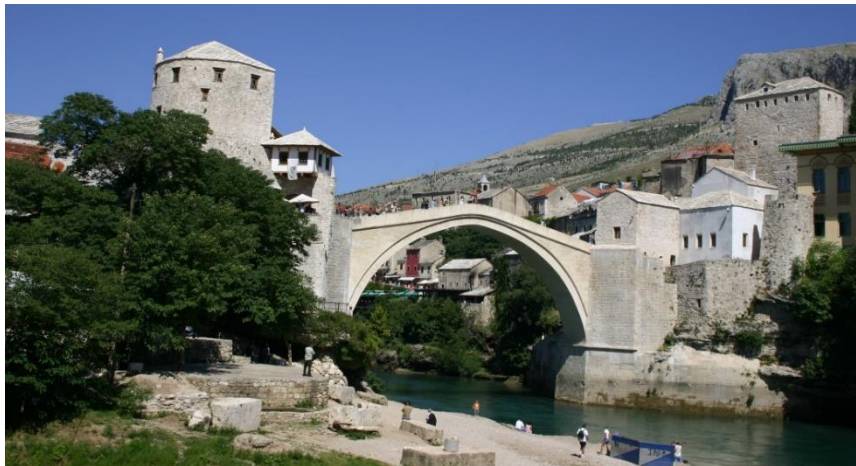
Fig. 12. Stari Most after restoration (downstream view), September 2006.
(Image source: © A. Pašić)

The bearing arch (Fig.3 and Fig. 12), which is the most important part of the bridge, has the form of a humbled semicircle and is sharp-edged. Its total opening on the upstream side is 28.71m, while on the downstream side it is 28.62m. Its width ranges from 3.95 to 4.05m and its height is 12.06m [25]. The height from the lowest (dry) level of the Neretva River ranges from 19.0m to 21.00m and the curvature of its interior is almost circular. It consists of approximately 1,100 pieces of stone. None of the stones used had the same dimensions. The dimensions of the average of these are: 0.40m x 0.80m x 1.00m [24].
