# Extensive Restorations of Arched Stone Bridges: the Examples of Plaka Bridge in Greece and Stari Most in Bosnia and Herzegovina

**Abstract.** In the last thirty years, Europe has experienced two major destructions of important monuments of its cultural heritage. They are both related to the collapse of stone-built, arched bridges, which were closely linked to the history and evolution of the bridging areas.

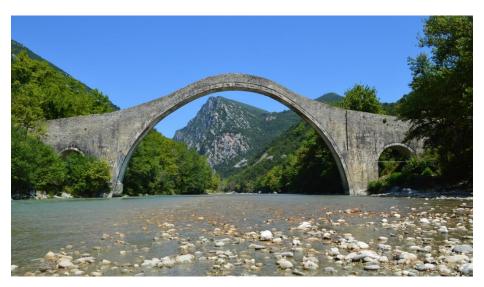
Fig. 1. Plaka Bridge (downstream view), August 2014.

It consists of the central arch (Fig.1 and Fig. 11) that has a free opening of about 40m, a height of about 20m and two false-arches, the eastern arch with an opening of 6.6m and the western arch with an opening of 5.2m. The total length at the level of the parapets is 72m. Its width is 4.5m on the eastern and 5.0m on the western pedestal, decreasing progressively towards the piers, remaining constant only along the central arch, which is 3.7m wide at its bottom.

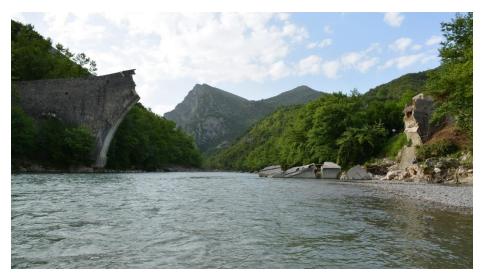
Fig. 2. Plaka Bridge (downstream view), May 2015.(Image source: © Ch. Giannelos)

Both bridges suffered significant losses for different reasons. Plaka Bridge (Fig.1) collapsed in a significant part (Fig.2), on February 1, 2015, after heavy rainfalls in the area.

On February 1, 2015, the largest part of Plaka Bridge collapsed, after heavy rainfalls and a large rise in the water level in Arachthos River, due to extensive scouring of the eastern pier [7, 14]. It completely collapsed the central arch and almost 90% of the eastern pedestal (Fig.6).

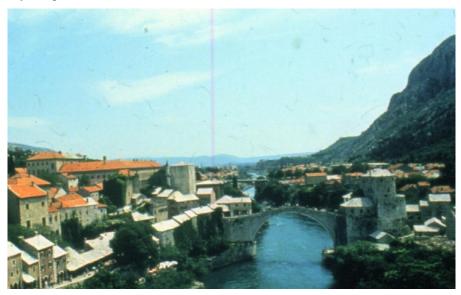
Fig. 3. Stari Most complex before the bombardement, August 1989. (Image source: © A.Pašić)

The bearing arch (Fig.3 and Fig. 12), which is the most important part of the bridge, has the form of a humbled semicircle and is sharp-edged. Its total opening on the upstream side is 28.71m, while on the downstream side it is 28.62m. Its width ranges from 3.95 to 4.05m and its height is 12.06m [25]. The height from the lowest (dry) level of the Neretva River ranges from 19.0.m to 21.00m and the curvature of its interior is almost circular. It consists of approximately 1,100 pieces of stone. None of the stones used had the same dimensions. The dimensions of the average of these are: 0.40m x0.80m x1.00m [24].

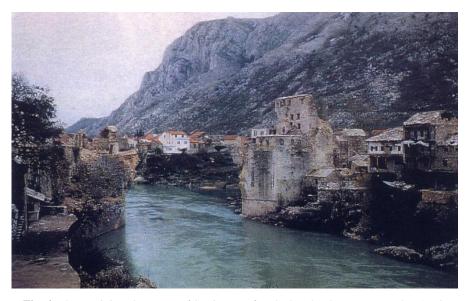
**Fig. 4.** The surviving abutments of Stari Most after the bombardement, December 1993. (Image source: © A. Pašić)

Stari Most (Fig. 3) was destroyed on November 9, 1993 (Fig. 4) due to bombardement by Croatian forces, during the war in Yugoslavia.

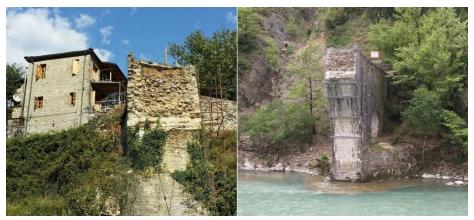
**Fig. 6.** Surviving sections of Plaka Bridge, September 2018. Left: part of east abutment and the Customs building. Right: West abutment and piers body.

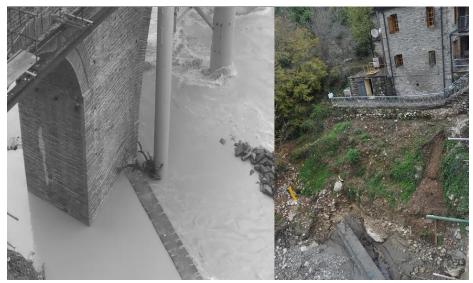
**Fig. 9.** Conditions in the area of the restoration project in Plaka, November 2019.<sup>6</sup> (Image source: ©Nirikos Techniki SA)

<sup>&</sup>lt;sup>6</sup>Photo on the left comes from a surveillance camera installed on the eastern slope (upstream view), where the large elevation of the water level can be seen, and the crest of the wing wall can be seen marginally. There have been cases where the supply has "disappeared" the wing wall. Photo on the right shows a landslide of part of the eastern slope after heavy rainfalls. The upstream wing wall can be seen again, as well as the Customs building.

Also, the level of difficulty of the projects related to the field conditions was certainly higher in the Plaka area, since the work had to take place in the Arachtos River, with intense rainfalls and (almost) flooding (Fig.9). On the contrary, the location of Stari Most as well as the field conditions in Mostar favored the avoidance of unforeseen situations during the progress of the works (Fig.10).

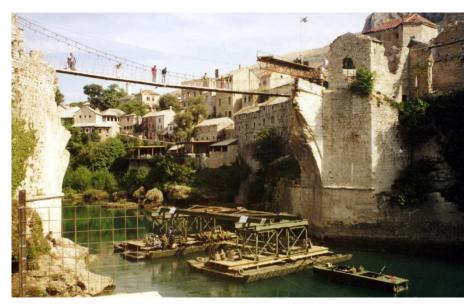
Fig. 10. Conditions in the area of the restoration project in Mostar, September 1997. (Image source: © A. Pašić)

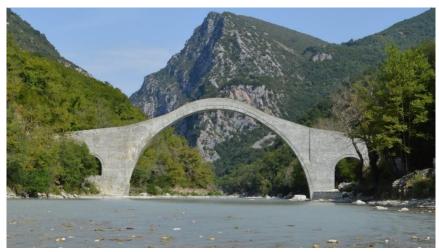
Fig.11. Plaka Bridge after restoration (downstream view), August 2021.

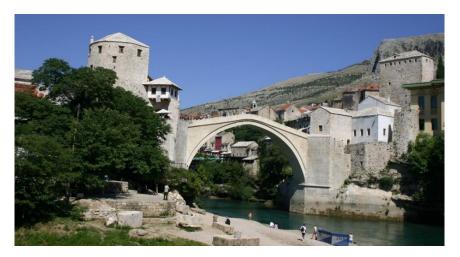
Fig. 12. Stari Most after restoration (downstream view), September 2006. (Image source: © A. Pašić)
