Vol 1, No 3 (2023)

# Extensive Restorations of Arched Stone Bridges: the Examples of Plaka Bridge in Greece and Stari Most in Bosnia and Herzegovina

**Abstract.** In the last thirty years, Europe has experienced two major destructions of important monuments of its cultural heritage. They are both related to the collapse of stone-built, arched bridges, which were closely linked to the history and evolution of the bridging areas.

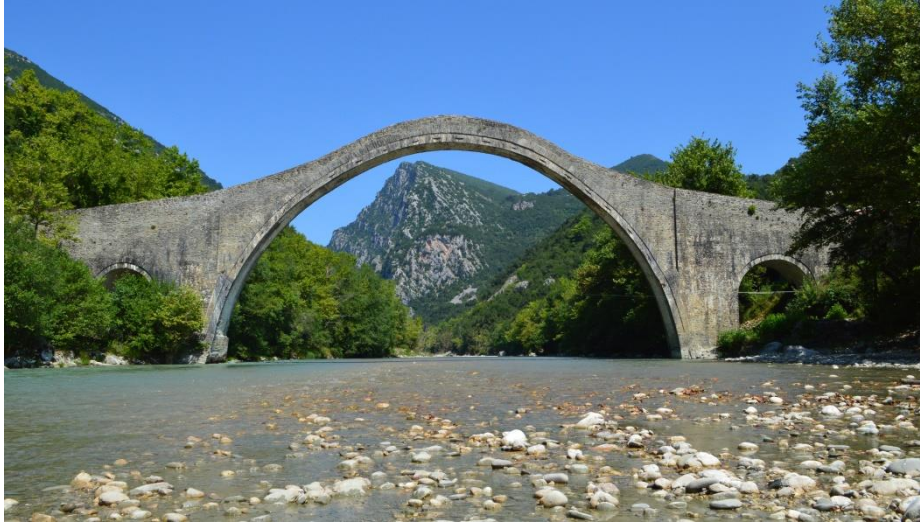
**Fig. 1.** Plaka Bridge (downstream view), August 2014.

Both bridges suffered significant losses for different reasons. Plaka Bridge (Fig.1) collapsed in a significant part (Fig.2), on February 1, 2015, after heavy rainfalls in the area.

After the initial failed attempt in 1863, the bridge was rebuilt in 1866 by the Tzoumerkioti master builder from Pramanta, Kostas Bekas [12], and was preserved until 2015 (Fig.1). The bridge worked beneficially for the people of Tzoumerka, since it was a vital necessity for the commercial communication of the region with Arta, from the time of its construction until 1881, the year in which most villages in the region gained their freedom from the Turkish yoke, after their annexation to the Greek State [12, 13], according to the Treaty of Berlin.

It consists of the central arch (Fig.1 and Fig. 11) that has a free opening of about 40m, a height of about 20m and two false-arches, the eastern arch with an opening of 6.6m and the western arch with an opening of 5.2m. The total length at the level of the parapets is 72m. Its width is 4.5m on the eastern and 5.0m on the western pedestal, decreasing progressively towards the piers, remaining constant only along the central arch, which is 3.7m wide at its bottom.

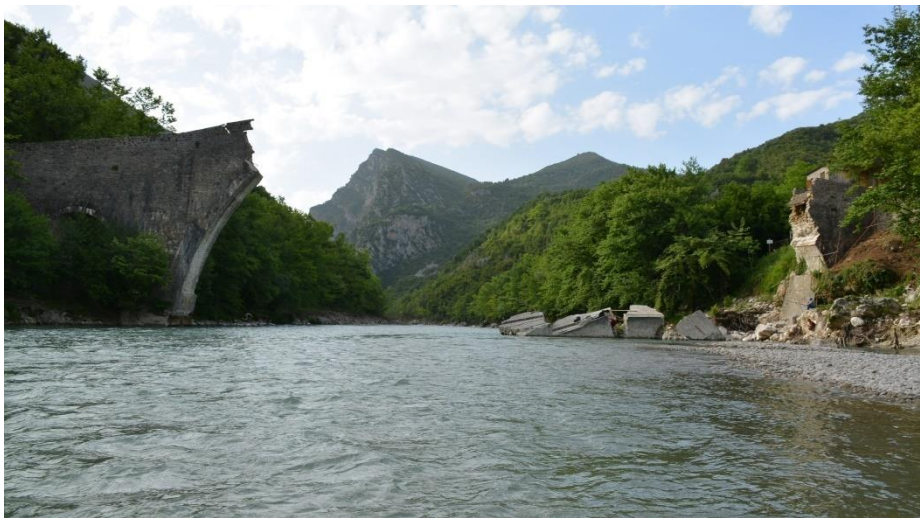
**Fig. 2.** Plaka Bridge (downstream view), May 2015.(Image source: © Ch. Giannelos)

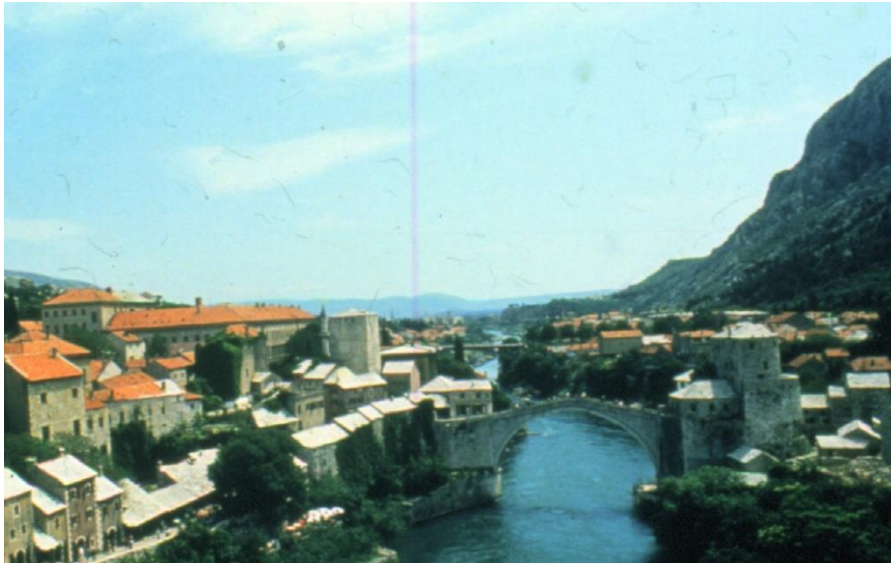
**Fig. 3.** Stari Most complex before the bombardment, August 1989. (Image source: © A. Pašić)

Stari Most (Fig. 3) was destroyed on November 9, 1993 (Fig. 4) due to bombardment by Croatian forces, during the war in Yugoslavia.

The bearing arch (Fig.3 and Fig. 12), which is the most important part of the bridge, has the form of a humbled semicircle and is sharp-edged. Its total opening on the upstream side is 28.71m, while on the downstream side it is 28.62m. Its width ranges from 3.95 to 4.05m and its height is 12.06m [25]. The height from the lowest (dry) level of the Neretva River ranges from 19.0m to 21.00m and the curvature of its interior is almost circular. It consists of approximately 1,100 pieces of stone. None of the stones used had the same dimensions. The dimensions of the average of these are: 0.40m x 0.80m x 1.00m [24].

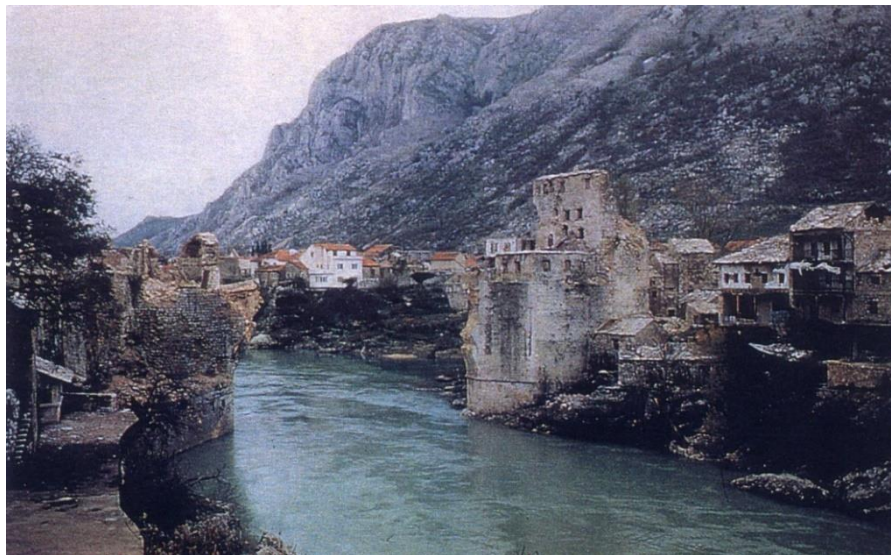
**Fig. 4.** The surviving abutments of Stari Most after the bombardment, December 1993. (Image source: © A. Pašić)

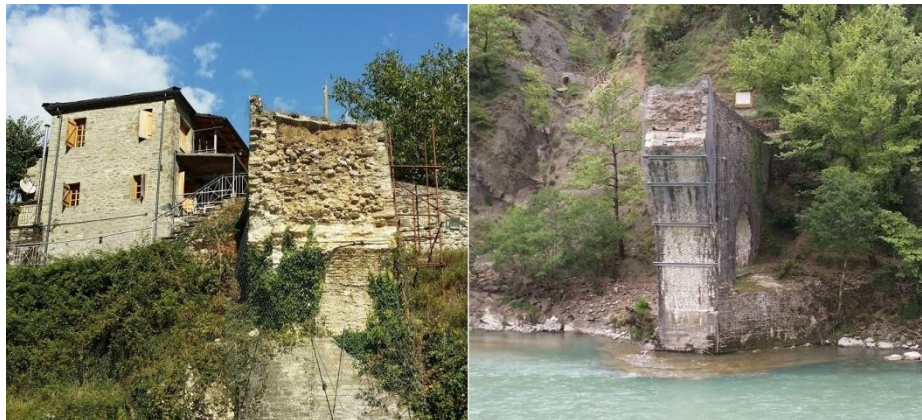
**Fig. 6.** Surviving sections of Plaka Bridge, September 2018. Left: part of east abutment and the Customs building. Right: West abutment and piers body.

On February 1, 2015, the largest part of Plaka Bridge collapsed, after heavy rainfalls and a large rise in the water level in Arachthos River, due to extensive scouring of the eastern pier [7, 14]. It completely collapsed the central arch and almost 90% of the eastern pedestal (Fig.6).

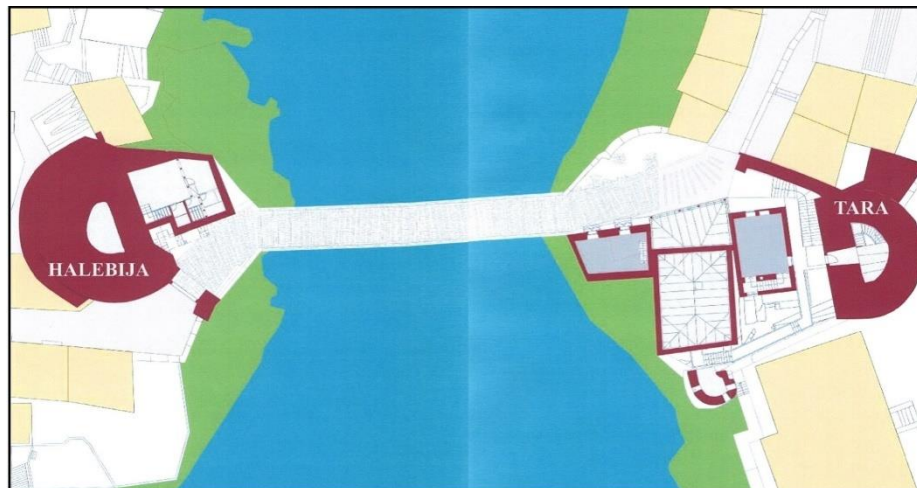
**Fig.8.**View of the bridge complex.(Image source: © A. Pašić)

In addition to the bridge, the Stari Most complex also includes a set of buildings consisting of three towers, two mosques and other medieval structures (Fig.8) [11]. A crossing already existed at this location in Mostar before the Ottoman Empire, as confirmed by archeological investigations during which authentic remains of a wooden bridge were identified [9, 25].

The project of the monumental restoration of Mostar concerned the restoration of the historical bridge complex and in particular the restoration (Fig.8): a) the bridge itself, b) the Tara tower, the smaller Herceguša tower, the mosque of Sultan Selim and two buildings of trade, on the east bank of the Neretva River and c) the Halebija tower, the outpost (Caradak) and a commercial structure between the tower and the bridge, on the west bank.

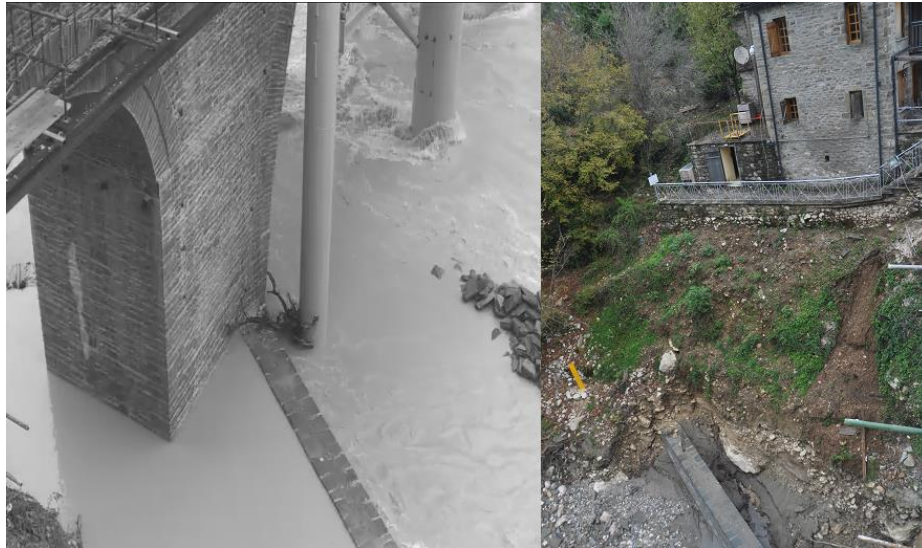
**Fig. 9.** Conditions in the area of the restoration project in Plaka, November 2019.<sup>6</sup>  
(Image source: ©Nirikos Techniki SA)

<sup>6</sup>Photo on the left comes from a surveillance camera installed on the eastern slope (upstream view), where the large elevation of the water level can be seen, and the crest of the wing wall can be seen marginally. There have been cases where the supply has “disappeared” the wing wall. Photo on the right shows a landslide of part of the eastern slope after heavy rainfalls. The upstream wing wall can be seen again, as well as the Customs building.

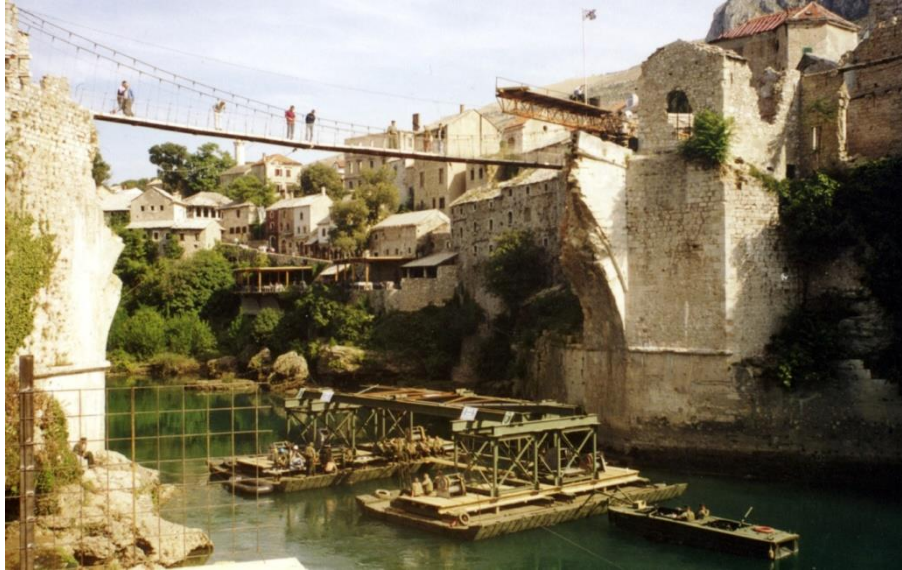
**Fig. 10.** Conditions in the area of the restoration project in Mostar, September 1997.  
(Image source: © A. Pašić)

Also, the level of difficulty of the projects related to the field conditions was certainly higher in the Plaka area, since the work had to take place in the Arachtos River, with intense rainfalls and (almost) flooding (Fig.9). On the contrary, the location of Stari Most as well as the field conditions in Mostar favored the avoidance of unforeseen situations during the progress of the works (Fig.10).

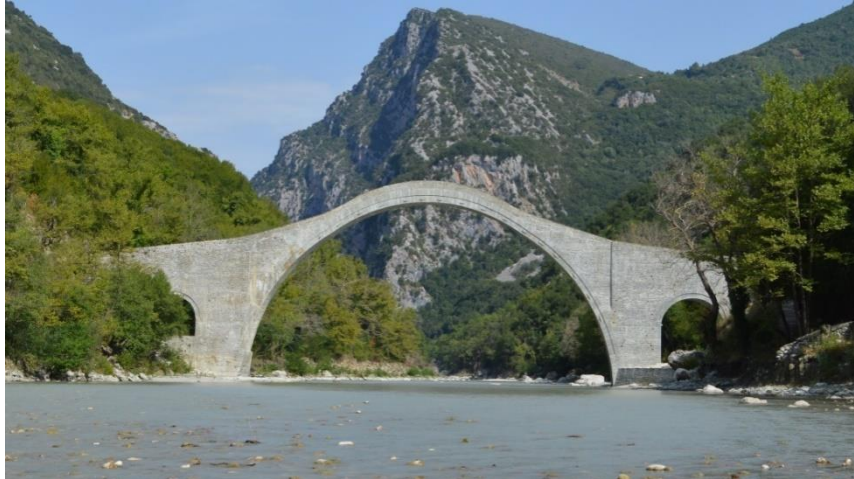
**Fig.11.**Plaka Bridge after restoration (downstream view), August 2021.

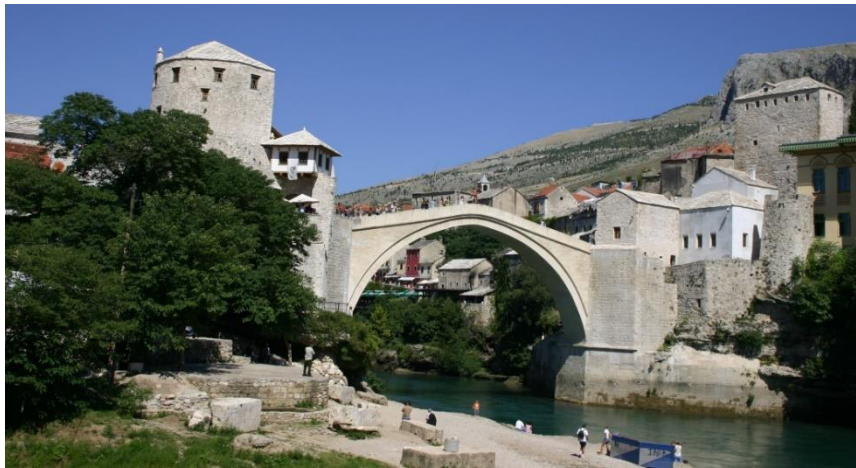
**Fig. 12.** Stari Most after restoration (downstream view), September 2006.  
(Image source: © A. Pašić)

Stari Most, built in 1566, has been considered for centuries a symbol of bridging the East and the West, not only the Christian world with the Islamic world, but also the Catholic Croats with the Orthodox Serbs. The restoration of the bridge in Mostar (Fig.
