### Post-earthquake assessment of monumental building in Croatia by 3Muri software

# Post-earthquake assessment of monumental building in Croatia by 3Muri software

**Keywords:** Earthquake 2020 Croatia, Monumental Building, Retrofitting, Structural Elements Model, Assessment, 3Muri program

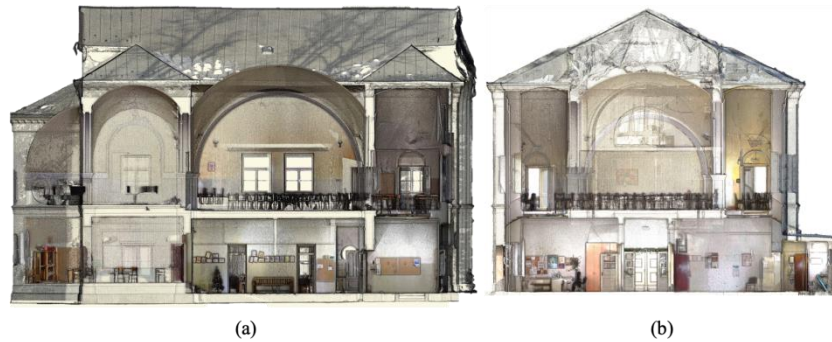
**Fig. 3.** Longitudinal (East-West) (a) and lateral (South-North)(b) cross-section of building acquired from 3D point cloud model after earthquake of December 2020

After expropriation of synagogue during the WW2, the ground floor interior was changed by adding partition walls of different thickness. The central open space was divided in height by massive new floor structures (see Fig.3(a)). Façade windows were partially or entirely closed by masonry infills. The massive masonry arches supporting the timber domes and domes themselves were preserved in the original form while passages between rooms were partially or entirely closed (see Fig.4).

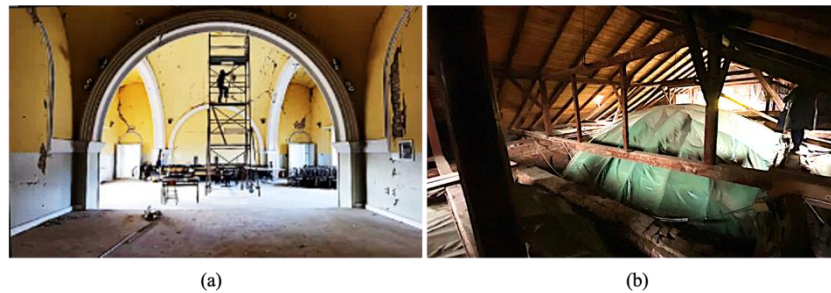
**Fig. 4.** The first floor (view towards West) damaged by the December 2020 earthquake (a) and attic with upper surface of the main timber dome (view towards West) (b)
