# **Protection and enhancement of the historical and architectural heritage in times of peace on apparently distant war wounds. Some cases in Cagliari (Italy) between restorations, current problems and future prospects**

Maria Dessi<sup>1[0000-1111-2222-3333]</sup>, Emanuela Fara<sup>2[1111-2222-3333-4444]</sup>,  
Piervanna Piredda<sup>3[2222-3333-4444-5555]</sup>

Laboratory of Analysis and Conservation of Cultural Heritage (LACHE) –  
Department of Architecture, Design and Urban Planning of Alghero - University of Sassari;  
Palazzo del Pou Salit, Piazza Duomo, 6 - 07041 Alghero (SS), Italia,  
mdessi@uniss.it<sup>1</sup>, faramanu@hotmail.it<sup>2</sup>,  
piervannap@gmail.com<sup>3</sup>

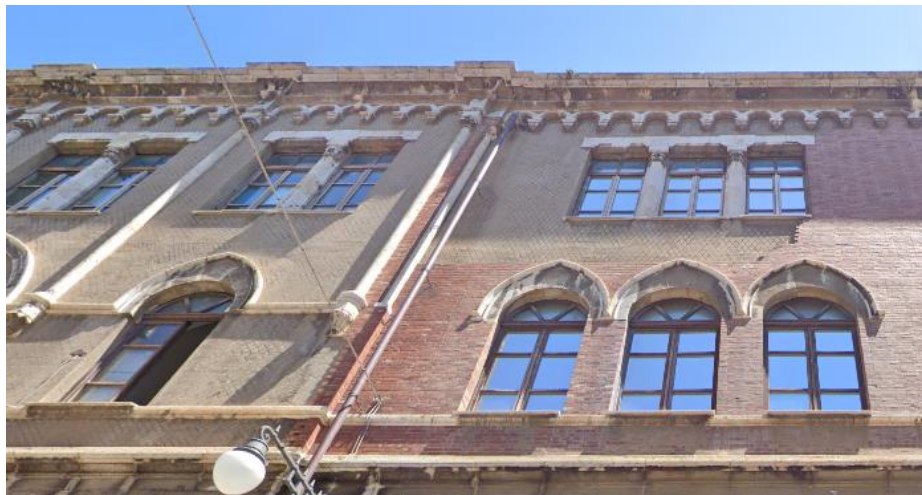
**Fig. 2.** Palazzo Vivanet [[www.sardegnageoportale.it](http://www.sardegnageoportale.it)]

**Fig. 3.** Scuola Satta [[www.sardegnageoportale.it](http://www.sardegnageoportale.it)]

Only in a few cases we can see an interesting attention for restoration: for example the intervention on "Palazzo Vivanet" and the "Scuola Satta", on the facades of these buildings the reconstruction of damaged parts using different materials is clearly visible, in full compliance with the criterion of recognizability of the intervention.

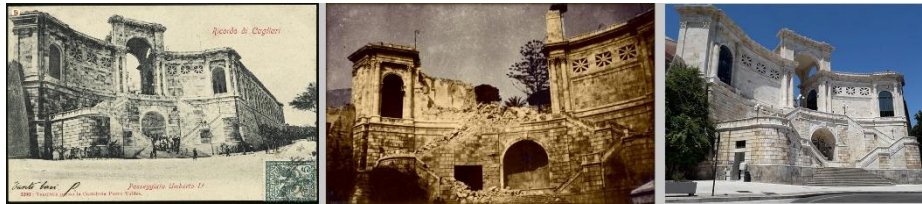
The case of Bastioni San Remy (fig.9) is emblematic, considering the monumentality of this architecture. The structure, built between 1896 and 1902, was classified as highly damaged by war bombing. Observing the historical images, the main elevation on Viale Regina Margherita was affected by a partial collapse: we can see the total loss of the central arch and part of the stairs on its right side. After the inevitable debate on the method of reconstruction, the gap was compensated, and without any distinction, the missing part was rebuilt in the years 1946-1948.

**Fig. 9.** Bastioni San Remy: before 1943, after damage, today (1st photo by <https://www.sardegnaigitallibrary.it/> and 2th by <http://www.sardegnaotterranea.org/>)

In this area the current problems do not derive directly from war damages: there are no static instabilities. However, there is a lack of a general strategy for the redevelopment of the center, now less and less inhabited and, consequently habitable: it is an area of marginality, where it is impossible to overcome the problem of continuous vandalism. Architecture often not valuable, creates uncomfortable situations whose consequences are also reflected in the architecture of value.
