Technical Annals

Vol 1, No 3 (2023)

Protection and enhancement of the historical and architectural heritage in times of peace on apparently distant war wounds. Some cases in Cagliari (Italy) between restorations, current problems and future prospects

Maria Dessi, Emanuela Fara, Piervanna Piredda

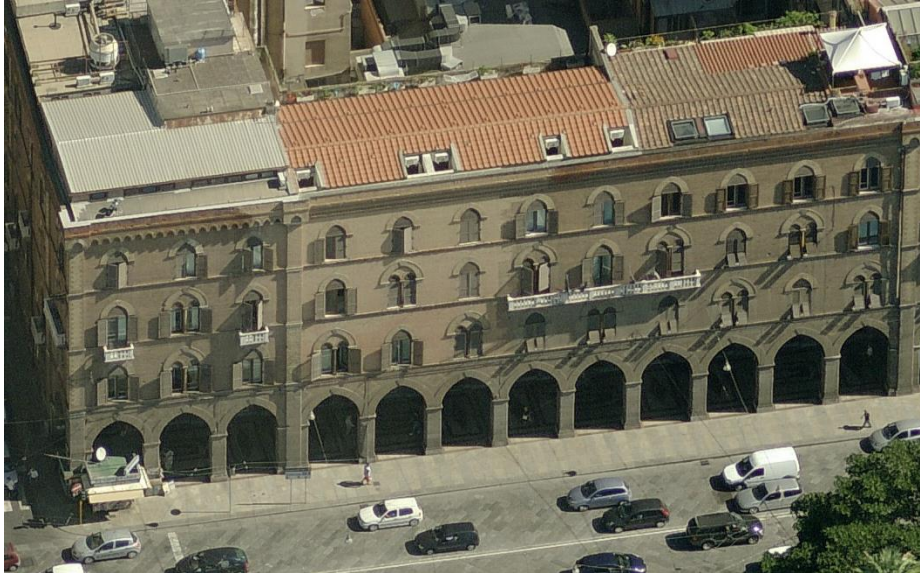
Fig. 2. Palazzo Vivanet [www.sardegnaeoportale.it]

Only in a few cases we can see an interesting attention for restoration: for example the intervention on "Palazzo Vivanet" and the "Scuola Satta", on the facades of these buildings the reconstruction of damaged parts using different materials is clearly visible, in full compliance with the criterion of recognizability of the intervention.

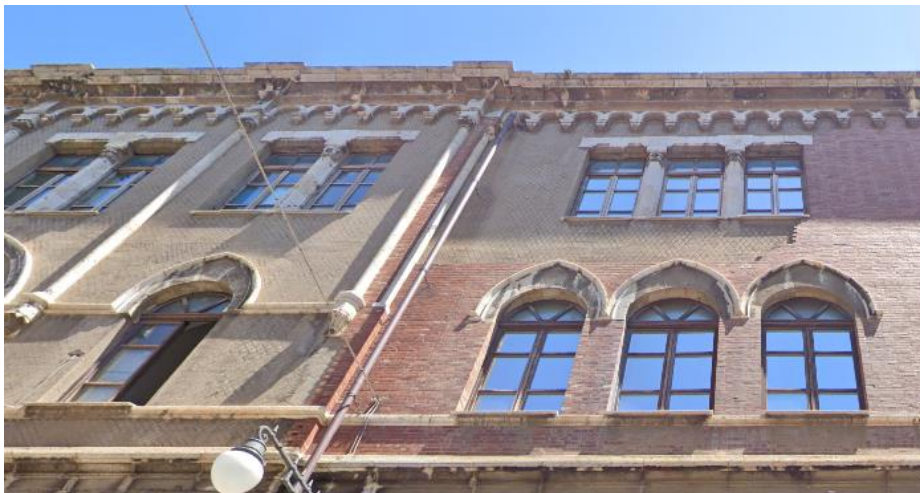
Fig. 3. Scuola Satta [www.sardegnaeoportale.it]

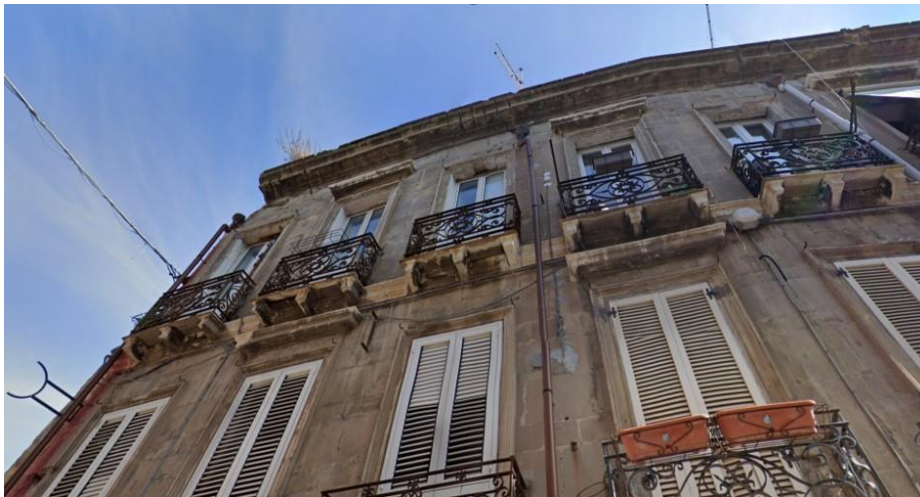
Fig. 6. A building in front of empty urban

The result is the presence of an urban emptiness, a vulnerability for other buildings, which has not found a total resolution with the adopted measures: it is observed in fact that the buttress appears here not to be sufficient to ensure the balance to the architectural building that was not thought to constitute the head of the block. Obviously, there is a correlation between the fissuring framework that is present today and the damage caused by the bombings occurred 80 years ago: we can call this the “indirect damage”. The buttress in the facade in front of the urban void has a lower height than the building itself, and this generates a particular criticality on the upper floor, where clearly there is a disconnection of the joints with hinge on the interfloor. It is not a coincidence that the lintel of the upper door, close to the cantonal, is propped up while, with further distance from the cantonal, the instability appears to be less and less worrying. (fig. 6)

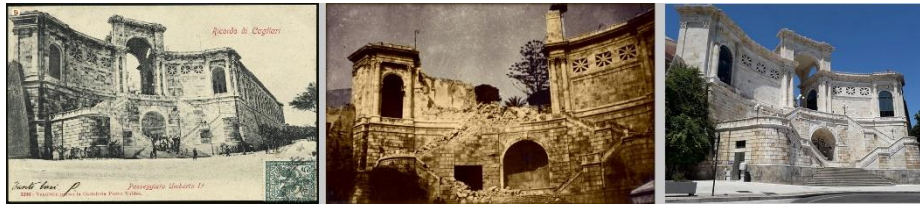
Fig. 9. Bastioni San Remy: before 1943, after damage, today (1th photo by <https://www.sardegna digital library.it/> and 2th by <http://www.sardegna sotterranea.org/>)

The case of Bastioni San Remy (fig.9) is emblematic, considering the monumentality of this architecture. The structure, built between 1896 and 1902, was classified as highly damaged by war bombing. Observing the historical images, the main elevation on Viale Regina Margherita was affected by a partial collapse: we can see the total loss of the central arch and part of the stairs on its right side. After the inevitable debate on the method of reconstruction, the gap was compensated, and without any distinction, the missing part was rebuilt in the years 1946-1948.
