Vol 1, No 3 (2023)

Protection and enhancement of the historical and architectural heritage in times of peace on apparently distant war wounds. Some cases in Cagliari (Italy) between restorations, current problems and future prospects

Maria Dessi, Emanuela Fara, Piervanna Piredda

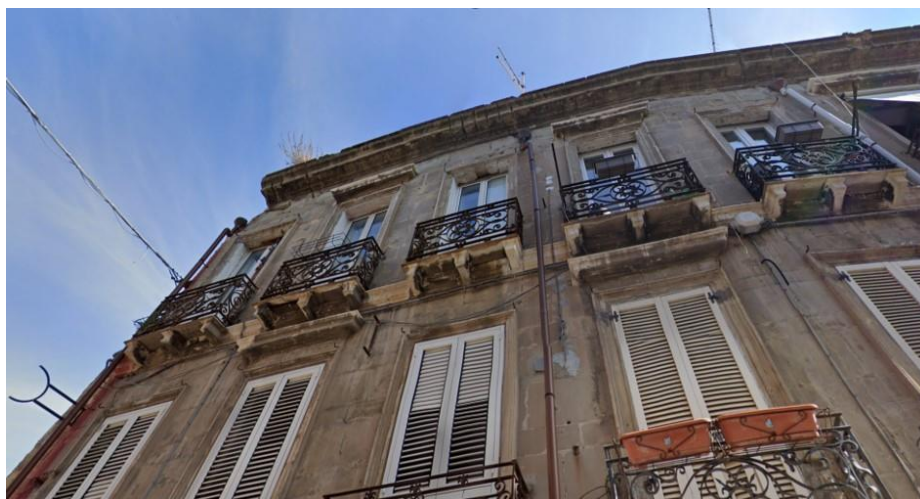
Fig. 6. A building in front of empty urban

The result is the presence of an urban emptiness, a vulnerability for other buildings, which has not found a total resolution with the adopted measures: it is observed in fact that the buttress appears here not to be sufficient to ensure the balance to the architectural building that was not thought to constitute the head of the block. Obviously, there is a correlation between the fissuring framework that is present today and the damage caused by the bombings occurred 80 years ago: we can call this the “indirect damage”. The buttress in the facade in front of the urban void has a lower height than the building itself, and this generates a particular criticality on the upper floor, where clearly there is a disconnection of the joints with hinge on the interfloor. It is not a coincidence that the lintel of the upper door, close to the cantonal, is propped up while, with further distance from the cantonal, the instability appears to be less and less worrying. (fig. 6)
