Vol 1, No 3 (2023)

**Protection and enhancement of the historical and architectural heritage in times of peace on apparently distant war wounds. Some cases in Cagliari (Italy) between restorations, current problems and future prospects**

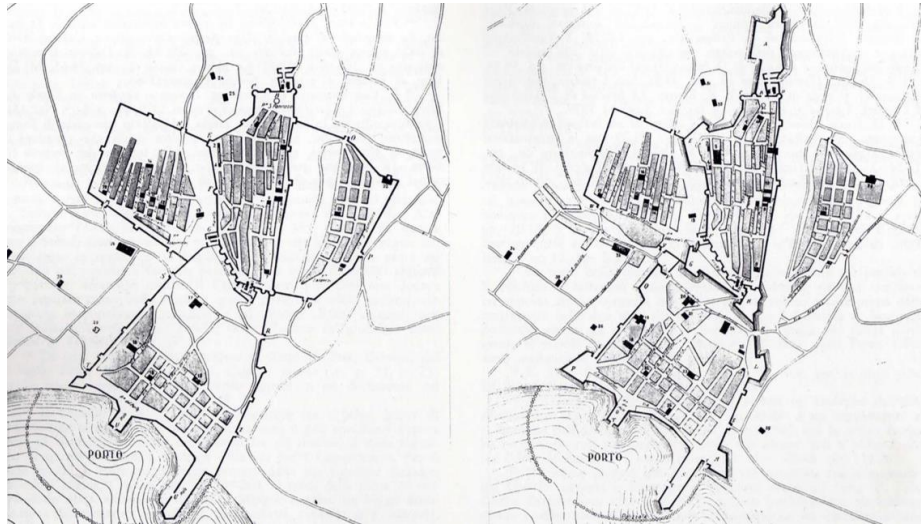
**Fig. 1.** Cagliari in XIV-XV century (left) and XVI century (right) [6].

Its road and architectural structure is distinguished from other cities due to the unique arrangement in an irregular checkerboard pattern [6]. Its expansion is the most consistent due to the early demolition of parts of the walls that bordered this historic district, which took place between the 15th and 16th centuries (Fig. 1) [7].

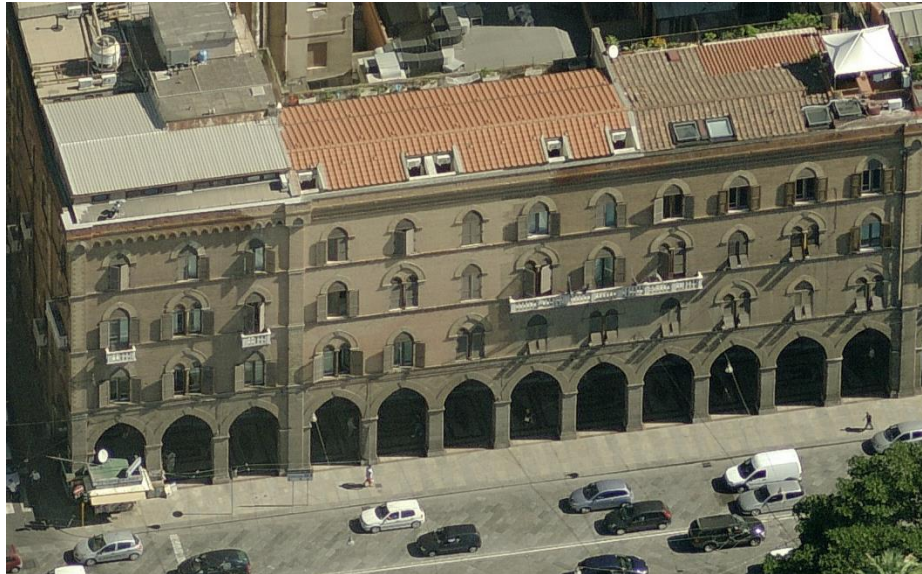
**Fig. 2.** Palazzo Vivanet [[www.sardegnaeoportale.it](http://www.sardegnaeoportale.it)]

Only in a few cases we can see an interesting attention for restoration: for example the intervention on "Palazzo Vivanet" and the "Scuola Satta", on the facades of these buildings the reconstruction of damaged parts using different materials is clearly visible, in full compliance with the criterion of recognizability of the intervention.

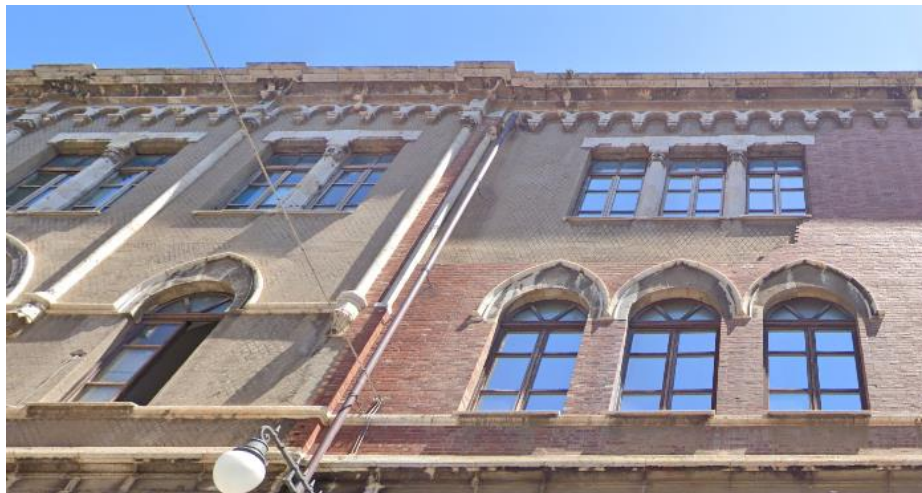
**Fig. 3.** Scuola Satta [[www.sardegnaeoportale.it](http://www.sardegnaeoportale.it)]

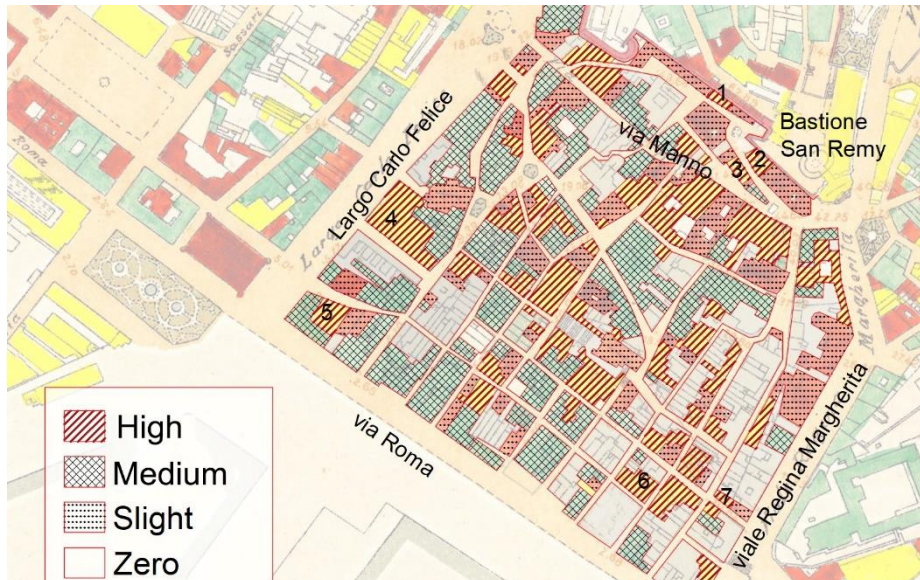
**Fig. 5.** The II war damage in the neighborhood of Marina (synthesis of historical cartography)

For example, we notice that areas adjacent to the Bastion San Remy (classified with high damage), remain empty, and are now used for public parking. In the case of the urban void, in Via Spano (fig.5, n.1), the result of the bombing is visible in the stratigraphy of the walls, as the signs are visible both on the ramparts and in the adjacent houses: wall thickenings, buttresses, spurs, but also walled windows, reparations walls,

On “Manno street” (via Manno), the gap is filled by a new single-level building (fig.5, n.3), which responds to the needs of the street and its mainly commercial use. In this road there are lots of buildings that replace the destroyed ones, both if the damage was considered of high or medium intensity. But the whole neighborhood appears to be dotted with new architectures, which simply respond to housing and functional needs, often with poor architectural quality and rarely interacting with the historic building style.

This is the case, for example, of the “Banca d'Italia” building, in “Largo Carlo Felice”, which was built on a highly damaged area, but which does not consider either the presence of the near church of Sant'Agostino [29], nor what re-emerged in the area from archaeological excavations [30] (Fig.5, n.4).

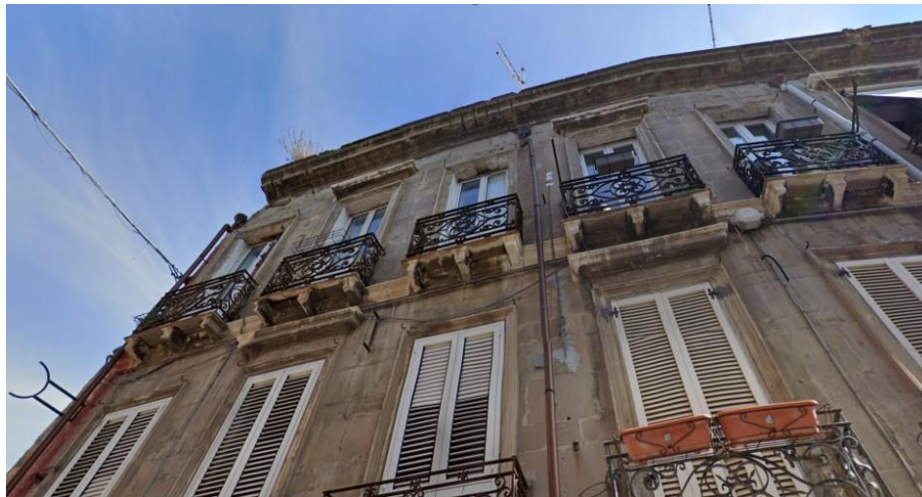
**Fig. 6.** A building in front of empty urban

The result is the presence of an urban emptiness, a vulnerability for other buildings, which has not found a total resolution with the adopted measures: it is observed in fact that the buttress appears here not to be sufficient to ensure the balance to the architectural building that was not thought to constitute the head of the block. Obviously, there is a correlation between the fissuring framework that is present today and the damage caused by the bombings occurred 80 years ago: we can call this the “indirect damage”. The buttress in the facade in front of the urban void has a lower height than the building itself, and this generates a particular criticality on the upper floor, where clearly there is a disconnection of the joints with hinge on the interfloor. It is not a coincidence that the lintel of the upper door, close to the cantonal, is propped up while, with further distance from the cantonal, the instability appears to be less and less worrying. (fig. 6)

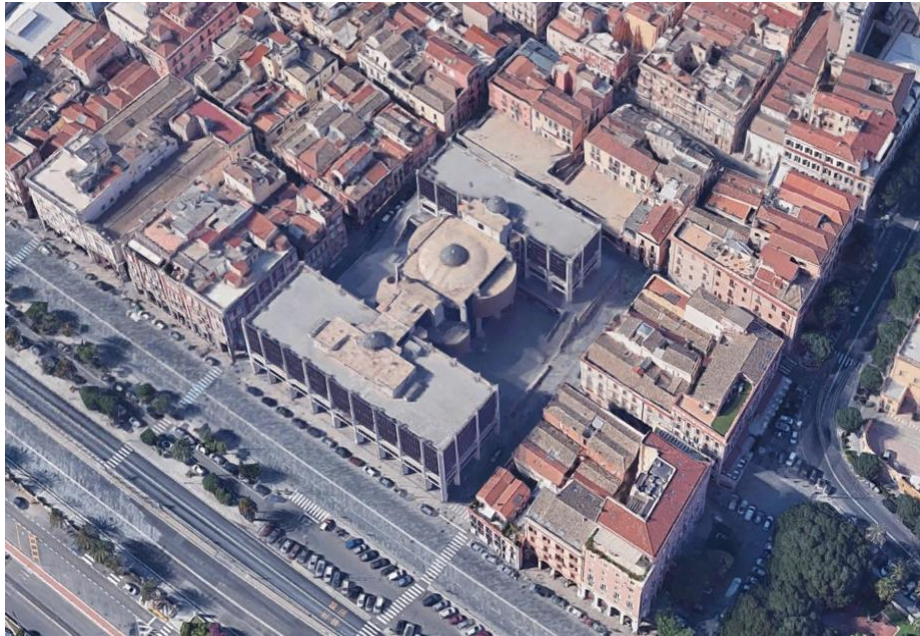
**Fig. 7.** Palazzo della Regione ([www.sardegnaeopoportale.it](http://www.sardegnaeopoportale.it))

damaged ones are sacrificed: this is, for example, the case of the “Regional Palace” (“Palazzo della Regione”), built in this area because was partly affected by urban voids caused by the bombs (Fig.5, n.6 and Fig. 7). In 1963 the process for the rebuilding began, and its first solution was rejected by the municipality due to the limitation the view of the Castle, until the end of the 1988, when the present building was inaugurated. The block behind, also affected by damage classified partially as high and medium, will give space to a volume which, once again, hosts parking spaces.

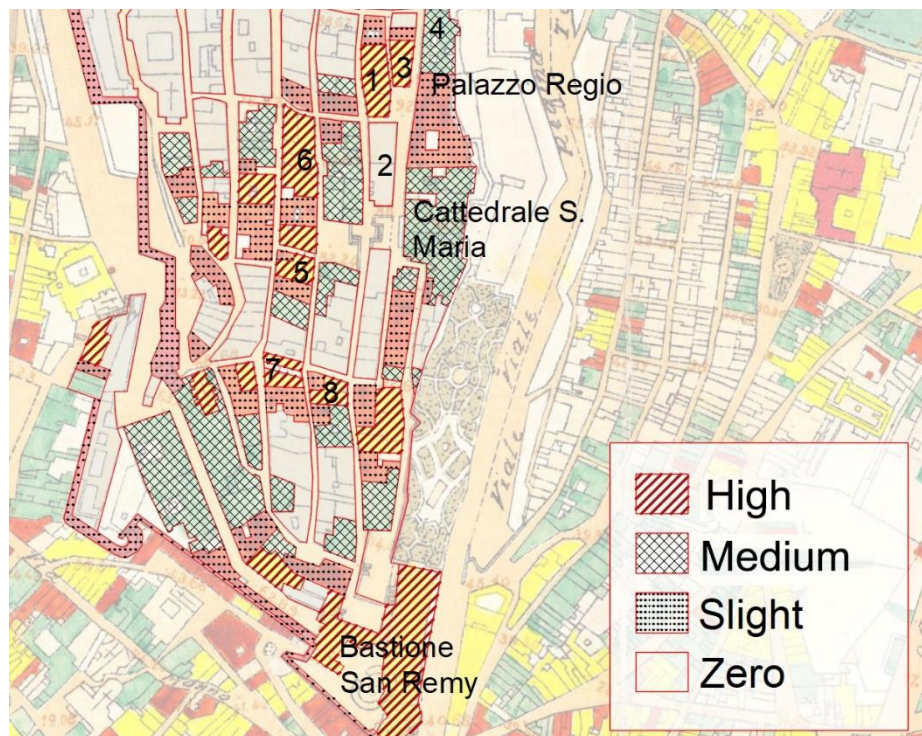
**Fig. 8.** The II war damage in the neighborhood of Castello (synthesis of historical cartography)

In other situations, the generated gaps are the occasion to create parking spaces (e.g. fig.8, n.1-3-6), a need that causes demolitions for the expansion on blocks without damage in other areas (e.g. fig.8, n.2) where buildings for public use and of great importance, such as the cathedral or Palazzo Regio, need to be reached by vehicles. Among these monuments are not lacking of attention to restoration, we find situations that are far from be resolved, such as buildings in a state of ruin like some of the constructions in the parking area on the north side (fig. 8) or, not far from the Cathedral, other buildings in a partial state of ruins and with a few parking lots (e.g. fig.8, nbs. 6, 7, 8); among them there are also buildings of a certain value, such as Palazzo Aymerich (Fig.8, n.7), the noble residence of a wealthy family of the city, which covers an area of approximately 670 m<sup>2</sup>. Another one, Palazzo Asquer (Fig.8 front of n.5) was partly rebuilt, and its instability can be traced back to these two phases.

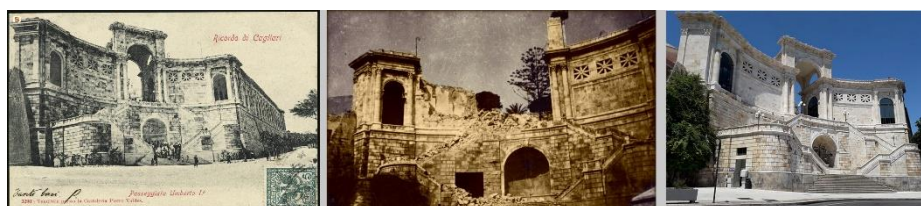
**Fig. 9.** Bastioni San Remy: before 1943, after damage, today (1st photo by <https://www.sardegnaigitallibrary.it/> and 2th by <http://www.sardegnaotterranea.org/>)

The case of Bastioni San Remy (fig.9) is emblematic, considering the monumentality of this architecture. The structure, built between 1896 and 1902, was classified as highly damaged by war bombing. Observing the historical images, the main elevation on Viale Regina Margherita was affected by a partial collapse: we can see the total loss of the central arch and part of the stairs on its right side. After the inevitable debate on the method of reconstruction, the gap was compensated, and without any distinction, the missing part was rebuilt in the years 1946-1948.

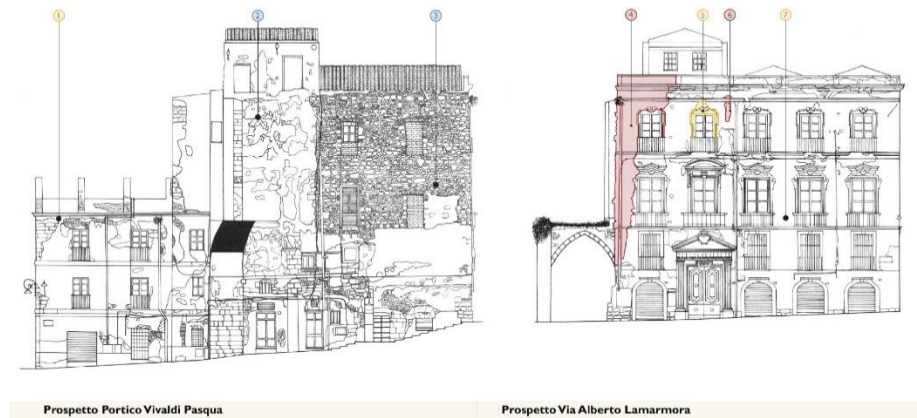
**Fig. 10.** Geometric survey of Palazzo Asquer [LACHE Archive]

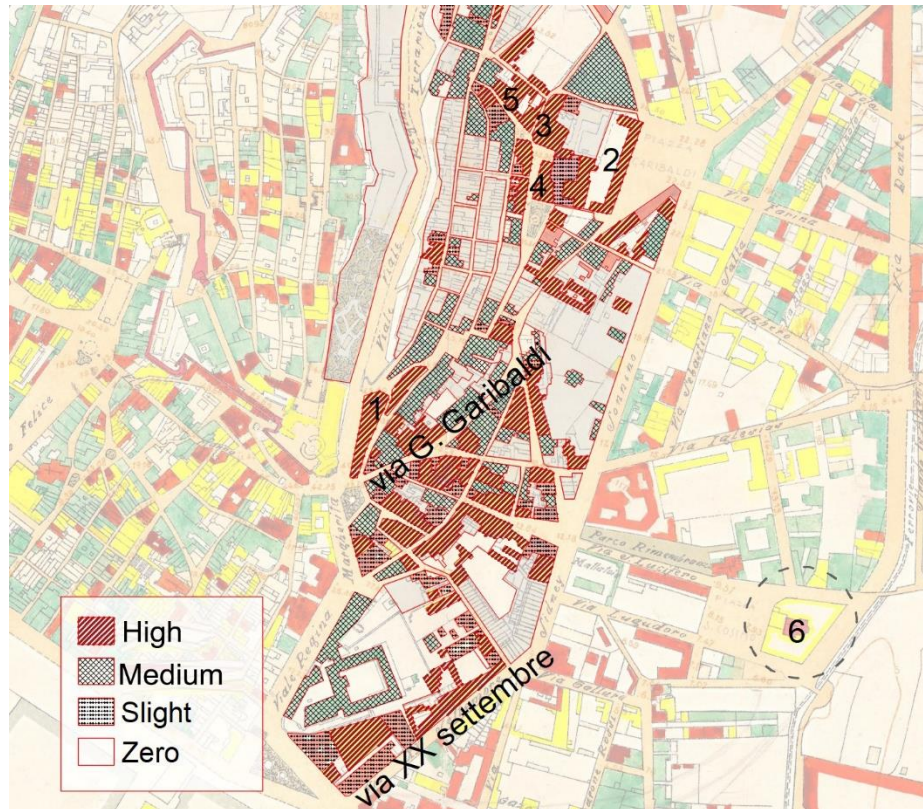
**Fig. 11.** The II war damage in the neighborhood of Villanova (synthesis of historical cartography)

In the neighborhood of Villanova, during the II World War, the buildings were damaged as reported on the table below. The situation in the Villanova district (an example of which is shown in figure 11) appears to be not very dissimilar from the adjacent district, although the number of highly damaged buildings is slightly higher, and the figure relating to average damage is lower.

There was no desire to denounce the rebuilt part, but today everything is unique and damaged by disfiguring writings on the base: this is the result of a failure to overcome the overall redevelopment of the city, which is also reflected in the most prestigious buildings. Another example of war damage in valuable architecture partially rebuilt is the convent of San Domenico (fig.11, n.2). The blocks near it or near the other church present here, the Church of San Vincenzo de' Paoli, are almost all highly damaged (fig.11, nn.3 -4). They are most of all unbuilt spaces, private courtyards, parking lots and small green areas, according to the needs of the church building complex. Not far from there (n.2) a new building was built, for the nursery school (fig.11, n.5).

Finally, the Basilica of San Saturnino, of Byzantine foundation, dating back to the 5th/6th century (fig.11, n.6) and located near this district, is worthy of mention. Already incorporated into the historic city since the beginning of the twentieth century, it suffered some war damages, and since then, a whole series of restorations have taken place, leaving many critical unresolved issues. Although we could discuss a lot about

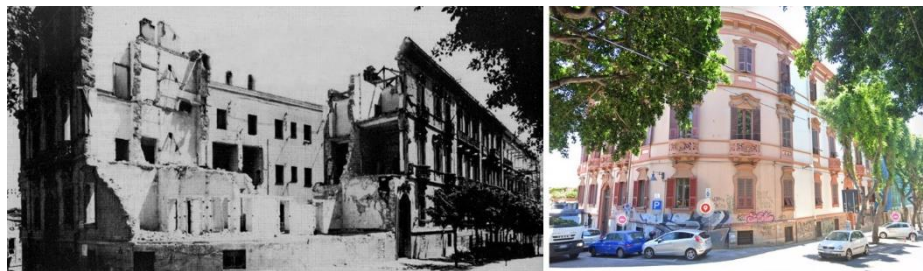
**Fig. 12.** Palazzo Valdes, Image after the 1943 bombing [<https://www.cagliariperimmagini.it/>] and the building today [google maps] images consultation date 05.01.2022

The historical images give back the complete picture of the damage which seems sometimes to have been overcome by erasing traces and reconstructing both the structure and the finishes in every detail. This is the case, for example, of Palazzo Valdes (on the map, fig.11, n.1 and Fig. 12), a prestigious building, built in two phases, first in 1894 and enlarged in 1905 [32]. We observe how the gap generated by the collapses affected a large portion of the building, particularly interesting for its geometry, with a curvilinear solution to connect the main and side elevations, in the decorative pattern attributable for the most part to the Art Nouveau style.

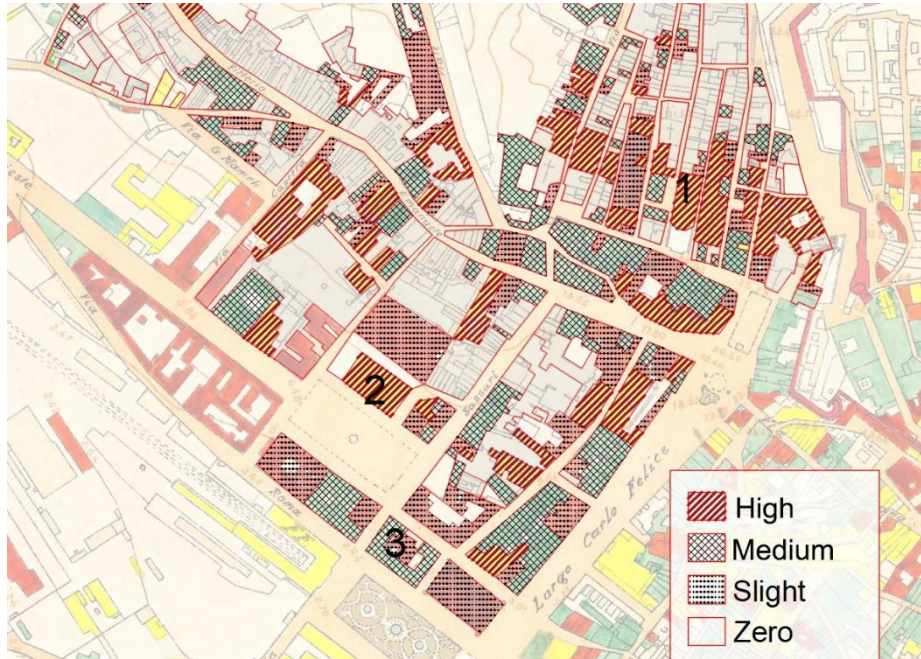
**Fig. 13.** The II war damage in the neighborhood of Stampace  
(synthesis of historical cartography)

The Church of Sant'Anna [34] (fig.13, n.1) was highly damaged, as well as the block facing its right side: the church was restored while, in the other block, historical buildings were totally eliminated, and about in 1/3 of the surface new palaces without any architectural value were built. The remaining area has urban voids, where we find spontaneous green, with no serviceability, and also extended to the part of the block on which the structures surveyed as free of damage. The entire northern part of the district is characterized by new buildings (architectures which can be dated from the second half of the last century), which do not attempt to harmonize with the context, but only respond to functional needs. A different synthesis must be made for monumental buildings, such as the Post Office, in Piazza del Carmine (n.2) [35]. The building, built between 1926 and 1932, reveals no sign of this page of history. On the contrary, Palazzo Vivanet (fig.2 paragraph 3) clearly demonstrates the compensation for the gap. This last example, therefore, shows generally missing sensitivity that appears during any intervention of reconstruction carried out in the city.
