Murat Reis complex: Survey, Documentation and Restoration of the Mosque

Chrysidis Anna¹, Konstantinidou Elena², Miltiadou - Fezans Androniki²,
Tsakanika Eleftheria²

Abstract. At the northern end of the new city of Rhodes, just outside the medieval city an 8-acre "dead zone" includes the cemetery and the "Murat Reis" complex. Murat Reis the Elder, after whom the complex takes its name, was one of the important corsairs that served the Ottoman Navy during the Suleiman reign. Shortly after the death of Murat Reis in 1609, a complex of important monuments was created around his tomb, which includes the mosque, the purification fountain and the tekke accommodation buildings. The subject of this work was the historical and architectural documentation, the constructional analysis, the recording of the pathology and the elaboration of a proposal for the restoration of the mosque. Compared to the other mosques of the city, the Murat Reis is a special example with characteristics of the Ottoman Baroque era with the introduction of neoclassical elements. In addition, the mosque stands out for the morphology of its minaret, which is not found in any of the other mosques of Rhodes. In this st

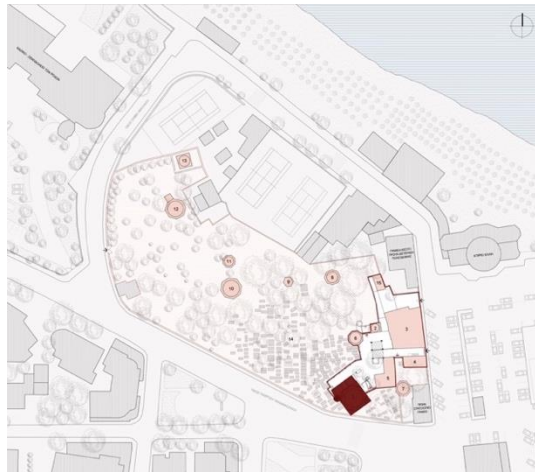
Fig. 3. General plan of the Murat Reis complex

The complex, today, consists of an important monumental ensemble (Fig. 2), that extends around the mausoleum of Murat Reis and includes:

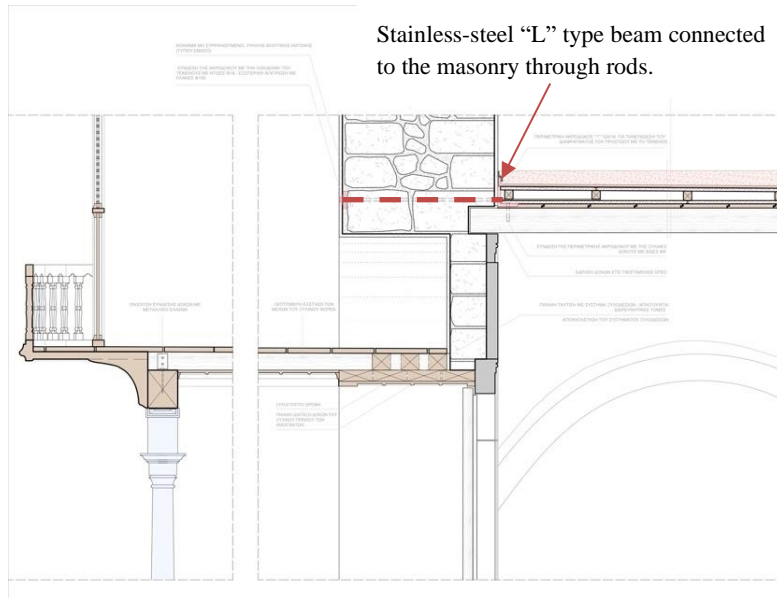
Fig. 15. Construction detail of the restoration proposal of the porch.

The most important structural problems faced by the mosque are found in the area of the porch, which has collapsed and has been temporarily propped up with wooden elements. By its nature the porch is a vulnerable structure seismically compared to the mosque and is exposed to the environmental conditions at a faster rate. The stones of the porch, due to the loss of the renders and plasters, are exposed to descending moisture, direct effect of rain and soluble salts transported from the sea. Thus, they suffer surface erosion in the form of sanding, which progresses from the outer surface to the inner, reaching a great depth. As a result, in addition to the weakening of the mechanical strength of the stones, wear develops unevenly between adjacent stones.

The most important operation is the reconstruction of the porch. Due to the high percentage of worn stones and loss of material, the surviving section will be removed and reconstructed from new carved sandstone. The new wooden beams of the flat roof will be reinstalled in the existing nests of the NW face. On top of the beams the wooden sheathing will be nailed consisting of timber planks (ceiling) and a layer of marine plywood plates over them, in order to improve the diaphragmatic behavior of the roof. To connect the diaphragm to the NW wall of the mosque, a stainless-steel L type beam is placed above the wooden beams around the perimeter and in contact with the masonry, which is connected to it through rods that are anchored to its inner side. The L type stainless steel element is screwed on all the timber beams completing the connection of the diaphragm with the NW wall of the mosque. The roof's small inclinations are formed with wooden elements of varying height on which a second layer of marine plywood plates is nailed. The surface is smeared with bituminous emulsion and the final coating is done with a waterproofing membrane with fine aggregates. At the end, a mortar finishing of kourasani is applied (Fig. 15).

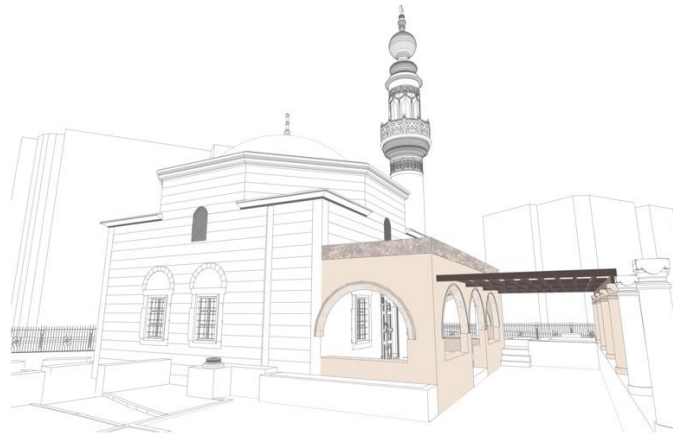
Fig. 16. Representation of the restoration proposal of the porches

The wooden 2nd porch, since there is no sufficient documentation of its original form and structure, is proposed to be constructed in the form of a pergola (Fig. 16). For its construction, 4 wooden beams of 15x17 cm will be used, which will be based on a timber main beam over the colonnade of the courtyard. The connection with the timber main beam and the columns will be reinforced with L-shaped metal elements. In the other direction, the beams are placed in the beam holders of the porch. Across the main beams every 30 cm secondary wooden beams of 9x8 cm are nailed. The shading of the pergola will be completed with arbors.
