Murat Reis complex: Survey, Documentation and Restoration of the Mosque

Chrysidi Anna¹, Konstantinidou Elena², Miltiadou - Fezans Androniki², Tsakanika Eleftheria²

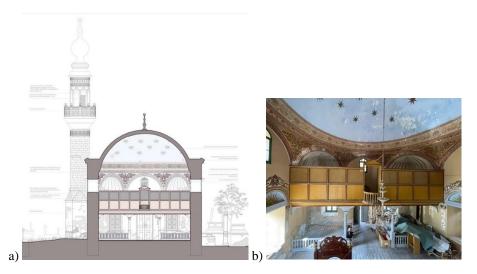
Fig. 5. (a) Section of the Mosque looking to the NW, where the mezzanine is also shown, (b) View of the mezzanine from the SE (March 2022)

The length of the north-west wall of the hall is occupied by the mezzanine, (Fig. 5) which is accessed through the inner stairs of the minaret. It is characterized by privacy, as the screen of crossed wooden plates is so high that it prevents anyone from seeing the worshipers praying. Usually, the mezzanines are reserved for praying women, however there is no official document confirming that this mezzanine was a place of prayer for women.

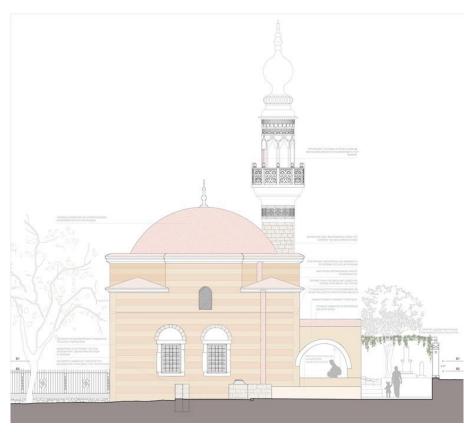
Fig. 14. Restoration proposal of the NE façade following the existing phase of the plastering with the horizontal zones in ceramic and ocher colors.

- The preservation of the phase that the mosque was plastered and the revealing of the morphological elements of the openings that have been covered with the plaster. (Fig.14)
- The opening of the inner access of the original minaret to the southwest wall of the hall and the addition of a rigid metallic frame with glass in the arched opening.
- The reconstruction of the stone porch according to its original form, as documented in this work.
- The reconstruction of the wooden successive porch in the form of a pergola, as its original form could not be fully documented.
