Technical Annals

# Murat Reis complex: Survey, Documentation and Restoration of the Mosque

**Abstract.** At the northern end of the new city of Rhodes, just outside the medieval city an 8-acre "dead zone" includes the cemetery and the "Murat Reis" complex. Murat Reis the Elder, after whom the complex takes its name, was one of the important corsairs that served the Ottoman Navy during the Suleiman reign. Shortly after the death of Murat Reis in 1609, a complex of important monuments was created around his tomb, which includes the mosque, the purification fountain and the tekke accommodation buildings. The subject of this work was the historical and architectural documentation, the constructional analysis, the recording of the pathology and the elaboration of a proposal for the restoration of the mosque. Compared to the other mosques of the city, the Murat Reis is a special example with characteristics of the Ottoman Baroque era with the introduction of neoclassical elements. In addition, the mosque stands out for the morphology of its minaret, which is not found in any of the other mosques of Rhodes. In this study, the main findings of a detailed research are first presented, reg

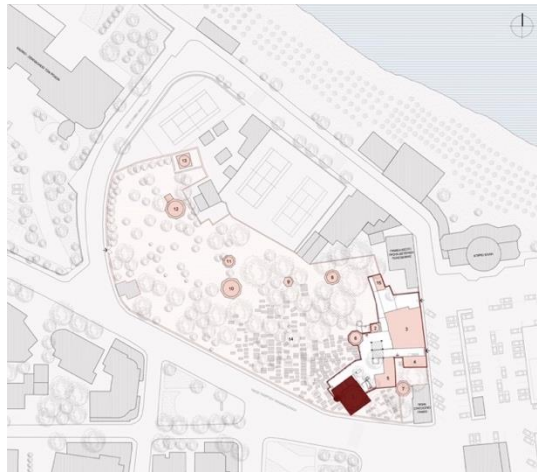
**Fig. 3.** General plan of the Murat Reis complex

The complex, today, consists of an important monumental ensemble (Fig. 2), that extends around the mausoleum of Murat Reis and includes:

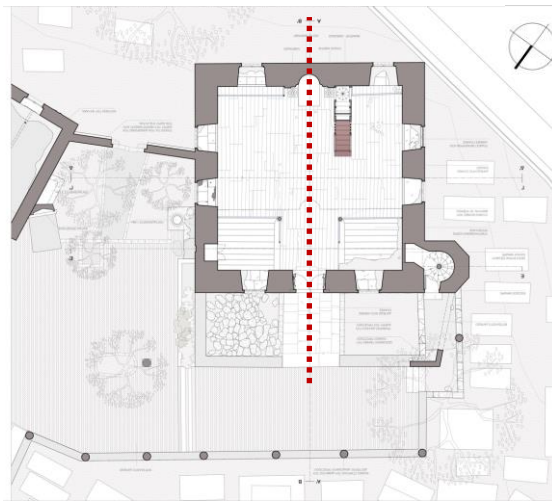
**Fig. 4.** Plan of the Mosque. The mihrab is located directly opposite the entrance door following the symmetry axes of the square floor plan.

The mosque was built to serve a small community of dervishes, as well as worshipers visiting the tomb of Murat Reis. Following the typology of the Bursa's mosques in its simple form, it consists of a prayer hall with a square floor plan (Fig. 4) with internal dimensions of 7.80 x 7.80m and a height of 9.00m. The hall is covered with a hemispherical dome supported by arches, squinches and pendentives, forming an octagon.

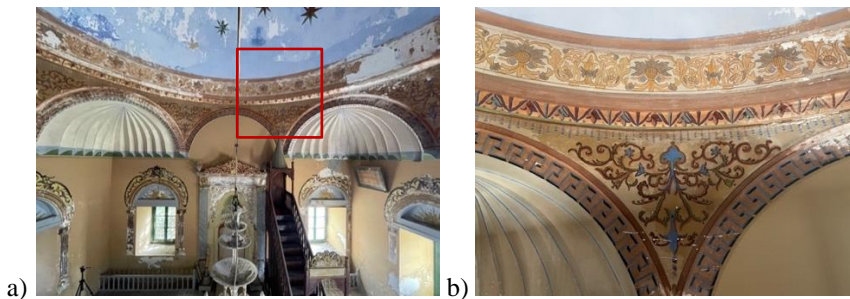
**Fig. 6.** a) General view of the painted decoration with floral motifs between the arches. b) Detail of floral motifs

The painted decoration (Fig. 6) of the mosque, is a typical example of the trend that appeared in the 18<sup>th</sup> century in Ottoman buildings, known as Turkish baroque. The influence of Western architectural forms, led to the replacement of traditional Arabic or Persian themes with decorative reliefs and Western motifs. All these decorations were executed with watercolors on top of the first coat of plaster.

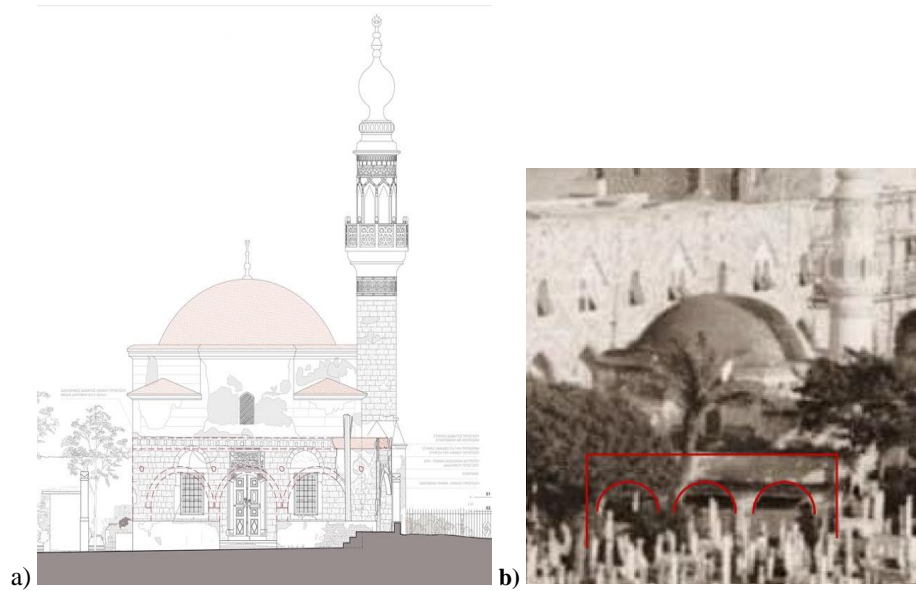
**Fig. 7.** (a) Representation of the porch's façade. (b) Photo of the Mosque in 1927, on which the porch is shown with red lines. [Reproduced from the archive of Stavros Georgallidis]

Before the entrance of the mosque, there was a stone arched porch, the "revak", which is considered as the outer extension of the prayer hall. From the part that is preserved in the western area of the temple, as well as from the springer of the arch in the east, it seems that the façade of the porch was constructed with three consecutive arches. (Fig. 7a). This assumption is also confirmed by the photographic archives (Fig. 7b). The porch was covered with a flat roof, which is confirmed by the beam sockets on the northwest wall of the mosque and by the preserved section of the porch.

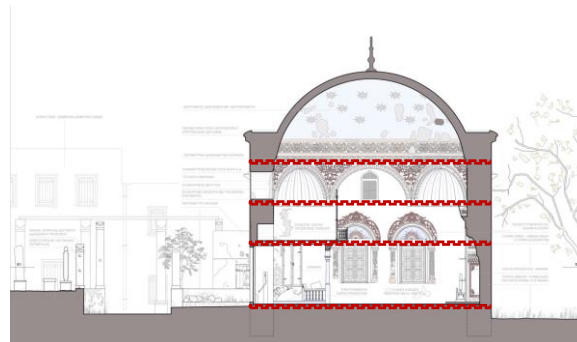
**Fig. 10.** The possible position of the horizontal timber laces system (xylodesias)

The masonry seems to be reinforced with a horizontal timber system (xylodesia). Specifically, underneath the load bearing elements of the mezzanine (i.e., as bedding for its timber beams) and above the openings (level of lintels), 3 timber wooden laces of 11x9 cm were found. The position of these laces suggests that they are part of a wooden horizontal framing system for the tying and confinement of the building. Due to the plasters, it was not possible to document their existence at other levels. As documented from other similar structures, the possible positions of wooden frameworks are above the openings, at the base of the masonry, at the level of springing of the arches and at the base and the top of the tympanon of the hemispherical dome. A better presentation of their possible position in the structure of Murat Reis Mosque is given in the drawing of Fig. 10.

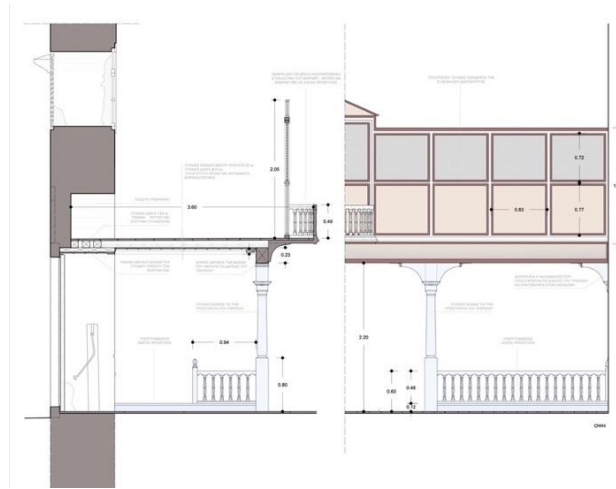
**Fig. 11.** Constructional details of the mezzanine

The load-bearing structure of the mezzanine (Fig. 11), consists of wooden beams with an average cross-section of 8 x 10 cm, which rest on one end on the external NW masonry and on the other end on a large beam of dimensions 18 x 23 cm, which rests on the masonry of NE and SW walls. The large beam is supported by two wooden columns on either side of the central entrance area and two corbels in contact with the walls.

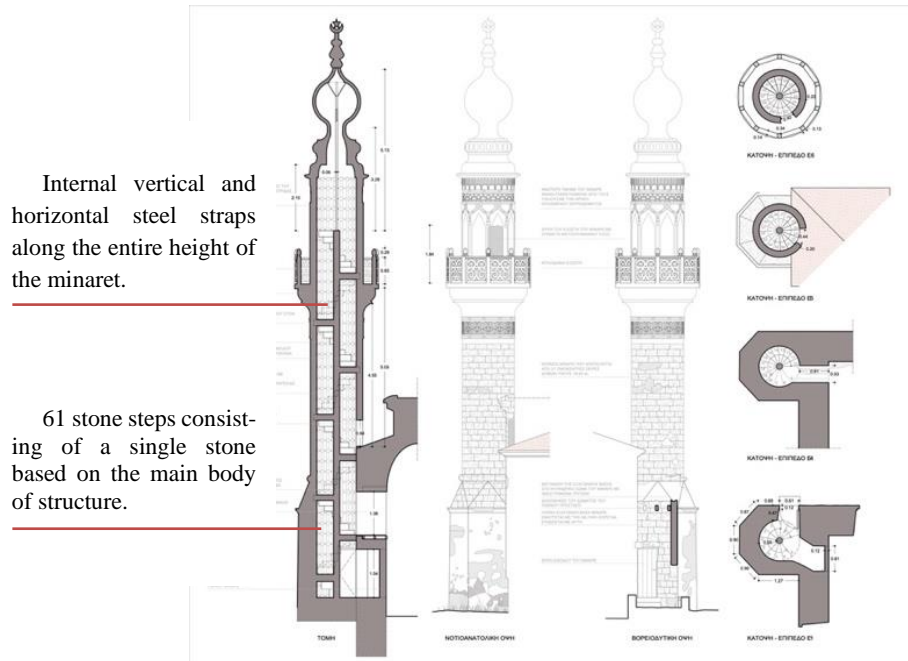
Fig. 12. Constructional details of the minaret.

The minaret has a hexagonal base which touches the SW face of the mosque without being connected to it. Its body consists of 21 concentric rows of stones, 19-20 cm high. The cohesion of the construction is enhanced by the use of mortar between the joints of the stones, (Fig. 12)

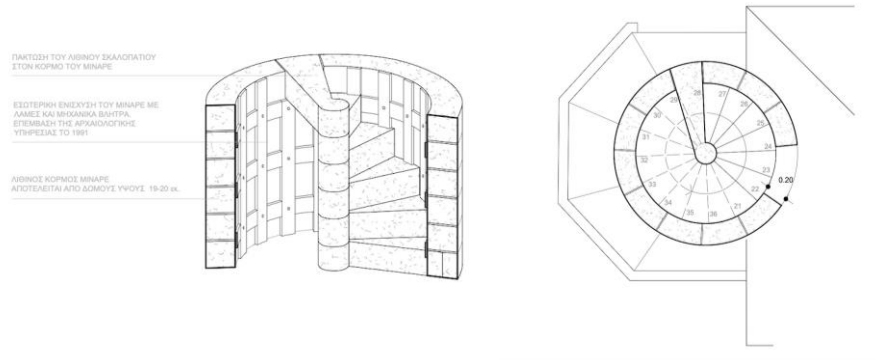
**Fig. 13.** Construction detail of the staircase of the minaret. The internal intervention with metallic vertical and horizontal steel straps is also shown.

The staircase of the minaret is formed by 61 stone steps. Each step consists of a single stone, which is shaped like a 'trapezium'. This 'trapezium' moves circularly by one position per level. The way the steps in the minaret were put together, could not be precisely determined, however, the most common way is for the step to be based on the main body of structure or even to be a part of the body. The staircase is a very important structural element for the stability of the minaret, due to the significant weight that adds to the center of gravity of the structure, as well as due to the continuous connection of the cylindrical external masonry to the core of the minaret, along its height (Fig. 13).

In the following years, important repair and strengthening structural interventions were carried out in the minaret. Internal vertical and horizontal steel straps were placed, using bolts and special cement mortar. Repairs and repositioning of the collapsed upper part were made too and a stainless-steel metal tube was installed to the last step of the ladder, in order to strengthen the stability of the upper part. More information about the date and type of the applied interventions will emerge after further investigation.

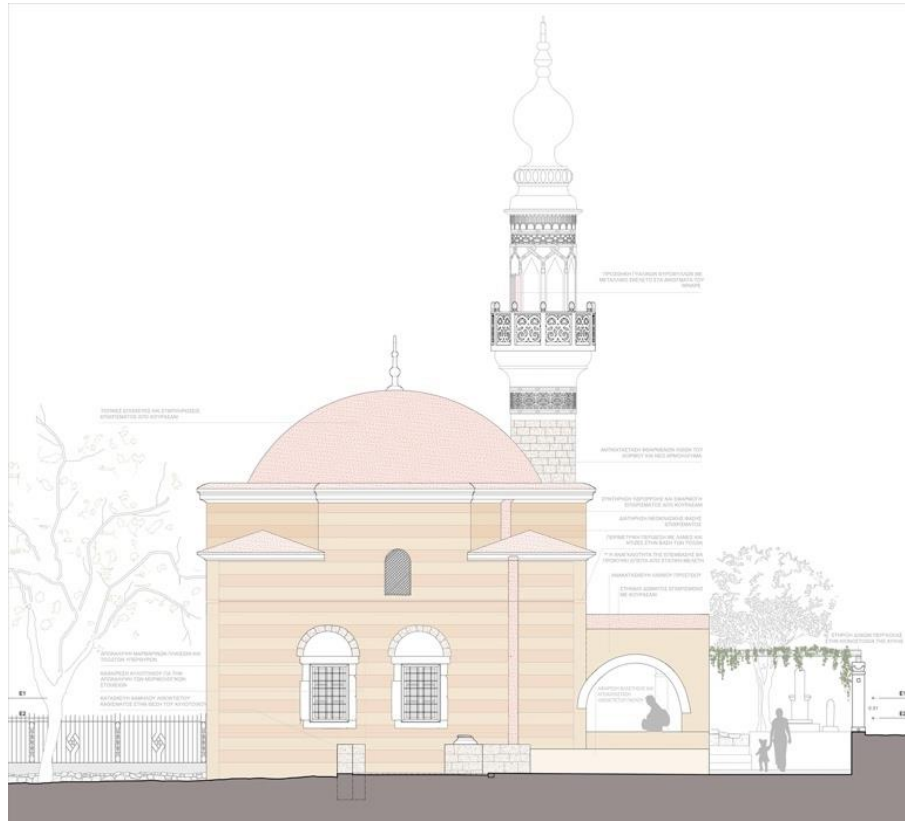
**Fig. 14.** Restoration proposal of the NE façade following the existing phase of the plastering with the horizontal zones in ceramic and other colors.

- The preservation of the phase that the mosque was plastered and the revealing of the morphological elements of the openings that have been covered with the plaster. (Fig.14)
- The opening of the inner access of the original minaret to the southwest wall of the hall and the addition of a rigid metallic frame with glass in the arched opening.
- The reconstruction of the stone porch according to its original form, as documented in this work.
- The reconstruction of the wooden successive porch in the form of a pergola, as its original form could not be fully documented.

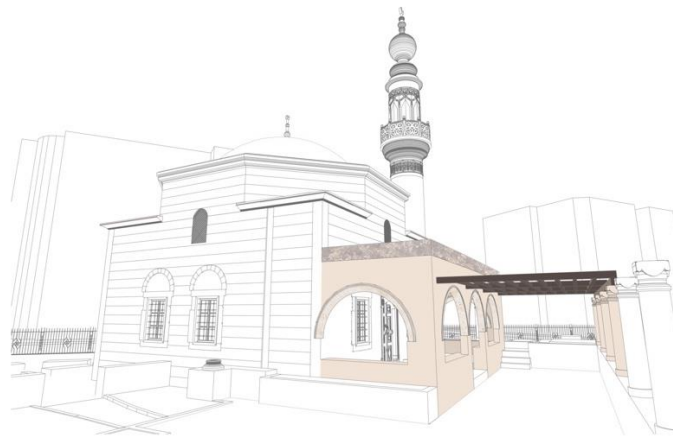
**Fig. 16.** Representation of the restoration proposal of the porches

The wooden 2<sup>nd</sup> porch, since there is no sufficient documentation of its original form and structure, is proposed to be constructed in the form of a pergola (Fig. 16). For its construction, 4 wooden beams of 15x17 cm will be used, which will be based on a timber main beam over the colonnade of the courtyard. The connection with the timber main beam and the columns will be reinforced with L-shaped metal elements. In the other direction, the beams are placed in the beam holders of the porch. Across the main beams every 30 cm secondary wooden beams of 9x8 cm are nailed. The shading of the pergola will be completed with arbors.
