Seabed Morphology Assessment and Pockmark Detection for Port Construction and Maintenance, Using a Multibeam Echo-sounder: A Case study in Katakolo Port, Western Peloponnese, Greece

Dimitra Kiousi^{1,2}, Panagiotis Sartampakos² and Vasiliki K. Tsoukala¹

¹Laboratory of Harbour Works, National Technical University of Athens, Iroon Polytechniou st., 15780 Athens, Greece

Abstract. The port of Katakolo is located in the Kyparissian Gulf, where the escape of natural gas is being observed. Result of this systematic leakage is the formation of circular depressions, known as pockmarks, which undermine the integrity of the seabed where port infrastructures might be established. This study investigates the current condition of pockmark formations inside the port of Katakolo, following an incident that occurred in 2009, when sections of the commercial quay sub-sided. Additionally, it studies the morphology and activity of these features and their potential influence on the structural integrity of the port. Detailed bathymetric data, using a multibeam echosounder, were collected and studied. The generated 3D model of the port indicated the presence of active pockmarks, which exhibit elongate

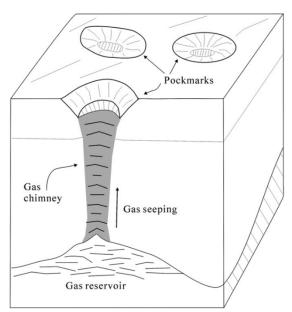
Fig. 1. Diagram illustrating gas seepage from a subsurface reservoir through a gas chimney, leading to the formation of pockmarks on the seafloor (Source: Hovland M., 1989)

This accumulation creates domes on the seafloor, and small tension fractures on these domes allow gas to escape. As the gas venting enlarges these cracks, the venting velocity and erosion increase, leading to a violent burst of escaping gas, which forms a unit pockmark. These unit pockmarks can continue to develop, cluster and coalesce to develop a fully-grown composite pockmark [9, 10].

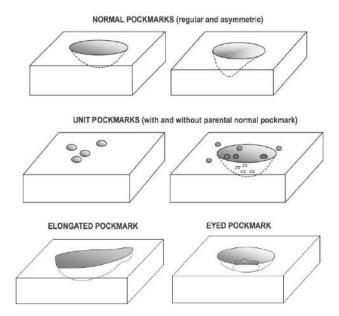
Fig. 2. Pockmark formation main morphological classes. (Source: Hovland M., et al., 2002).

Pockmarks exhibit diverse morphological characteristics [5,6], influenced by factors such as fluid expulsion rate, sediment composition, and hydrodynamic conditions. They are generally categorized into six morphological classes, as illustrated in Fig. 2. Unit pockmarks are small depression typically measuring 1 to 10 m across and up to 0.5 m deep, probably representing a one-time expulsion event [11, 12,13]. This type is common inside and around normal pockmarks [13]. Normal pockmarks are more common, characterized as circular depressions that range from 10 to 700 m in diameter and from 1 to 45 m deep [12]. Their cross sections can vary from low-angle basin-formed shapes to asymmetrical and steep-walled features, with some even displaying a funnel shape in the centre. Elongated pockmarks are depressions with one axis that is much longer than the other. They occur on slopes and areas of seafloor influenced by strong bottom currents. Eyed pockmarks contain an acoustically high-reflective object on region in its central part, which could either be caused by coarse material remaining after the erosive process (winnowing), from biological activity (dead and living shells) or from authigenic carbonate precipitation. [13]. Strings of pockmarks consist of unit pockmarks or small normal pockmarks arranged in curvilinear chains or strings, which may be kilometers in length. They are suspected to be a result of fluid focusing along near vertical faults, flexures, or weakness zones in the upper sedimentary layer. Complex pockmarks occur as clusters of normal pockmarks or amalgamations of large pockmarks [13].

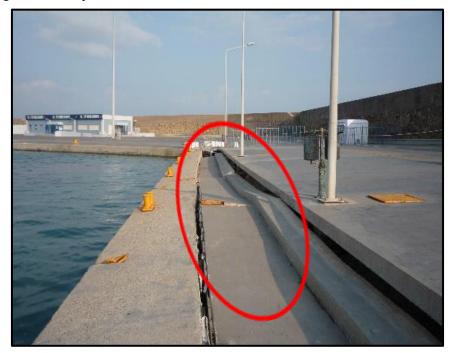
Fig. 5. Subsidence of sections of the commercial quay of Katakolo Port in 2009, circled in red. (Kiousi et al., 2023)

At the port of Katakolo, a significant incident occurred in 2009 attributed to pock-mark formations, provoked the subsidence of sections of the commercial mooring quay (Fig. 5). In addition, during the survey conducted in 2018 [14], related to the impact of gas seepages on the port and surrounding infrastructure, it was observed that gas accumulation beneath asphalt and concrete surfaces led to mechanical deformation, swelling, and the formation of cracks. The study particularly noted significant increases in asphalt swelling and the opening of linear fissures after 2010, highlighting the deteriorating ground conditions due to intensified subsurface gas flow. Given the port's considerable annual traffic, which encompasses numerous cruise ships and yachts, the

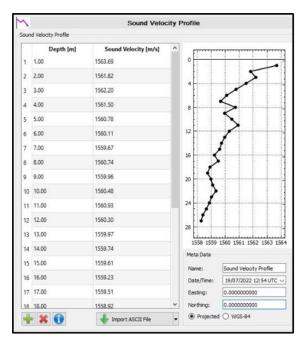
Fig. 6. Sound velocity profile collected in Katakolo, Greece, showing how acoustic speed varies with water depth

The acquisition of accurate velocity profile in the vicinity was imperative due to the principles of Snell's law, which governs the refraction of acoustic waves as they propagate through the water layers of varying densities and temperatures. A sound velocity profiler (SVP) was deployed at the beginning of the survey at a deep point close to the survey area (~-28m). This dataset was essential for correcting beam angle refraction effects and ensuring the accuracy of depth measurements across the multibeam swath.

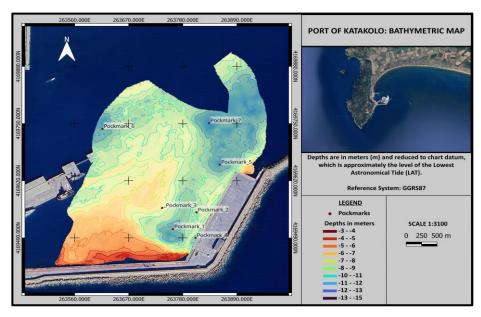
The outcome of the survey was a bathymetric map [Fig. 7] that visually represented the distribution of pockmarks in relation to the port structures and a backscatter intensity visualisation of the area. Seven pockmarks were detected, exhibiting a variety of morphologies, including normal, elongated and unit shapes [Fig. 8].

Fig. 7. Bathymetric map of the Port of Katakolo, Greece, highlighting depth variations and the presence of seafloor pockmarks

The pockmarks were distributed both inside and outside the port area, raising concerns about potential structural implications. Of particular importance is Pockmark 4, located directly beneath the quay structure. This feature presents a significant safety

risk due to its potential impact on the structural integrity of the quay. The formation's presence in close proximity to the quay suggests a possible reduction in load-bearing capacity, which may compromise the stability of port infrastructure and affect its ability to safely support vessels, cargo, and personnel. The variability in pockmark morphology and size indicates differing formation mechanisms, likely influenced by sediment composition, fluid dynamics, and localized geological conditions.

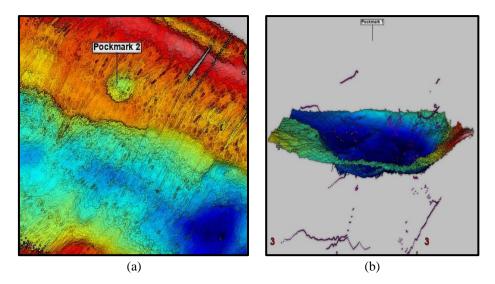
Fig. 8. (a) Illustration of unit-shaped pockmark formation (Pockmark 2), (b) Illustration of elongated shaped pockmark (Pockmark 1)

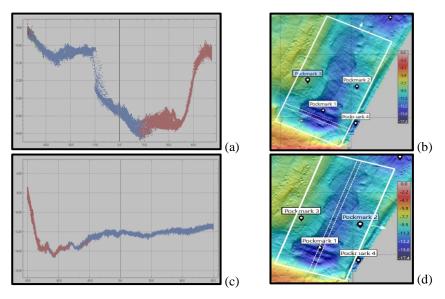
More specifically: Pockmark 1 [Fig. 9.], comprises an elongated pockmark and is the most prominent feature, reaching a depth of -14.8 meters with a 5-meter depression from the seabed and extending 180 meters in length, suggesting a well-developed erosional feature likely influenced by prolonged fluid seepage or sediment displacement. Pockmark 5 [Fig. 12.] exhibits similar depth characteristics (-14.7 meters) but is notably broader, with a width of 80 meters, indicating lateral expansion potentially due to subsurface gas migration or sediment instability.

Fig. 9. Bathymetric profile of Pockmark 1 (Elongated Pockmark), the largest surveyed depression. (a) Slice view across the pockmark formation, (b) Illustration of inspection area used for dimension analysis, (c) Slice view along the pockmark formation, (d) Illustration of inspection area used for dimension analysis

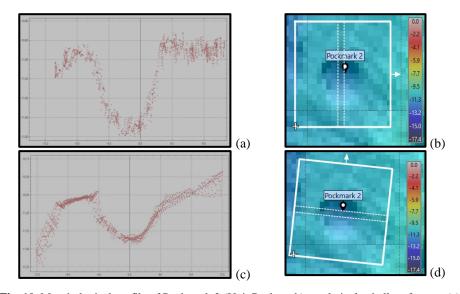
In contrast, Pockmarks 2 and 3 [Fig. 10,11], constitute unit pockmark formations and are significantly smaller, with depths of -11.8 meters and -9.5 meters, respectively. These formations show less pronounced seabed depressions (1 meter and 0.6 meters, respectively) and relatively limited spatial extent (Pockmark 3 being only 4 meters in length). These smaller pockmarks suggest either early-stage formation processes or reduced erosional influence compared to their larger counterparts.

Fig. 10. Morphological profile of Pockmark 2 (Unit Pockmark), a relatively shallow feature. (a) Slice view along the pockmark formation, (b) Illustration of inspection area used for dimension analysis, (c) Slice view across the pockmark formation, (d) Illustration of inspection area used for dimension analysis

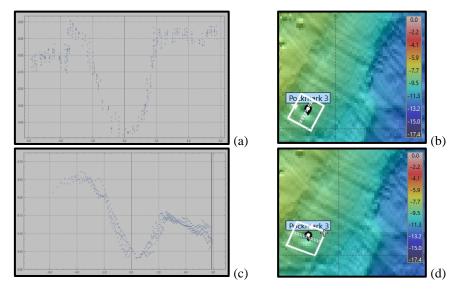
Fig. 11. Bathymetric profile of Pockmark 3 (Unit Pockmark), the largest surveyed depression. (a) Slice view along the pockmark formation, (b) Illustration of inspection area used for dimension analysis, (c) Slice view across the pockmark formation, (d) Illustration of inspection area used for dimension analysis

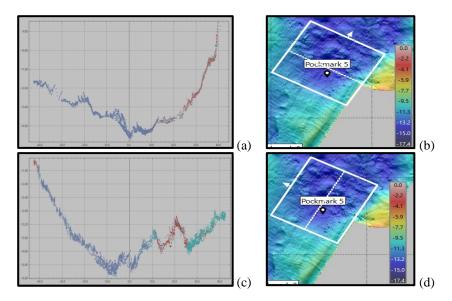
Fig. 12. Bathymetric profile of Pockmark 5, one of the widest formations surveyed. (a) Slice view across the pockmark formation, (b) Illustration of inspection area used for dimension analysis, (c) Slice view along the pockmark formation, (d) Illustration of inspection area used for dimension analysis

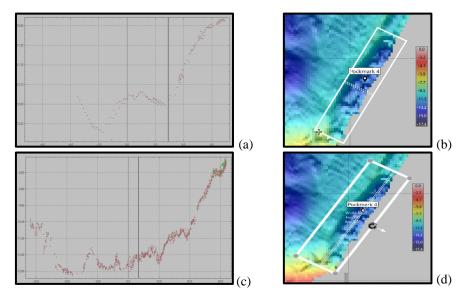
Pockmark 4 [Fig. 13.], located in close proximity to the pier, presents a unique challenge in terms of morphological interpretation. Its geometry remains ambiguous, as its spatial extent is partially obscured by the presence of the pier structure, making it difficult to ascertain whether the pockmark extends beneath it. Unlike the other formations, where depth and lateral dimensions could be clearly delineated, the precise characteristics of Pockmark 4 require further investigation. The use of sub-bottom profiler data is essential to resolve this uncertainty, as it would allow for the detection of underlying gas migration pathways and the potential presence of a gas chimney morphology.

Fig. 13. Bathymetric profile of Pockmark 4. (a) Slice view across the pockmark formation, (b) Illustration of inspection area used for dimension analysis, (c) Slice view along the pockmark formation, (d) Illustration of inspection area used for dimension analysis

To address these challenges, it is imperative to implement a robust monitoring program that includes regular inspections of both the surface and subsurface conditions of critical structures. Utilizing advanced geophysical techniques, such as high-resolution

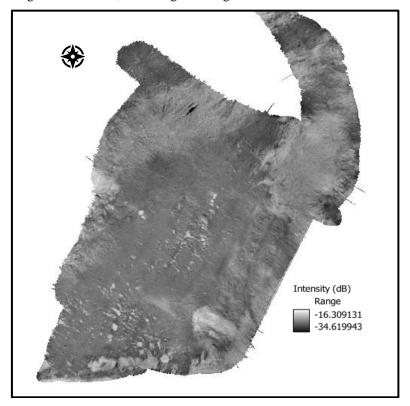
The backscatter processing of the seabed data revealed a range of acoustic intensities between -16 dB and -35 dB, with a predominant occurrence of high to medium backscatter values [Fig. 14]. Backscatter values ranging from -15 to -35 dB, with predominant values around -22 dB, indicate a seabed composition that is likely moderately coarse, such as coarse sand or a mix of sand and gravel. The higher backscatter values closer to -15 dB suggest harder and rougher substrates, such as rocky areas or gravel,

while the lower values near -35 dB correspond to softer, smoother materials like fine sand, silt, or mud. The predominant value of -22 dB suggests a seabed that is generally coarse but not entirely hard, likely with a mix of sediment types. The variability across the range reflects spatial changes in seabed composition, with potential transitions between rough and soft areas, indicating a heterogeneous seabed environment.

Fig. 14: Backscatter data from hydrographic survey in Katakolo, Greece, illustrating acoustic intensity variations in dB

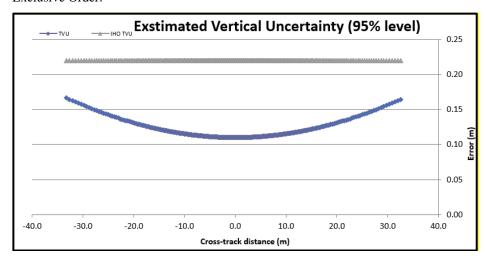
The parameters for the International Hydrographic Organization (IHO) Exclusive Order are defined as a=0.15 m15 and b=0.0075. For an average survey depth of 20 meters, the maximum allowable TVU was calculated to be 0.212 meters. The accompanying figure [Fig.15.] presents the estimated vertical uncertainty at the 95%

confidence level as a function of cross-track distance. The blue curve represents the observed TVU, while the gray line denotes the IHO threshold. The observed TVU follows a characteristic U-shaped distribution, exhibiting lower uncertainty values at the nadir and increasing towards the outer beams. Notably, the measured TVU remains consistently below the IHO-prescribed limit across the entire swath width, indicating that the survey adheres to the vertical uncertainty requirements established for the Exclusive Order.

Fig. 15. Estimated Total Vertical Uncertainty (TVU) at the 95% confidence level across track in a hydrographic survey, compared to IHO TVU standards
