Seabed Morphology Assessment and Pockmark Detection for Port Construction and Maintenance, Using a Multibeam Echo-sounder: A Case study in Katakolo Port, Western Peloponnese, Greece

Dimitra Kiousi[1,2], Panagiotis Sartampakos[2] and Vasiliki K. Tsoukala[1]

[1]Laboratory of Harbour Works, National Technical University of Athens,
Iroon Polytechniou st., 15780 Athens, Greece
[2]NIREAS Engineering, 8 Katsikogianni D. Street, 34132 Chalkida Evia
dimitra_kiousi@mail.ntua.gr, sartabakos@yahoo.gr,
tsoukala@mail.ntua.gr

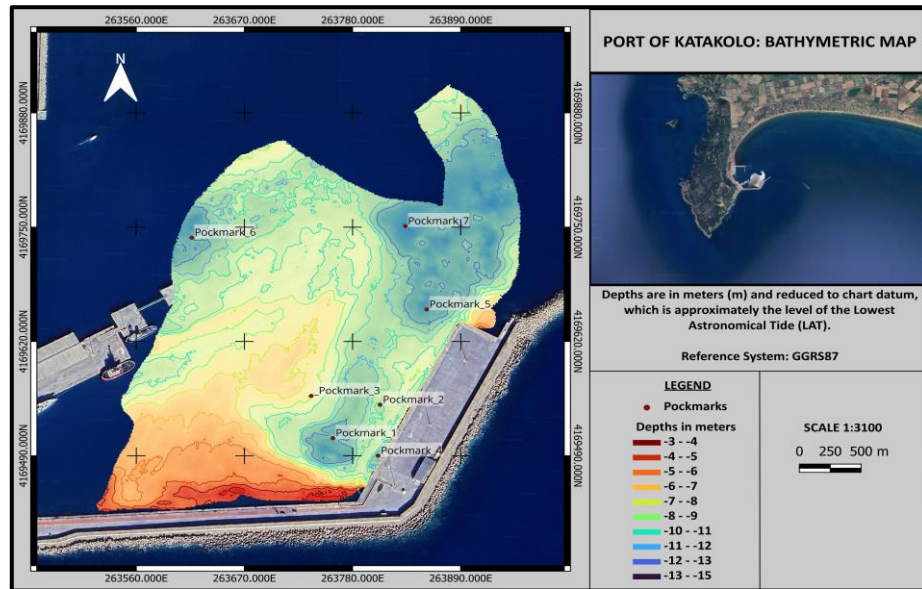
Fig. 7. Bathymetric map of the Port of Katakolo, Greece, highlighting depth variations and the presence of seafloor pockmarks

The pockmarks were distributed both inside and outside the port area, raising concerns about potential structural implications. Of particular importance is Pockmark 4, located directly beneath the quay structure. This feature presents a significant safety

risk due to its potential impact on the structural integrity of the quay. The formation's presence in close proximity to the quay suggests a possible reduction in load-bearing capacity, which may compromise the stability of port infrastructure and affect its ability to safely support vessels, cargo, and personnel. The variability in pockmark morphology and size indicates differing formation mechanisms, likely influenced by sediment composition, fluid dynamics, and localized geological conditions.

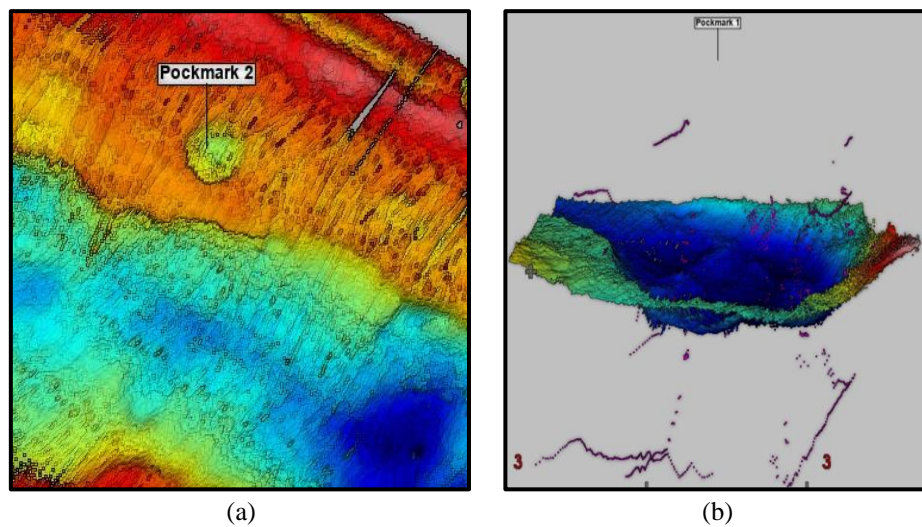
Fig. 8. (a) Illustration of unit-shaped pockmark formation (Pockmark 2), (b) Illustration of elongated shaped pockmark (Pockmark 1)

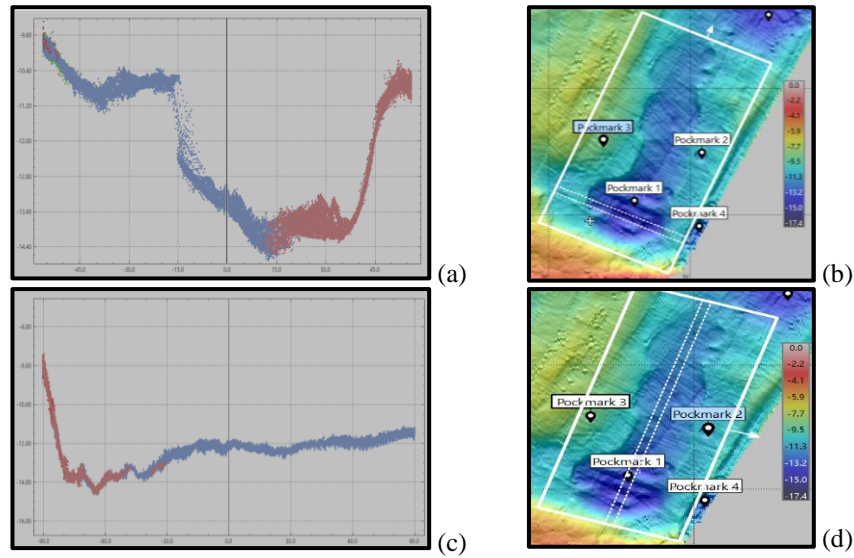
More specifically: Pockmark 1 [Fig. 9.], comprises an elongated pockmark and is the most prominent feature, reaching a depth of -14.8 meters with a 5-meter depression from the seabed and extending 180 meters in length, suggesting a well-developed erosional feature likely influenced by prolonged fluid seepage or sediment displacement. Pockmark 5 [Fig. 12.] exhibits similar depth characteristics (-14.7 meters) but is notably broader, with a width of 80 meters, indicating lateral expansion potentially due to subsurface gas migration or sediment instability.

Fig. 9. Bathymetric profile of Pockmark 1 (Elongated Pockmark), the largest surveyed depression. (a) Slice view across the pockmark formation, (b) Illustration of inspection area used for dimension analysis, (c) Slice view along the pockmark formation, (d) Illustration of inspection area used for dimension analysis

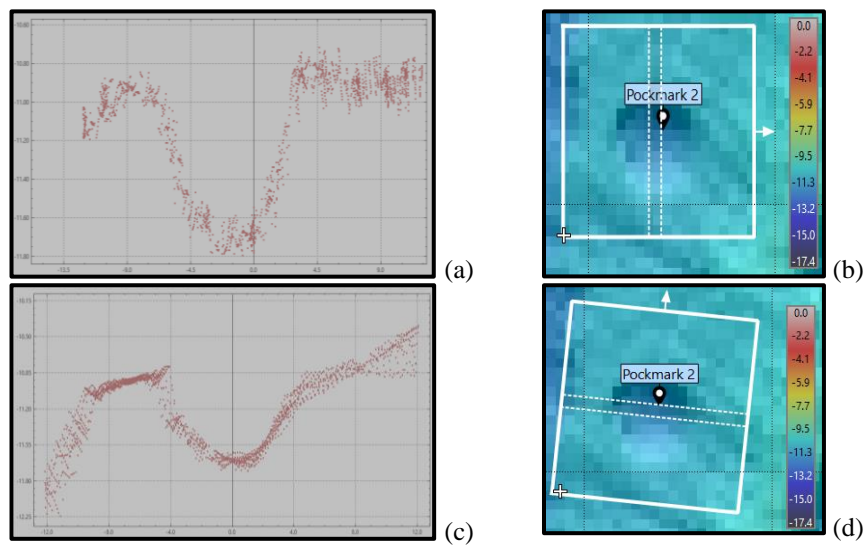
In contrast, Pockmarks 2 and 3 [Fig. 10,11], constitute unit pockmark formations and are significantly smaller, with depths of -11.8 meters and -9.5 meters, respectively. These formations show less pronounced seabed depressions (1 meter and 0.6 meters, respectively) and relatively limited spatial extent (Pockmark 3 being only 4 meters in length). These smaller pockmarks suggest either early-stage formation processes or reduced erosional influence compared to their larger counterparts.

Fig. 10. Morphological profile of Pockmark 2 (Unit Pockmark), a relatively shallow feature. (a) Slice view along the pockmark formation, (b) Illustration of inspection area used for dimension analysis, (c) Slice view across the pockmark formation, (d) Illustration of inspection area used for dimension analysis

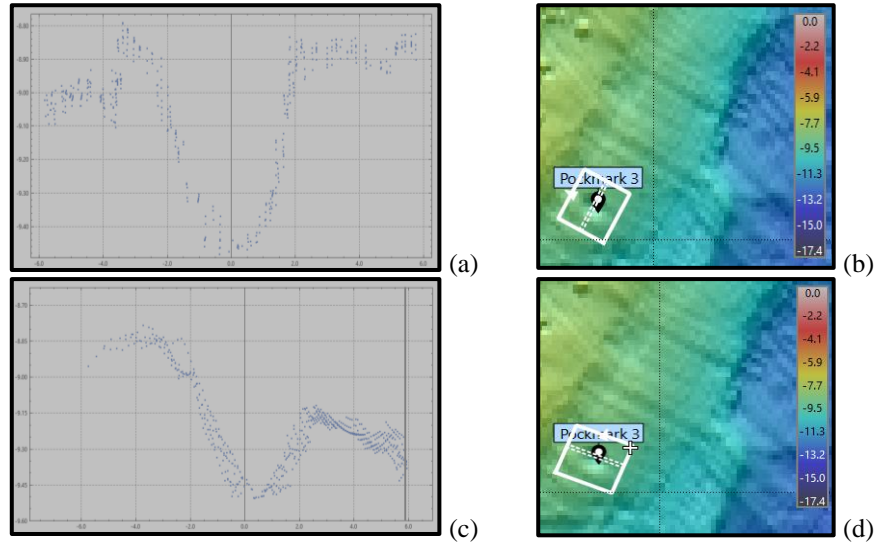
Fig. 11. Bathymetric profile of Pockmark 3 (Unit Pockmark), the largest surveyed depression. (a) Slice view along the pockmark formation, (b) Illustration of inspection area used for dimension analysis, (c) Slice view across the pockmark formation, (d) Illustration of inspection area used for dimension analysis

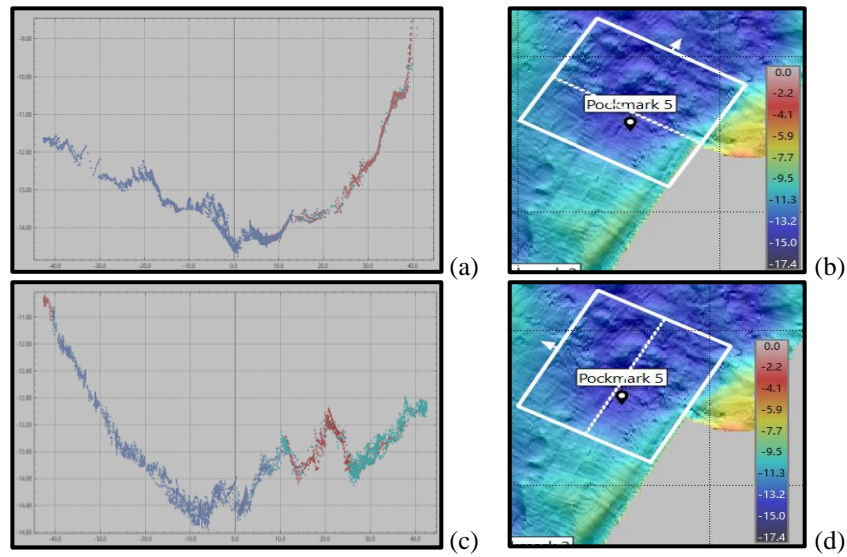
Fig. 12. Bathymetric profile of Pockmark 5, one of the widest formations surveyed. (a) Slice view across the pockmark formation, (b) Illustration of inspection area used for dimension analysis, (c) Slice view along the pockmark formation, (d) Illustration of inspection area used for dimension analysis

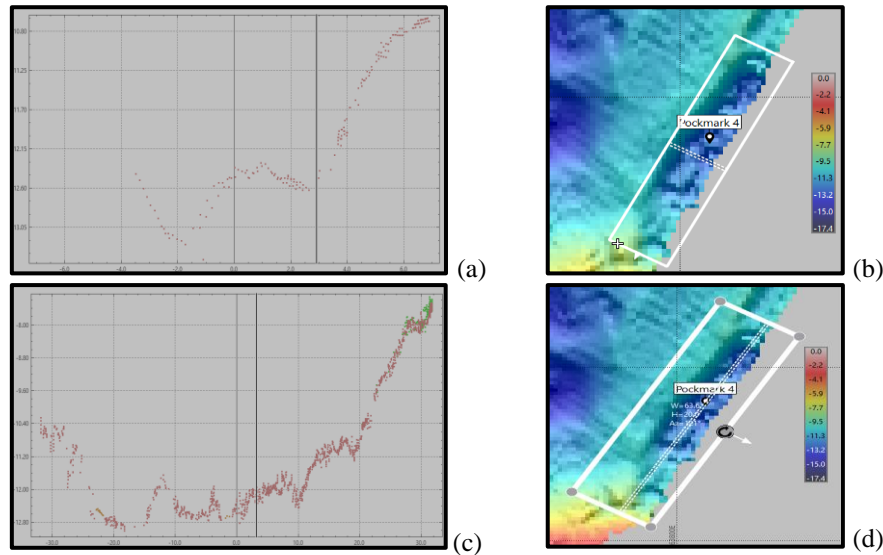
Pockmark 4 [Fig. 13.], located in close proximity to the pier, presents a unique challenge in terms of morphological interpretation. Its geometry remains ambiguous, as its spatial extent is partially obscured by the presence of the pier structure, making it difficult to ascertain whether the pockmark extends beneath it. Unlike the other formations, where depth and lateral dimensions could be clearly delineated, the precise characteristics of Pockmark 4 require further investigation. The use of sub-bottom profiler data is essential to resolve this uncertainty, as it would allow for the detection of underlying gas migration pathways and the potential presence of a gas chimney morphology.

Fig. 13. Bathymetric profile of Pockmark 4. (a) Slice view across the pockmark formation, (b) Illustration of inspection area used for dimension analysis, (c) Slice view along the pockmark formation, (d) Illustration of inspection area used for dimension analysis

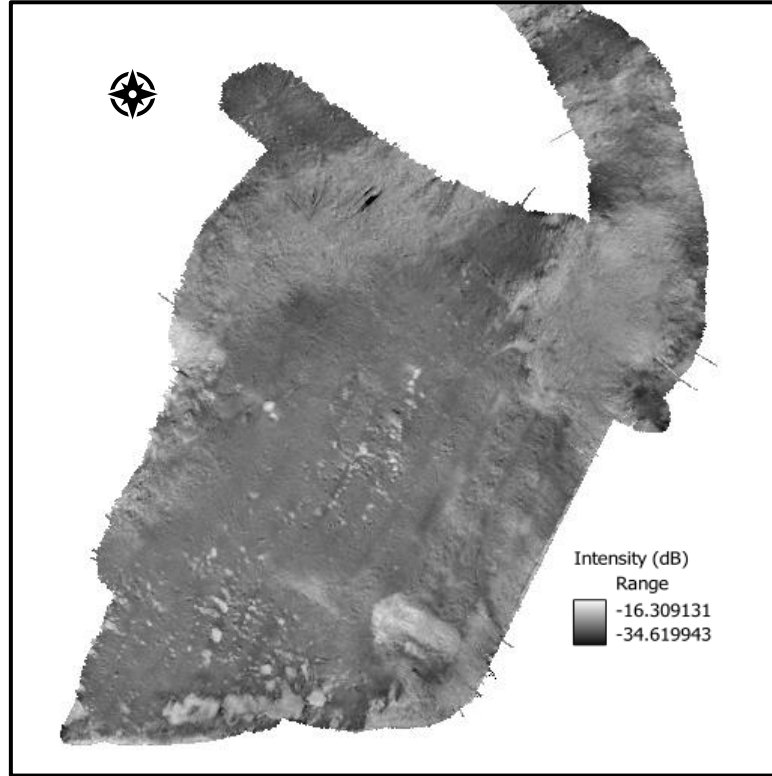
The backscatter processing of the seabed data revealed a range of acoustic intensities between -16 dB and -35 dB, with a predominant occurrence of high to medium backscatter values [Fig. 14]. Backscatter values ranging from -15 to -35 dB, with predominant values around -22 dB, indicate a seabed composition that is likely moderately coarse, such as coarse sand or a mix of sand and gravel. The higher backscatter values closer to -15 dB suggest harder and rougher substrates, such as rocky areas or gravel,

while the lower values near -35 dB correspond to softer, smoother materials like fine sand, silt, or mud. The predominant value of -22 dB suggests a seabed that is generally coarse but not entirely hard, likely with a mix of sediment types. The variability across the range reflects spatial changes in seabed composition, with potential transitions between rough and soft areas, indicating a heterogeneous seabed environment.

Fig. 14: Backscatter data from hydrographic survey in Katakolo, Greece, illustrating acoustic intensity variations in dB

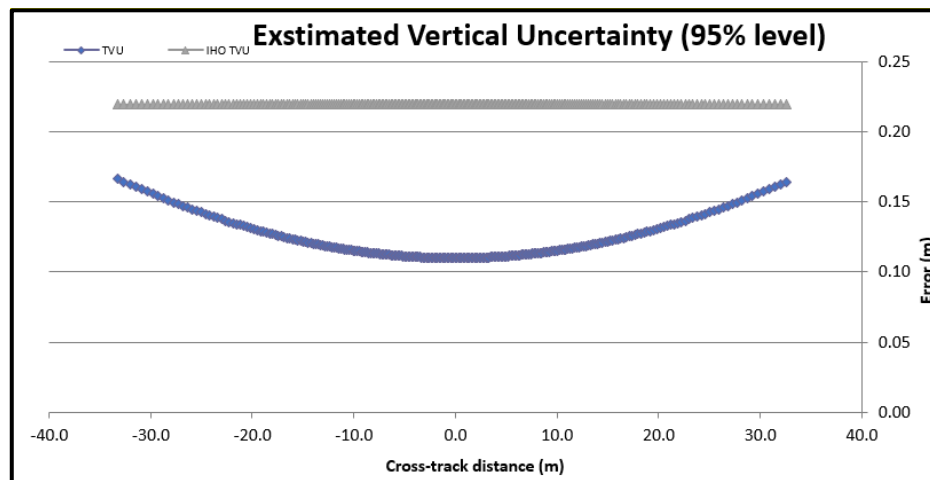
The parameters for the International Hydrographic Organization (IHO) Exclusive Order are defined as a=0.15 m15 and b=0.0075. For an average survey depth of 20 meters, the maximum allowable TVU was calculated to be 0.212 meters. The accompanying figure [Fig.15.] presents the estimated vertical uncertainty at the 95%

confidence level as a function of cross-track distance. The blue curve represents the observed TVU, while the gray line denotes the IHO threshold. The observed TVU follows a characteristic U-shaped distribution, exhibiting lower uncertainty values at the nadir and increasing towards the outer beams. Notably, the measured TVU remains consistently below the IHO-prescribed limit across the entire swath width, indicating that the survey adheres to the vertical uncertainty requirements established for the Exclusive Order.

Fig. 15. Estimated Total Vertical Uncertainty (TVU) at the 95% confidence level across track in a hydrographic survey, compared to IHO TVU standards
