SAFETY ASSESSMENT AND REMEDIAL MEASURES DESIGN FOR AN EXTENSIVE ROCKFALL ALONG THE MAIN ROAD TO KIMI, EAST EUBOEA, GREECE

Loupasakis C.¹, Lalos G.¹ and Rozos D.¹

¹Laboratory of Engineering Geology and Hydrogeology, School of Mining and Metallurgical Engineering, National Technical University of Athens, 9 Iroon Polytechniou, Athens, Greece
cloupasakis@metal.ntua.gr, rozos@metal.ntua.gr

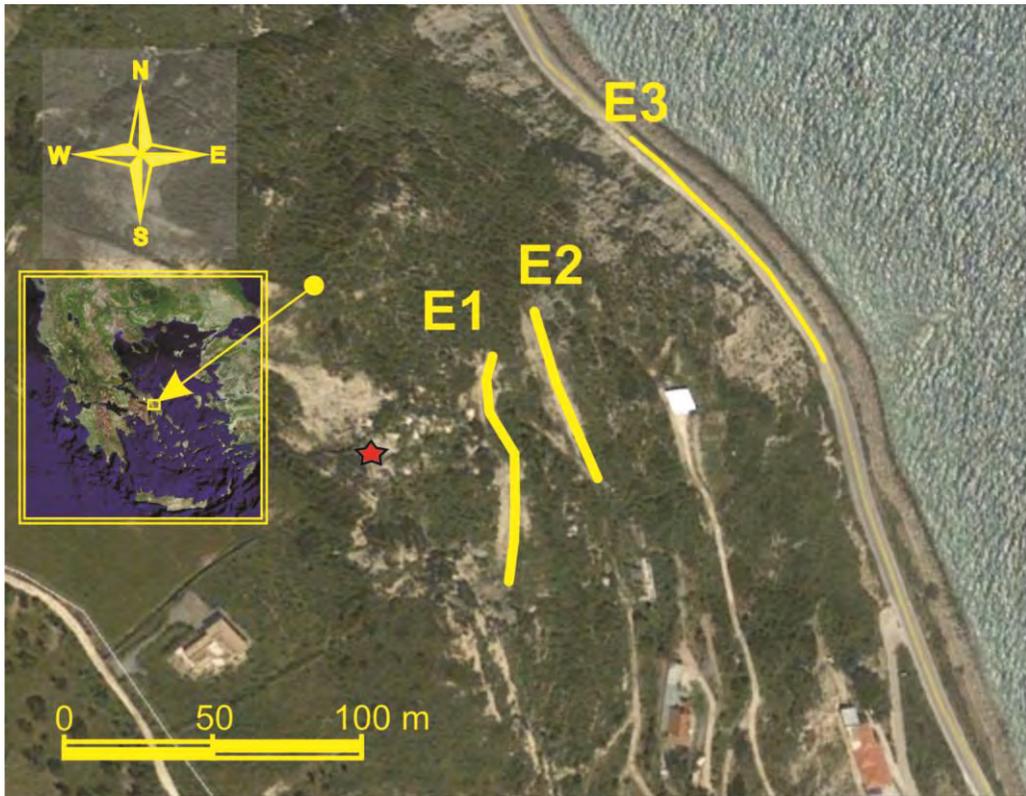
As mentioned above, the examined failure took place on August 13, 2008, at 20:30 approximately, at the provincial road connecting Paralia village with Kimi seaport, 900m from Paralia village. The rock seeder (rock detachment area) was defined 200m away and at an altitude of 140m (130m higher from the road) (Figures 2 & 3). The marly limestone rock pieces were detached from the upper parts of the slope. The majority of the limestones' rectangular rock pieces slid a few tens of meters from the seeders and stopped without causing any damages. Unfortunately a few oversized pieces, reaching to a maximum volume of 4m³, rolled down the slope and finally reached the road. The rock pieces reached the road with an enormous kinetic energy causing the aforementioned results.

Figure 2 – Location map of the study area. The star indicates the rock detachment area of the August 13, 2008 failure. The lines E1 and E2 indicate the position of the soil embankments constructed over the slope and line E3 the position of a temporary embankment installed in the middle of the road, with gravel filled big bags.

The following days, and before conducting a complete geotechnical study, a temporary embankment was installed in the middle of the road (Figures 2 & 4A,B). This 2m high embankment (E3 at Figure 2) was constructed by two series of big bags filled with gravels, aiming to provide a safety at the external lane of the road, preventing the complete blocking of the traffic. This temporary embankment still remains there as none ever decided to remove it. Figure 4A, B proves that although it was installed based on empirical estimations, it operated perfectly during the years, trapping several rock block and protecting the external lane of the road.

Besides the above mentioned embankment, extensive earth moving works took place on the slope aiming to modify its morphology, forming a complex of ditches and embankments, E1 & E2, as remediation measures (Figures 2 & 4C,D). This works took place after the installation of the E3 temporary embankment by contractors appointed by the municipality. Despite all these works the temporary embankment E3 was not removed at the end.
