GEOLOGICAL AND GEOTECHNICAL BEHAVIOUR OF EVINOS DAM FOLLOWING THE IMPOUNDMENT

Angelopoulos A.¹, Soulis V.J.², Malandraki V.³

Abstract

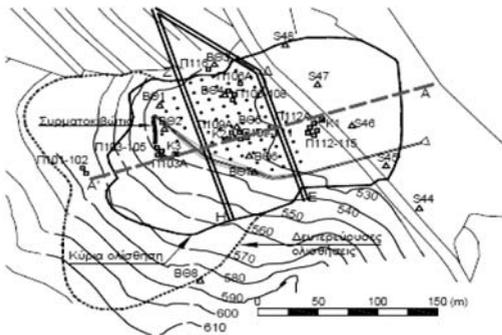
Fig. 7: Drainage tunnels and piezometers located in the area of the Landslide of the left abutment '93.

In August 1993 a landslide occurred in the left abutment of Agios Demetrios just before the entrance of the spillway. The stabilization works included the construction of a drainage tunnels together with the construction of wells. The behaviour of the stabilization measurements are monitored by in-situ measurements in a) piezometers, b) inclinometric - settlement columns, c) surface monumental stations, d) devices measuring the flow in the exit of the drainage tunnels. In fig. 7, the stabilization measurements are depicted together with the positions of piezometers and surface monumental stations (Dounias & Dede, 2006).

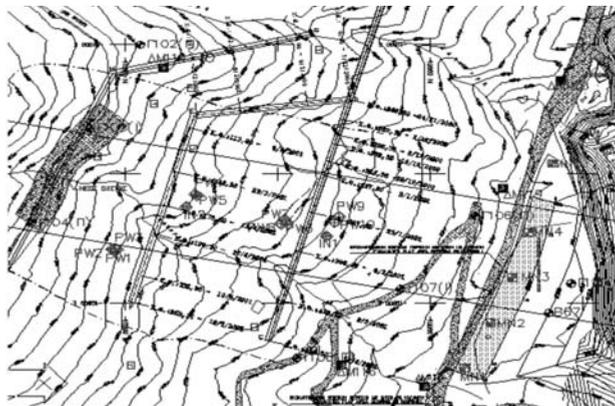
Fig. 12: Drainage tunnels and piezometers located in the area of the Road Landslide.

The landslide occurred at the Agios Demetrios – Arahova Country Road during the construction of the Evinos reservoir project (1993). The stabilization interventions included the construction of toe berms, drainage tunnels, and surface runoff collection works. The behaviour of the stabilization interventions are monitored by in-situ measurements in a) piezometers, b) inclinometric-settlement columns, c) surface monumental stations, d) devices measuring the flow in the outlet of drainage tunnels. In fig. 12, the stabilization interventions are depicted together with the piezometers and surface monumental stations (Dounias et al., 2006).
