Bulletin of the Geological Society of Greece

Vol. 43, 2010

GEOLOGICAL AND GEOTECHNICAL BEHAVIOUR OF EVINOS DAM FOLLOWING THE IMPOUNDMENT

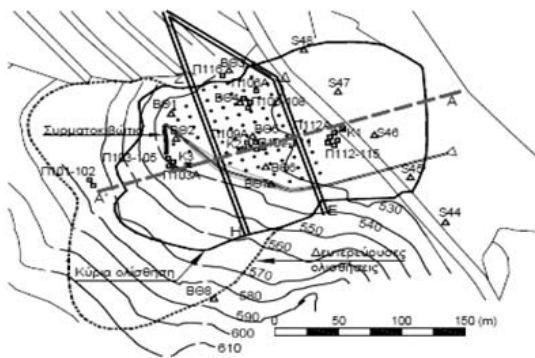
Fig. 7: Drainage tunnels and piezometers located in the area of the Landslide of the left abutment '93.

In August 1993 a landslide occurred in the left abutment of Agios Demetrios just before the entrance of the spillway. The stabilization works included the construction of a drainage tunnels together with the construction of wells. The behaviour of the stabilization measurements are monitored by in-situ measurements in a) piezometers, b) inclinometric - settlement columns, c) surface monumental stations, d) devices measuring the flow in the exit of the drainage tunnels. In fig. 7, the stabilization measurements are depicted together with the positions of piezometers and surface monumental stations (Dounias & Dede, 2006).

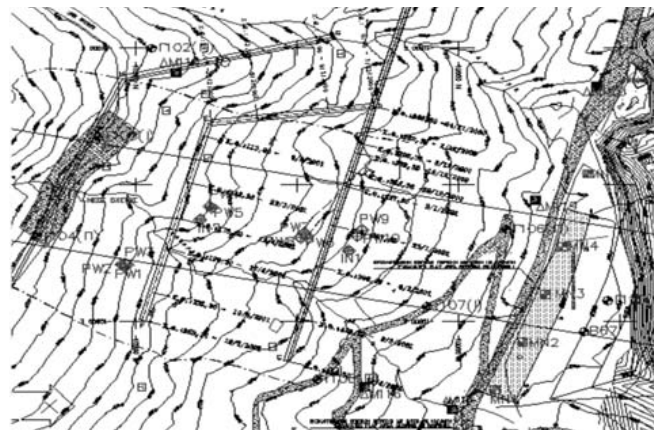
Fig. 12: Drainage tunnels and piezometers located in the area of the Road Landslide.

The landslide occurred at the Agios Demetrios – Arahova Country Road during the construction of the Evinos reservoir project (1993). The stabilization interventions included the construction of toe berms, drainage tunnels, and surface runoff collection works. The behaviour of the stabilization interventions are monitored by in-situ measurements in a) piezometers, b) inclinometric-settlement columns, c) surface monumental stations, d) devices measuring the flow in the outlet of drainage tunnels. In fig. 12, the stabilization interventions are depicted together with the piezometers and surface monumental stations (Dounias et al., 2006).
