## GEOTECHNICAL INVESTIGATION OF THE ROCK SLOPE STABILITY PROBLEMS OCCURRED AT THE FOUNDATIONS OF THE COASTAL BYZANTINE WALL OF KAVALA CITY, GREECE

### Abstract

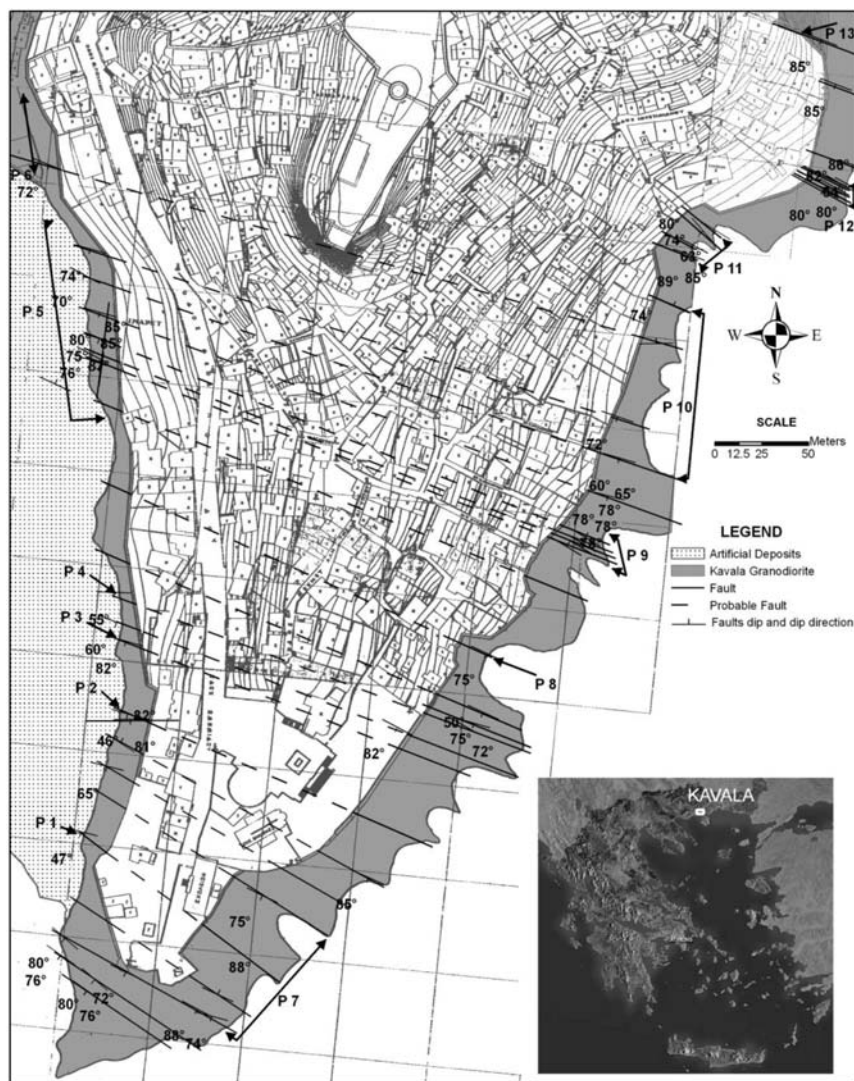
**Fig. 1:** Geological map of the peninsula presenting the location of the numerous normal faults recorded along the slopes. The gulfs excavated, by the wave erosion, along the faults' zones are clearly presented. The locations indicated by the P1 to P13 signs refer to parts where slope stability problems occur.

The main systems of faults of the Rodopic mass have SW – NE and NW – SE direction. Panagia peninsula is intersected by numerous parallel normal faults (Fig. 1), forming extended zones of intensively fractured rock mass. The sub-horizontal shearing, the dense systems of joints and the perpendicular faults intersect the rock mass forming numerous wedges along the slopes of the peninsula.

Along the slopes were located thirteen (13) parts with serious stability problems, able to effect the Byzantine wall (Fig. 1 Parts P1 to P13). These problems are a) wedge or plain failures (Varnes, 1978; Koukis & Sabatakakis, 2007), especially along the W-SW slopes and the fault zones, b) toppling failures (Goodman & Bray, 1976), along the SE slopes and c) extensive underexcavation problems, especially along the unprotected by the pier SE slopes. Further more, random rockfalls were recorded all around the peninsula, even along the stable parts of the slopes, because of the rock blocks sited along the slopes. Those blocks were formed by the joints intersecting the rock mass and they were displaced by the marine erosion and/or by the human activities.
