## LANDSLIDES IN VITSI (FLORINA) TERRITORY

**Keywords:** Slope failure, Drosopigi- Florina, seismicity, rainfalls, geotechnical investigations.

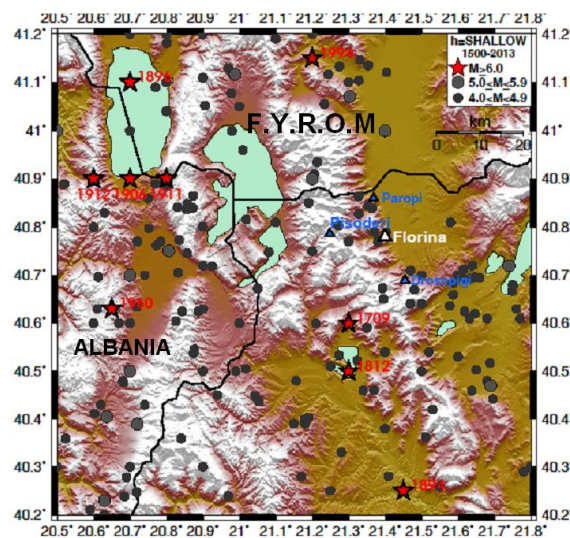
Field observations, geophysical studies and GPS measurements in the area denote an ongoing tectonic activity (Drakatos *et al.*, 2005; Mountrakis *et al.*, 2006) as well as a rather complicated structural evolution of the area. The earthquakes that occurred (Figure 1) are usually of magnitudes  $M_w < 5.0$ . However, the broader territory experienced large earthquakes with  $M_w > 6.0$  (Papazachos and Papazachou, 2003; The Monthly Bulletins of Earthquakes of the Geophysical Laboratory of Aristotle University of Thessaloniki).

**Figure 1 - The epicenters of all earthquakes that occurred in the broader study area during the time span 1500-2013 with magnitudes equal or greater than 4.0. Florina (white triangle), Pisoderi, Parori and Drosopigi villages (blue triangles) are also shown. The epicenters of large events  $M_w > 6.0$  are depicted with red star.**

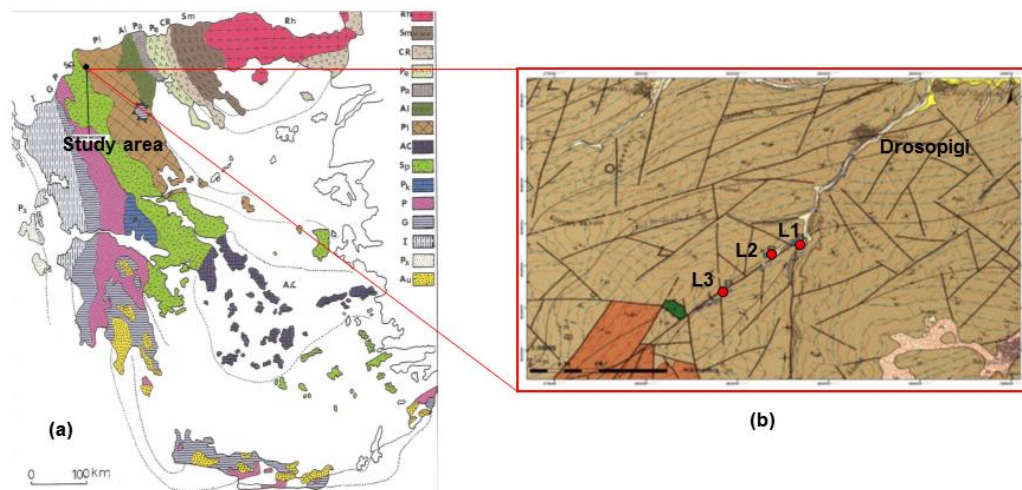
In August 2015, three landslides (Fig. 2) were observed in the study area (L1, L2, L3) mainly in the form of rockfalls and debris flow that destroyed part of the road near Drosopigi village. The

According to the geotectonic manifestation of the Internal Hellenides zones in Northern Greece (Figure 2), the region belongs to Pelagonian (PI) zone (Mountrakis, 1983). According to the geological features, the study roadline lies mainly on Carboniferous - early Triassic formations (Gneisses and Schists). Nearby the landslides, three geotechnical boreholes (G1, G2, G3) and Standard Penetration Tests (S.P.T) were performed together with Laboratory Tests.

**Figure 2 - a) The geotectonic manifestation of the Internal Hellenide zones in Northern Greece, b) Location of geotechnical boreholes (L1, L2, L3).**

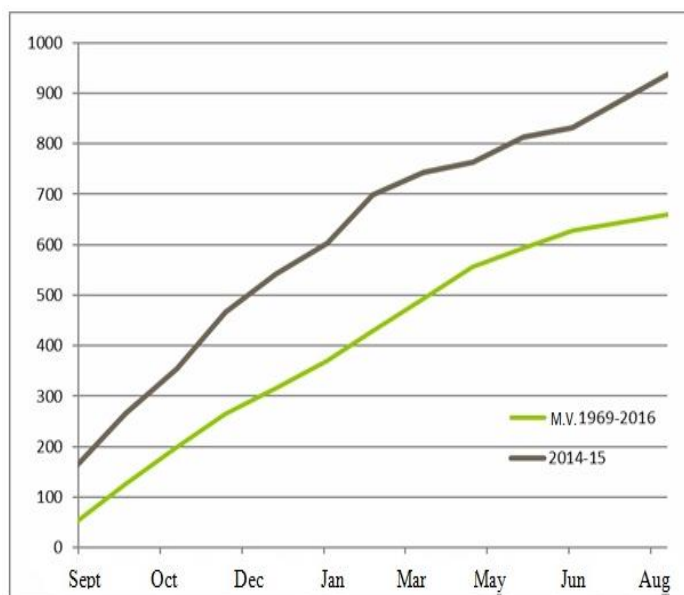
Figure 4 - Cumulative Precipitation of the Tropeuho AMS.
