SAFETY ASSESSMENT AND PROTECTION OF MONUMENTS LOCATED IN CAVES – A CASE STUDY FROM THE CITY OF VOLOS, GREECE

Loupasakis C.¹, and Nikolaou N.¹

Abstract

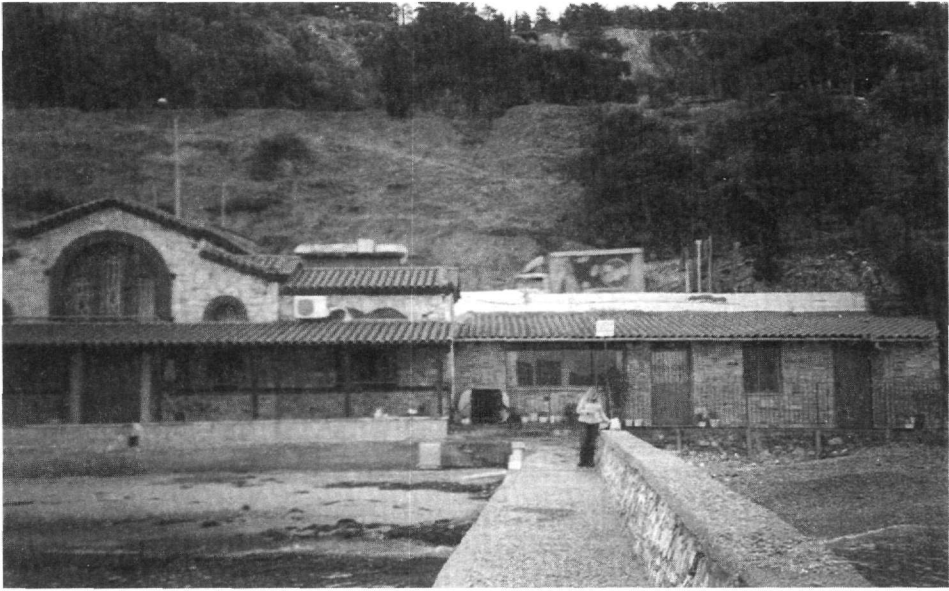
The geomorphological settings of the surrounding area are completely altered by the human activities. Several buildings, including the narthex, and a pier have been constructed across the coastline (Fig. 2). The national road and the railway line connecting Volos with Agia are crossing a few meters over the cave's ceiling (Fig. 3). Further more; an extremely large abandoned quarry is located over the cave, across the national road. This quarry was active for more than ten years during the '70's and the '80's.

Figure 2 – Front view of the holy shrine. The coastline and the position of the national road are clearly presented
