Post-earthquake assessment of monumental building in Croatia by 3Muri software

Roko Zarnic, Vlatka Rajcic

Keywords: Earthquake 2020 Croatia, Monumental Building, Retrofitting, Structural Elements Model, Assessment, 3Muri program

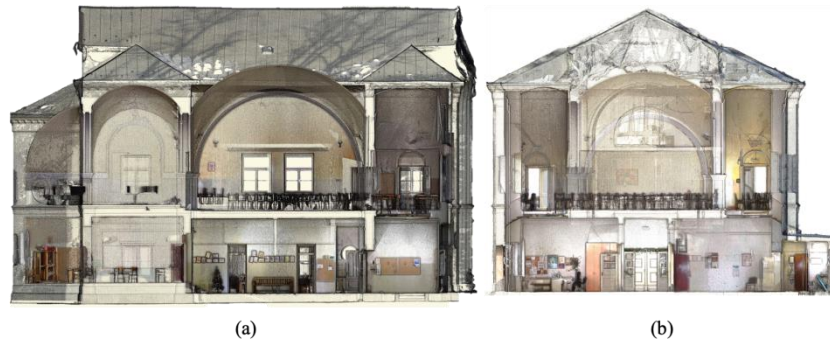
After expropriation of synagogue during the WW2, the ground floor interior was changed by adding partition walls of different thickness. The central open space was divided in height by massive new floor structures (see Fig.3(a)). Façade windows were partially or entirely closed by masonry infills. The massive masonry arches supporting the timber domes and domes themselves were preserved in the original form while passages between rooms were partially or entirely closed (see Fig.4).

Fig. 3. Longitudinal (East-West) (a) and lateral (South-North)(b) cross-section of building acquired from 3D point cloud model after earthquake of December 2020

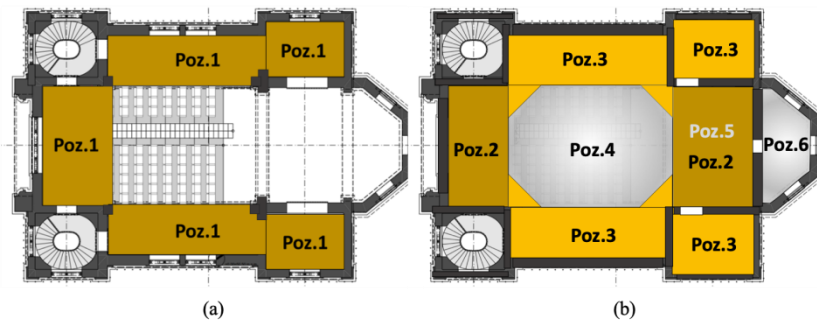
Fig. 6. Added horizontal diaphragms on first floor (a) and attic level (b) and timber domes on the attic level (b).

- Repairing of ground floor façade walls by grouting and partial replacing of weak mortar and construction of the inner r.c. frames (see Fig.5) and laying of horizontal r.c. tie beams atop the repaired ground floor façade walls.
- Construction of the first-floor inner masonry walls and façade walls extended to roof knee and gable walls with horizontal r.c. tie beams.
- Installation of laminated timber arches and domes on the first floor and CLT floor diaphragms (see Fig.6). Poz.1 and 2 are 15 cm thick CLT panel, Poz. 3 is 18 cm thick CLT panel, Poz. 4, 5 and 6 are timber domes.

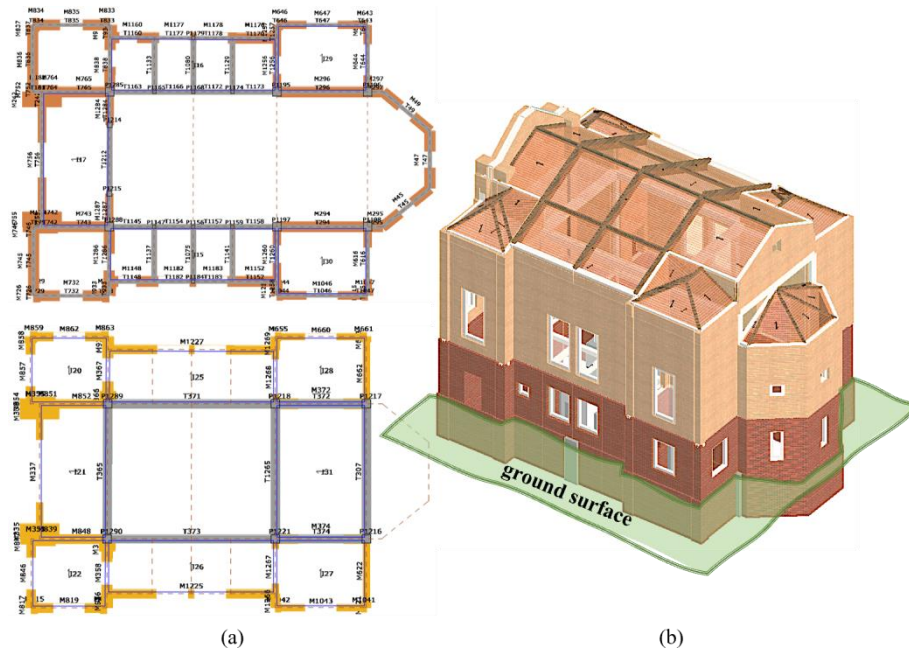
Fig. 7. Ground floor and the first-floor layout of building model (a) and its 3D model (b)

In the presented layouts of ground and first floor (see Fig.7 (a)) and 3D model of building (see Fig.7 (b)) the position of existing and new structural elements (masonry walls, r.c. frames and timber roof structure). The existing masonry which will be repaired is in darker color while the new one is in lighter color.

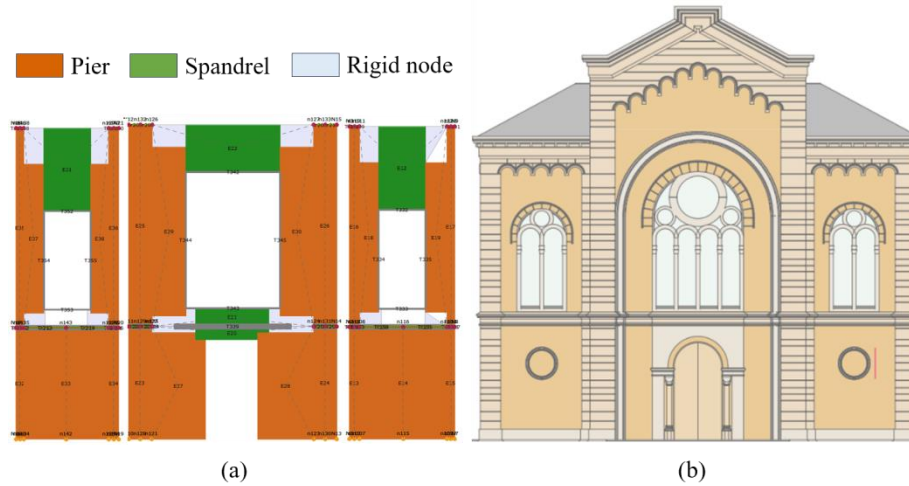
nonlinearity are likely to develop are assumed a priori. Despite these simplifications, this approach is one of the most spread both in engineering practice and at the research level thanks to its computational efficiency in performing nonlinear analyses and its reasonable accuracy, as proven by various numerical simulations in the literature [5]. Fig. 8 illustrates the discretization of the entrance façade walls.

Fig. 8. Equivalent frame idealization (a) of the entrance façade (b)

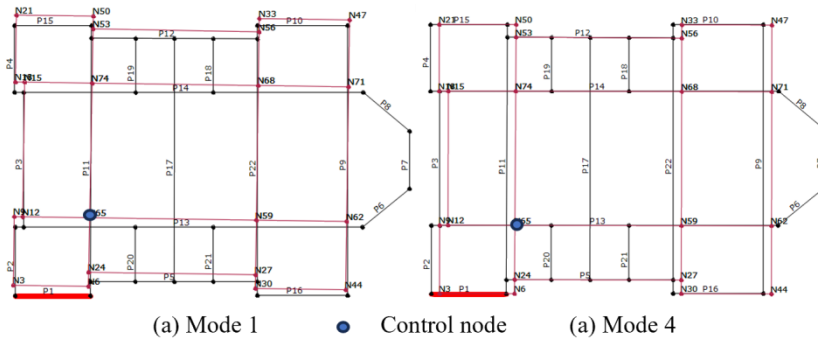
The modal analysis was performed to interpret the dynamic response of the whole building in the original and new configuration. The effect of replacing reinforce concrete heavy rigid floors with lightweight cross-laminated wooden floors is in reducing of total mass of building (M_{TOT}) for 9%.

Fig. 9. Comparison of modal shapes for Modes 1 (a) and 4 (b)

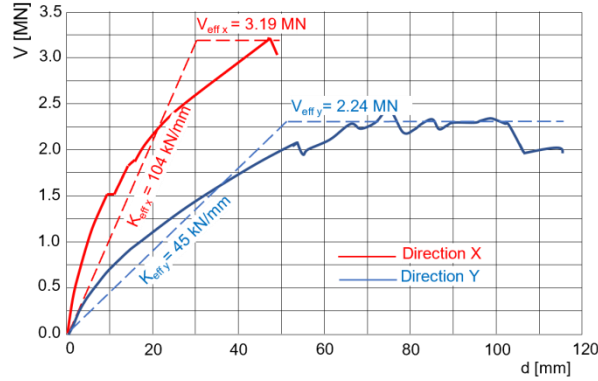
Fig. 10. Comparison of modal capacity curves in direction -X and +Y obtained by most significant analysis.

Altogether 24 analyses were performed and the capacity curves of the most significant ones, in -X and +Y are presented in the capacity curves in Fig. 9. The corresponding effective story stiffnesses (K_{eff}) and effective shear at the base of building (V_{eff}) were derived from the analysis results. As it can be seen from the values of periods (T) in table 2 and diagrams in Fig. 9 the stiffness and earthquake resistance of structure is much higher in the longitudinal direction (Y) due to the flexibility and ductility of the reinforced concrete frames creating the core of structure (Fig.7). The ductile mechanism of the structure response with sufficient level of resistance well justifies the selected strategy of structural strengthening introducing r.c. frames and lightweight, stiff CLT horizontal diaphragms and lightweight timber central dome.

The following tables 3 to 5 present the detail data of the response of structure. As it is presented, the repaired, strengthened and partially reconstructed building in each direction satisfies the demands of the Eurocode 8 (α parameters are higher than 1.0).
