Behavior of steel building structures subjected to strong and benchmark seismic actions: An overview of damage from the observations of the last 40 years

Anthimos Anastasiadis¹

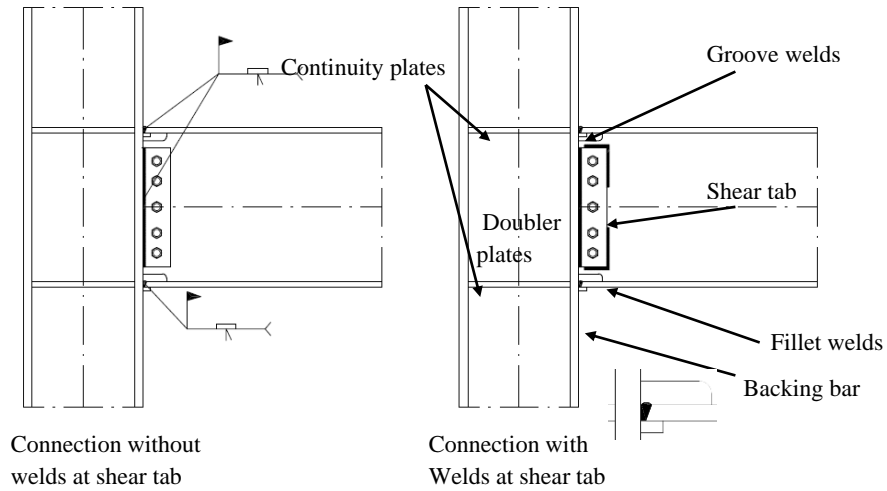
On January 17, 1994, a strong earthquake of $M_w = 6.7$ magnitude, with the epicenter near Northridge, about 30 km northwest of downtown Los Angeles, California, damaged more than 40,000 buildings of all structural systems. More than 150 tall and short (from one to 26-stories), new and old, steel moment-resisting frames suffered widespread brittle damage. It should be underlined that no steel building collapsed and no loss of life was registered. The typical US pre-Northridge flange welded-web bolted with shear tab connection is presented in Fig 2. The failure is concentrated at the joint region, especially at the beam-column connection and mainly at the bottom flanges [10,11], Fig. 3. The damage was observed in the welded connections, with complete penetration welds between the beam and column flanges. In some cases, cracks were propagated into the column's web and, as such, developed a column fracture or cracks into the beam's flanges. Prior to the Northridge earthquake, this connection type was believed to have adequate ductility capacity to withstand high seismic forces. Despite this, experimental testing of a large scale of such connections between 1970 and 1992 revealed relatively low beam plastic rotations between 0.010 and 0.030 rad [12,13,14]. Moreover, for economic reasons, a lot of buildings were constructed only with perimeter moment-resisting connections, while the rest were bolted with simple supported connections, and in many cases, the moment-resisting connections had no continuity and/or doubler plates or lapped plating. The brittle failure was attributed to the mechanical properties of materials, insufficient practices of constructional conformation, detailing, welding, and design, and poor workmanship [15,16], although an additional important contributing parameter was the near-field ground motion, which introduced a high strain rate leading to brittle mode failures [17,18,19].

Fig. 2. Typical US pre-Northridge flange welded-web bolted beam-column connection, with and without weld at shear plate, for welded steel moment frames.
