# Behavior of steel building structures subjected to strong and benchmark seismic actions: An overview of damage from the observations of the last 40 years

Anthimos Anastasiadis<sup>1</sup>

**Abstract.** It is well known that steel structures have a high ductility capacity and a high strength-to-weight ratio, which theoretically, by nature, makes them one of the most efficient seismic structural systems against strong earthquakes. However, the recorded experience of failures that have befallen over the last 40 years as a result of strong seismic actions suggests that this by itself isn't always sufficient. Generally, it is essential that an appropriate and preferred conformation and configuration of the structural system, and in particular of its joints, be adopted. In any case, the steel building structures showed local failures without general or complete collapses. The work in this paper presents the seismic performance focused on steel building structures, as revealed by strong earthquakes such as those of Mexico (1985), Northridge (1994), USA, Kobe (1995), Japan, Christchurch (2010–2011), and New Zealand, which affected and changed the design of metal structures, as well as

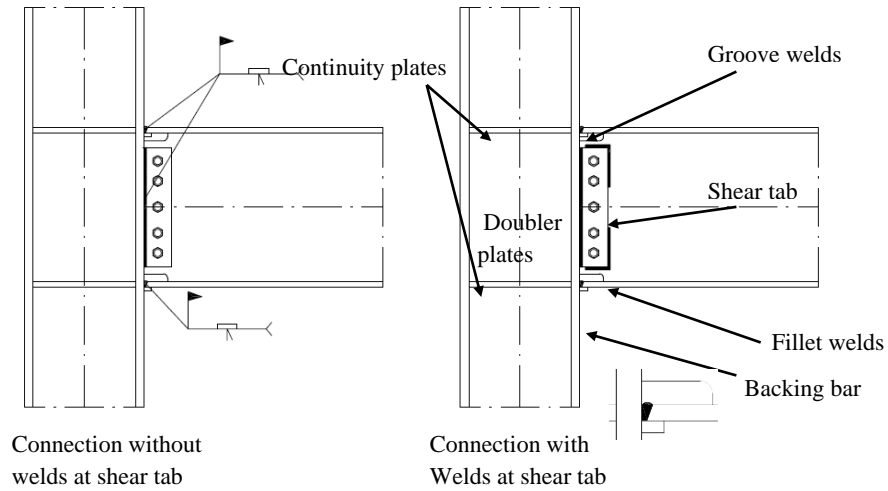
**Fig. 2.** Typical US pre-Northridge flange welded-web bolted beam-column connection, with and without weld at shear plate, for welded steel moment frames.

The Northridge earthquake, 1994, USA, is a benchmark point in the history of seismic design of steel structures, especially steel welded moment-resisting frames. The unexpected damage greatly surprised the US structural engineering community [20]. The response was immediate and radical; a great research program was initiated, starting in 1994 and ending in 2000, through the cooperation of The Structural Engineers Association of California (SEAOC), Applied Technology Council (ATC), and California Universities for Earthquake Engineering (CUREE) in cooperation with the Federal Emergency Management Agency (FEMA), forming the SAC Joint Venture with the main goal of “developing reliable, practical, and cost-effective guidelines and standards of practice for the repair or upgrading of damaged steel moment frame buildings, the design of new steel buildings, and the identification and rehabilitation of at-risk steel buildings” [21, 22]. It was an exemplary program; the result was design-oriented, namely, the development of guidelines, which were the basis for the further processing of new standards and codes not only for new structures and for the rehabilitation of existing ones [23, 24,25], but also sound information related to the metallurgy of structural steel, welding, inspection, and quality control [26,27,28].

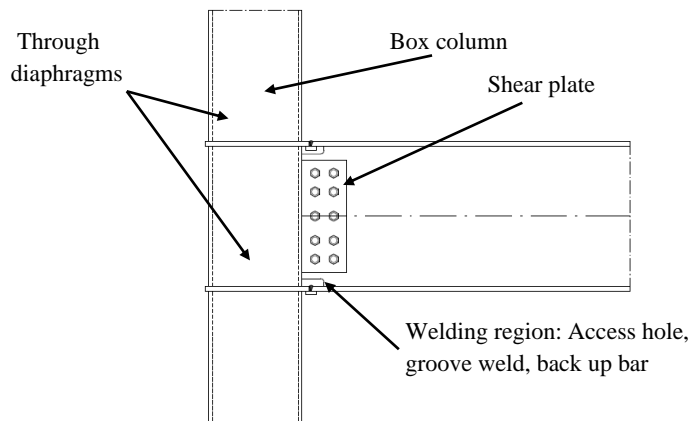
It was surprising that the same brittle damage at the beam-column connection, as it was in the case of the Northridge earthquake exactly a year ago, was observed. The same failure at the welds, heat-affected zone, and base material fracture is recorded, although the general conformation of a typical joint between US and Japanese practice is different, Fig. 4. Moreover, brittle failure also occurred at: (i) columns (of square hollow section mainly cold formed), with fracture at the base material of approximately 50–55 mm thickness, at welded column splices, and beam to brace connections; (ii) column bases at anchor bolts; and (iii) braces of small cross section and large slenderness like rods, angles, and flat plates for older buildings, while for modern buildings with larger cross sections, the damage was concentrated at the connection zone [46,47,48,49], Fig. 5,6.

The causes of damage attributed to the fracture toughness of steel material, general configuration and detailing of the beam to column connection, low toughness of weld metal and the severity of the strong ground motion having strong pulses and high V/H PGA ratio as well. The repeatability of the damage observed for both Northridge, 1994, USA, and Kobe 1995, Japan, unveiled the enhanced vulnerability of the welded beam-to column connection of the steel moment resisting frames. Moreover, the practice was to execute the welding on site. Hence, considering that joints are severely stressed, then the weldments that characterized by a potential brittleness, must be very well executed, inspected and assured the quality control; this was not the case. It was a failure of the seismic design and construction practice for both countries.

**Fig. 4.** Typical beam-column through diaphragm connection before Kobe earthquake.
