Seismic Assessment and Proposal for Interventions of a Historical Masonry Building in Rhodes

Andromachi Eleftheriou, Aristidis Papachristidis, Constantinos Repapis

Andromachi Eleftheriou¹, Aristidis Papachristidis² and Constantinos Repapis¹

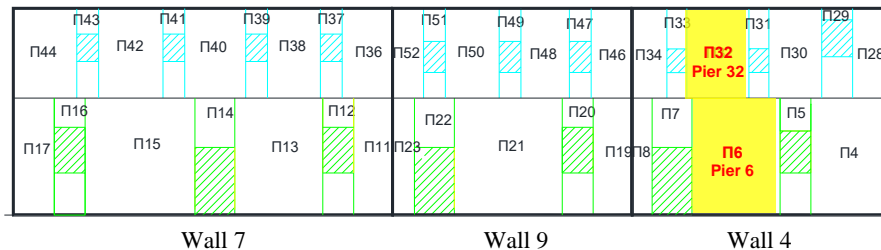
Fig. 8. Numerical representation of piers, for levels 1 and 2.

The maximum normal stress is calculated from the equation $\sigma_c = N_{sd,max}/A_w$, where $N_{sd,max}$ is the maximum axial force of each pier, resulting from the analysis of the building for the load combination $1.35G+1.50Q$, and A_w is the area of the pier at the control level. Pier 6 (Fig. 8) has length, $L=2.425m$, height $H=3.20m$ and width $t = 0.55m$.

The in-plane shear check, according to the global behaviour factor method and for load combination $G+0.30Q+Ex+0.30Ey$, is presented in detail for pier 6 (Fig. 8).

The out-of-plane check, according to the global behaviour factor method and for load combination $G+0.30Q+0.30Ex+Ey$, is presented in detail for Pier 32 of level 2 (Fig. 8). The length of Pier 32 is $L=1.71$ m, its height is $H= 2.46$ m and its width is $t = 0.55$ m. The results at the bottom of Pier 32, from the lateral force analysis (linear) of the structure, for the q factor approach and for the load combination $G+0.30Q+0.30Ex+Ey$, are the following
