Seismic Assessment and Proposal for Interventions of a Historical Masonry Building in Rhodes

Andromachi Eleftheriou¹, Aristidis Papachristidis² and Constantinos Repapis¹

Abstract. The aim of this study is the seismic assessment of a historical twostorey masonry building, located in the city of Rhodes and the investigation of intervention ways to strengthen the building and improve the mechanical characteristics of its materials. The 3DR.PESSOS software was used for the simulation and analysis of the structure. For the evaluation of the seismic behaviour of the building, an elastic static analysis (lateral force analysis) was carried out based on the Greek Code for Structural Interventions of Masonry Structures. Elastic static analysis methods with global behaviour factor (q) or local ductility indices (m) were applied for performance levels B1 and B2. From the analyses and the code checks it was concluded that the building is vulnerable to in-plane and outof-plane actions. For this reason, methods of intervention are being investigated to increase the diaphragm function of the building and to improve the mechanical characteristics of the masonry.

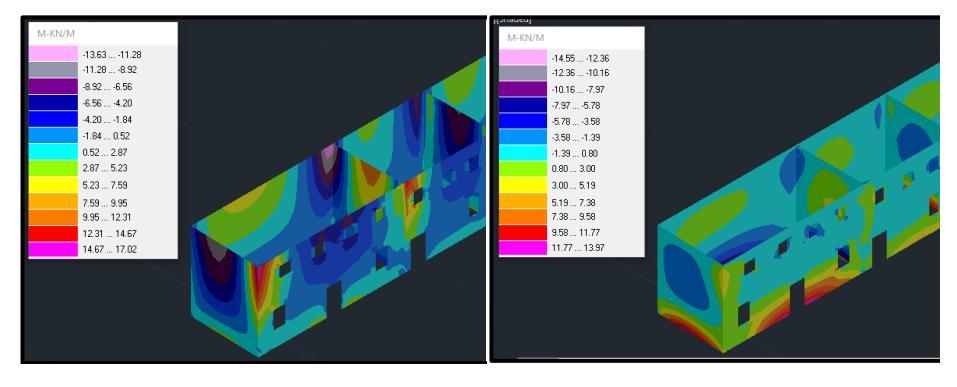
Fig. 3. Bending moment distribution for the seismic load combination G+0.30Q+Ex+0.30Ey.

(a) Bending moment distribution M_{xx} . (b) Bending moment distribution M_{yy} .

It is observed that the largest values of out-of-plane bending moments about the vertical axis are developed at the connections with the transverse walls, while the largest values of out-of-plane bending moments about the horizontal axis are developed at the base of the walls.

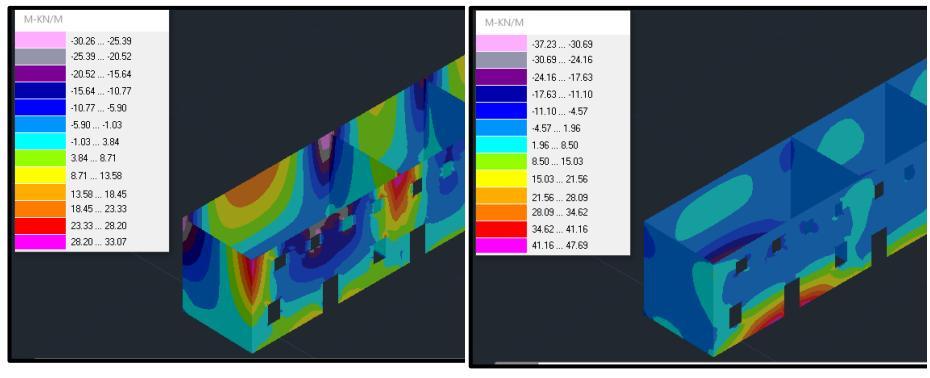
Fig. 1. Bending moment distribution for the seismic load combination $G+0.30Q+0.30E_x+E_y$.

(a) Bending moment distribution M_{xx}.

(b) Bending moment distribution Myy.
