Seismic Assessment and Proposal for Interventions of a Historical Masonry Building in Rhodes

In this study, an evaluation of a historical masonry building, located in Rhodes, is carried out based on the Greek Code for Structural Interventions of Masonry Structures. Specifically, it is checked whether the minimum requirements of its load-bearing capacity are met both during the assessment and during its redesign, after the proposed interventions. Under certain conditions, the minimum load-bearing capacity requirements for the assessment and redesign of an existing structure may be reduced compared to the provisions of the current design codes for new structures.

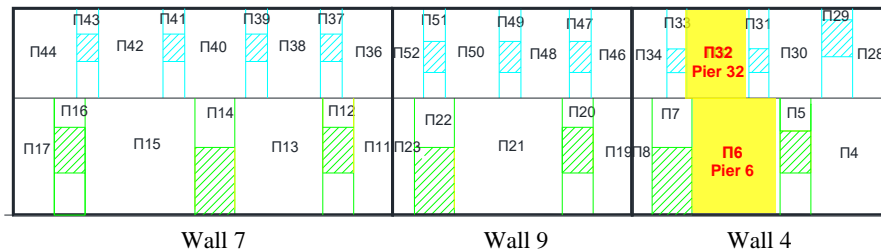
Fig. 8. Numerical representation of piers, for levels 1 and 2.

The maximum normal stress is calculated from the equation $\sigma_c = N_{sd,max}/A_w$, where $N_{sd,max}$ is the maximum axial force of each pier, resulting from the analysis of the building for the load combination $1.35G+1.50Q$, and A_w is the area of the pier at the control level. Pier 6 (Fig. 8) has length, $L=2.425m$, height $H=3.20m$ and width $t = 0.55m$.

The in-plane shear check, according to the global behaviour factor method and for load combination $G+0.30Q+Ex+0.30Ey$, is presented in detail for pier 6 (Fig. 8).

The out-of-plane check, according to the global behaviour factor method and for load combination $G+0.30Q+0.30Ex+Ey$, is presented in detail for Pier 32 of level 2 (Fig. 8). The length of Pier 32 is $L=1.71$ m, its height is $H= 2.46$ m and its width is $t = 0.55$ m. The results at the bottom of Pier 32, from the lateral force analysis (linear) of the structure, for the q factor approach and for the load combination $G+0.30Q+0.30Ex+Ey$, are the following
