### The interventions for the main dome of Hagia Sophia throughout its history and a preservation proposal

# The interventions for the main dome of Hagia Sophia throughout its history and a preservation proposal

**Abstract.** Throughout its history, Hagia Sophia has faced seismic risks due to structural issues. The ambitious design led to the complete collapse of the main dome merely 21 years after its construction, and partial collapses occurred in the 10th and 14th centuries. Over time, the structure underwent various repairs and reinforcements. Following the collapse of the southeastern section during the 1346 earthquake, flying buttresses were installed, attaching to the main dome from four directions. However, during the Fossati repairs (1847-1849), these elements were removed and replaced with iron beams, framing the upper perimeter of the pedestal supporting the main dome. The current challenges faced by the main dome are primarily rooted in the design of the piers and arches rather than the dome itself. Since reconstructing these structural elements is impossible, efforts to address the dome's issues have concentrated on retrofitting the supporting system. This study crit

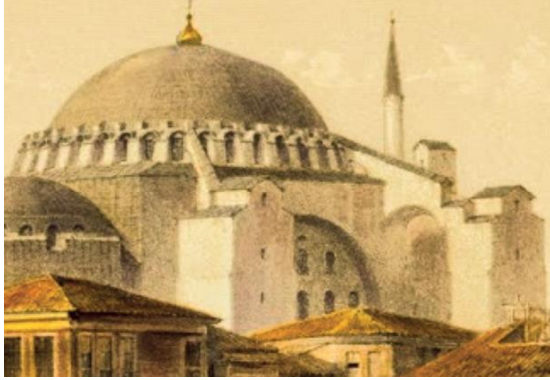
**Fig. 4.** Detail from Fossati's depiction before restoration

The most recent structural interventions on the main dome during the Ottoman period occurred between 1847-1849, conducted by Gaspare Fossati and his brother Guiseppe Fossati. Among the significant alterations in this repair was the removal of the flying buttresses that had supported the main dome for the past five centuries, forming a recognizable part of Istanbul's skyline. Instead of these buttresses, an iron frame was installed around the base where the main dome sits, concealed beneath the existing plaster. These elements became visible during the recent plaster rash over the surface (see Fig. 6-7 [13]). However, the structural function of this frame, intended as a substitute for the removed flying buttresses, remains a topic of debate [14, 15]. Its potential positive impact on the dome's structure is considered to be extremely limited due to its location and form.

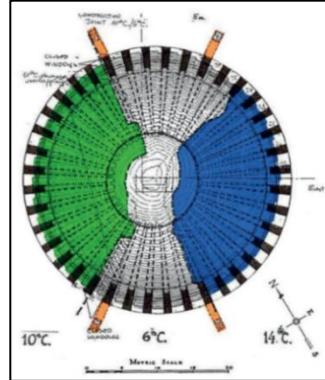
**Fig. 5.** Flying buttresses colored in orange

In the fall of 1343, a series of earthquakes struck the city, followed by another on October 6, 1344, resulting in structural weaknesses within Hagia Sophia. Subsequently, on May 19, 1346, one-third of the main dome collapsed along with the southeastern semi-dome. The restoration efforts were overseen by Stratopedarch Astras and Giovanni Peralta, with completion in 1354 [7]. Notably, within this repair, the main dome was supported by flying buttresses in four directions. These buttresses, displaying Gothic characteristics depicted in Hagia Sophia's descriptions, can be specifically attributed to the repairs in the 14th century (see Fig. 4 [12]). The integration of these flying buttresses with the connections of the remaining 6th-century dome and the reconstructions from the 10th and 14th centuries display the meaningful support they offered to the main dome (see Fig. 5 [2]).

Hagia Sophia's main dome has remained intact since 1354, showcasing remarkable stability. Architect Sinan's interventions during the peak of his career in the late 16th century likely played a role in this achievement. Although he didn't intervene the dome, he retrofitted the existing Byzantine buttresses and introduced new ones, potentially reinforcing the structure and aiding in its preservation.
