# Seismic Assessment and Proposal for Interventions of a Historical Masonry Building in Rhodes

**Abstract.** The aim of this study is the seismic assessment of a historical two-storey masonry building, located in the city of Rhodes and the investigation of intervention ways to strengthen the building and improve the mechanical characteristics of its materials. The 3DR.PESSOS software was used for the simulation and analysis of the structure. For the evaluation of the seismic behaviour of the building, an elastic static analysis (lateral force analysis) was carried out based on the Greek Code for Structural Interventions of Masonry Structures. Elastic static analysis methods with global behaviour factor ( $q$ ) or local ductility indices ( $m$ ) were applied for performance levels B1 and B2. From the analyses and the code checks it was concluded that the building is vulnerable to in-plane and out-of-plane actions. For this reason, methods of intervention are being investigated to increase the diaphragm function of the building and to improve the mechanical characteristics of the masonry.

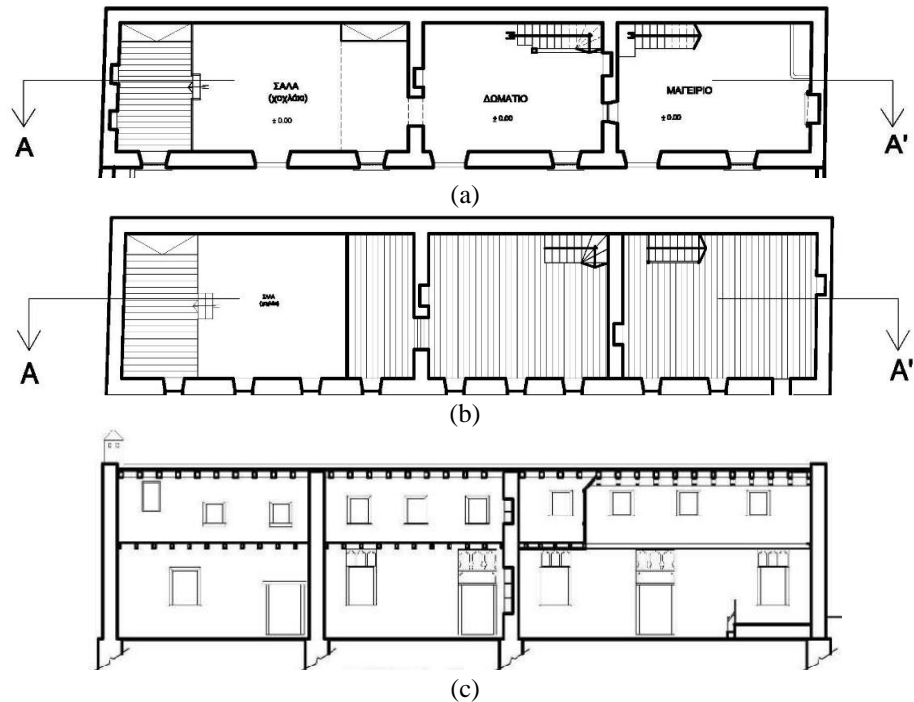
rectangular in plan, with three rooms and average external dimensions of 5.55 m wide and 24.60 m long. It consists of the ground floor, the mezzanine floor, which occupies 2/3 of the building, and the roof. The mezzanine consists of timber floorboard on wooden beams with dimensions of 10 cm x 15 cm at 50 cm spacing, while the roof consists of timber floorboard on wooden beams with dimensions of 15 cm x 20 cm at 50 cm spacing, covered with a light reinforced concrete slab. The height of the ground floor is 5.80 m and 3.25 m, while the height of the first floor is 2.55 m. Fig. 1. shows the ground floor plan and upper floor plan of the building.

**Fig. 1.** (a) Ground floor plan, (b) first floor plan and (c) longitudinal section A-A' [14].

The masonry structure under investigation is constructed with two-leaf stone masonry of local Rhodesian porous stone, 50 cm and 55 cm thick. The structure is

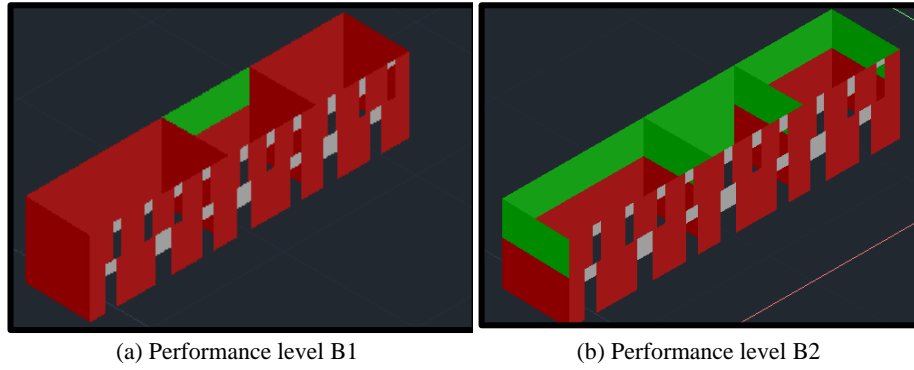
**Fig. 5.** Colour representation of inadequacies of the piers (green: adequacy, red: inadequacy).

In Fig. 5a, the piers for which there is a deficiency are illustrated in red colour in the 3D model. Therefore, when evaluating the seismic behaviour of the building using the method of the global behaviour factor  $q$  and taking as an assessment target the

The influence of the performance level on the seismic assessment results of the building was then investigated. The performance level B2 was selected and new elastic analyses were carried out based on the global behaviour factor ( $q$ ) for  $q = 1.5$ . Fig. 5b illustrates in colour the piers for which there is inadequacy, which are obviously less than in the analysis for performance level B1 (Fig. 5a). By adopting a less stringent performance objective, i.e. a 50% probability of exceeding the seismic action in 50 years, on the basis of which the seismic action is reduced by about 40%, the more favourable behaviour of the masonry is evident, mainly in out-of-plane bending.
