### Seismic Assessment and Proposal for Interventions of a Historical Masonry Building in Rhodes

# Seismic Assessment and Proposal for Interventions of a Historical Masonry Building in Rhodes

**Abstract.** The aim of this study is the seismic assessment of a historical two-storey masonry building, located in the city of Rhodes and the investigation of intervention ways to strengthen the building and improve the mechanical characteristics of its materials. The 3DR.PESSOS software was used for the simulation and analysis of the structure. For the evaluation of the seismic behaviour of the building, an elastic static analysis (lateral force analysis) was carried out based on the Greek Code for Structural Interventions of Masonry Structures. Elastic static analysis methods with global behaviour factor ( $q$ ) or local ductility indices ( $m$ ) were applied for performance levels B1 and B2. From the analyses and the code checks it was concluded that the building is vulnerable to in-plane and out-of-plane actions. For this reason, methods of intervention are being investigated to increase the diaphragm function of the building and to improve the mechanical characteristics of the masonr

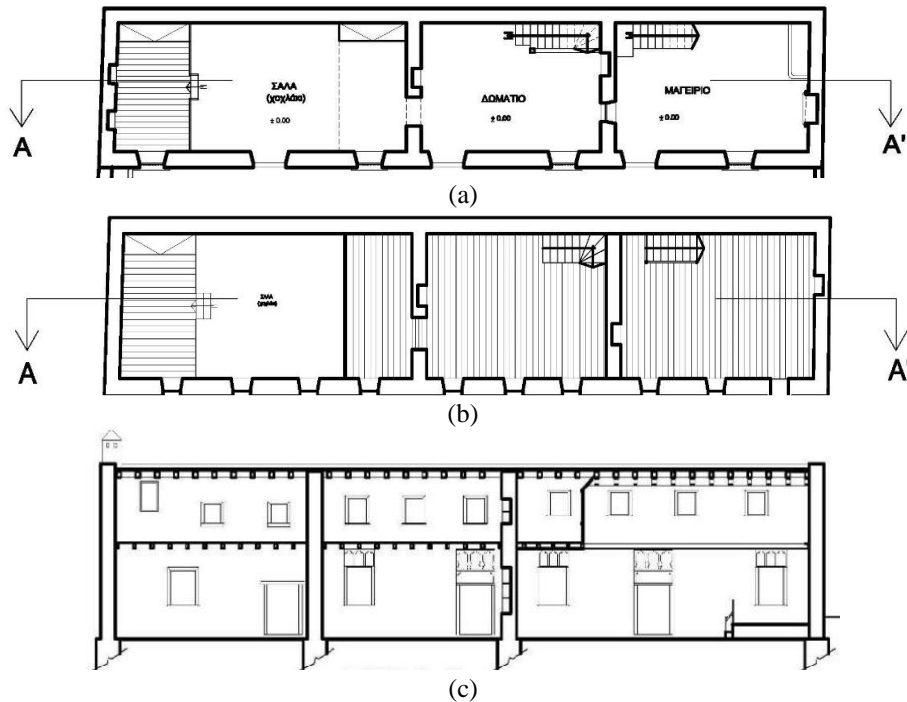
The masonry structure under investigation is constructed with two-leaf stone masonry of local Rhodesian porous stone, 50 cm and 55 cm thick. The structure is

rectangular in plan, with three rooms and average external dimensions of 5.55 m wide and 24.60 m long. It consists of the ground floor, the mezzanine floor, which occupies 2/3 of the building, and the roof. The mezzanine consists of timber floorboard on wooden beams with dimensions of 10 cm x 15 cm at 50 cm spacing, while the roof consists of timber floorboard on wooden beams with dimensions of 15 cm x 20 cm at 50 cm spacing, covered with a light reinforced concrete slab. The height of the ground floor is 5.80 m and 3.25 m, while the height of the first floor is 2.55 m. Fig. 1. shows the ground floor plan and upper floor plan of the building.

**Fig. 1.** (a) Ground floor plan, (b) first floor plan and (c) longitudinal section A-A' [14].

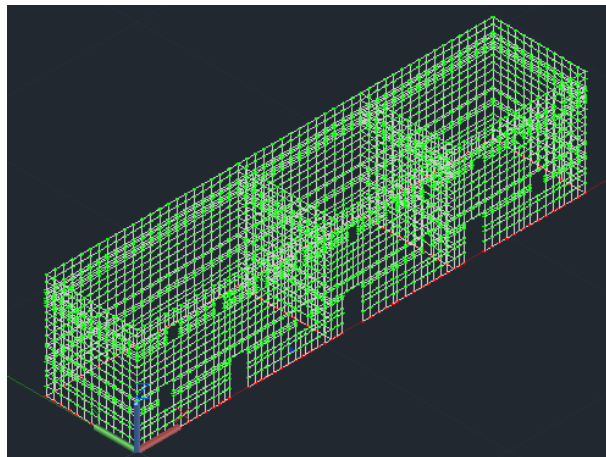
The finite element method was used for the simulation of the building, where the masonry was modelled with 3319 quadrilateral shell elements in 3DR.PESSOS software [12], with a maximum dimension of 50 cm (Fig. 2).

**Fig. 2.** 3D mathematical model of the building.

The wooden floors were not simulated as static entities in the program. They were taken into account through their self-weight, dead and live loads, so that these loads were distributed to the perimeter walls.

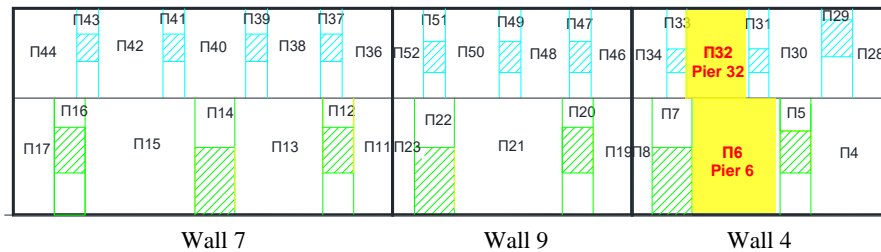
Fig. 8. Numerical representation of piers, for levels 1 and 2.

The maximum normal stress is calculated from the equation  $\sigma_c = N_{sd,max}/A_w$ , where  $N_{sd,max}$  is the maximum axial force of each pier, resulting from the analysis of the building for the load combination  $1.35G+1.50Q$ , and  $A_w$  is the area of the pier at the control level. Pier 6 (Fig. 8) has length,  $L=2.425m$ , height  $H=3.20m$  and width  $t = 0.55m$ .

The in-plane shear check, according to the global behaviour factor method and for load combination  $G+0.30Q+Ex+0.30Ey$ , is presented in detail for pier 6 (Fig. 8).

The out-of-plane check, according to the global behaviour factor method and for load combination  $G+0.30Q+0.30Ex+Ey$ , is presented in detail for Pier 32 of level 2 (Fig. 8). The length of Pier 32 is  $L=1.71$  m, its height is  $H= 2.46$  m and its width is  $t = 0.55$ m. The results at the bottom of Pier 32, from the lateral force analysis (linear) of the structure, for the  $q$  factor approach and for the load combination  $G+0.30Q+0.30Ex+Ey$ , are the following
