Seismic Assessment and Proposal for Interventions of a Historical Masonry Building in Rhodes

Abstract. The aim of this study is the seismic assessment of a historical two-storey masonry building, located in the city of Rhodes and the investigation of intervention ways to strengthen the building and improve the mechanical characteristics of its materials. The 3DR.PESSOS software was used for the simulation and analysis of the structure. For the evaluation of the seismic behaviour of the building, an elastic static analysis (lateral force analysis) was carried out based on the Greek Code for Structural Interventions of Masonry Structures. Elastic static analysis methods with global behaviour factor (*q*) or local ductility indices (*m*) were applied for performance levels B1 and B2. From the analyses and the code checks it was concluded that the building is vulnerable to in-plane and out-of-plane actions. For this reason, methods of intervention are being investigated to increase the diaphragm function of the building and to improve the mechanical characteristics of the masonry.

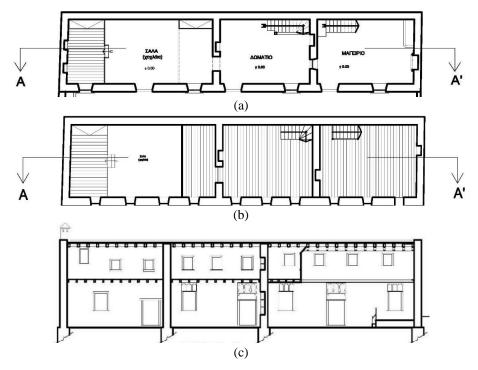
Fig. 1. (a) Ground floor plan, (b) first floor plan and (c) longitudinal section A-A' [14].

rectangular in plan, with three rooms and average external dimensions of 5.55 m wide and 24.60 m long. It consists of the ground floor, the mezzanine floor, which occupies 2/3 of the building, and the roof. The mezzanine consists of timber floorboard on wooden beams with dimensions of 10 cm x 15 cm at 50 cm spacing, while the roof consists of timber floorboard on wooden beams with dimensions of 15 cm x 20 cm at 50 cm spacing, covered with a light reinforced concrete slab. The height of the ground floor is 5.80 m and 3.25 m, while the height of the first floor is 2.55 m. Fig. 1. shows the ground floor plan and upper floor plan of the building.

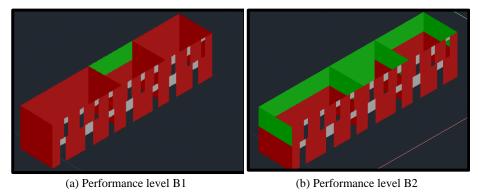
Fig. 5. Colour representation of inadequacies of the piers (green: adequacy, red: inadequacy).

In Fig. 5a, the piers for which there is a deficiency are illustrated in red colour in the 3D model. Therefore, when evaluating the seismic behaviour of the building using the method of the global behaviour factor q and taking as an assessment target the

The influence of the performance level on the seismic assessment results of the building was then investigated. The performance level B2 was selected and new elastic analyses were carried out based on the global behaviour factor (q) for q=1.5. Fig. 5b illustrates in colour the piers for which there is inadequacy, which are obviously less than in the analysis for performance level B1 (Fig. 5a). By adopting a less stringent performance objective, i.e. a 50% probability of exceeding the seismic action in 50 years, on the basis of which the seismic action is reduced by about 40%, the more favourable behaviour of the masonry is evident, mainly in out-of-plane bending.

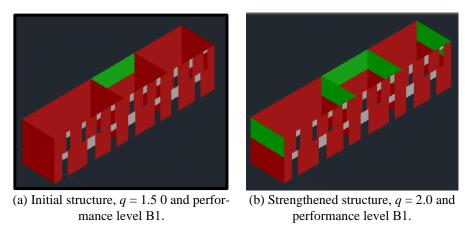
Fig. 6. Colour representation of failed piers (green: adequacy, red: inadequacy).

Fig. 6 illustrates in red colour the piers that fail in the original and the strengthened structure, respectively, for performance level B1. From Tables 5 to 7 and Fig. 6, it is observed that the failure indices for in-plane shear action for most of the piers have been significantly reduced after the interventions, however, shear failures of masonry remain. The same conclusion is reached for the out-of-plane action.

Significantly improved behaviour of the masonry appears mainly in the crown of the walls and in particular in out-of-plane bending for plane of failure perpendicular to the bedjoints. This can be attributed to the strengthening of the diaphragm function of the roof. Overall, despite the significant improvement observed in the failure indices, the building still exhibits deficiencies.

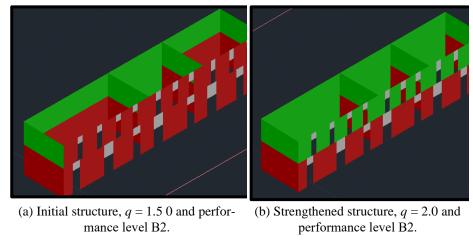
Fig. 7. Colour representation of failed piers (green: adequacy, red: inadequacy).

As with the original building, the behaviour of the strengthened building was investigated for performance level B2, i.e. for an earthquake with a 50% probability of exceedance in 50 years. In Fig. 7, the piers that fail in the original and the strengthened structure, respectively, for performance level B2 are shown in colour in the 3D model.

As shown by the analysis of the strengthened building, for performance level B2, failure occurs only for in-plane shear actions, in the face piers and in the piers along the transverse direction (short side) of the building, only for the ground floor level. The favourable function of the diaphragm at the crown of the building is evident, where no pier shows deficiency in out-of-plane bending.
