Charalambos BOURAS

Τόμος ΚΕ' (2004) • Σελ. 11-24 Αθηνα 2004

## THE SOTEIRA LYKODEMOU AT ATHENS. ARCHITECTURE\*

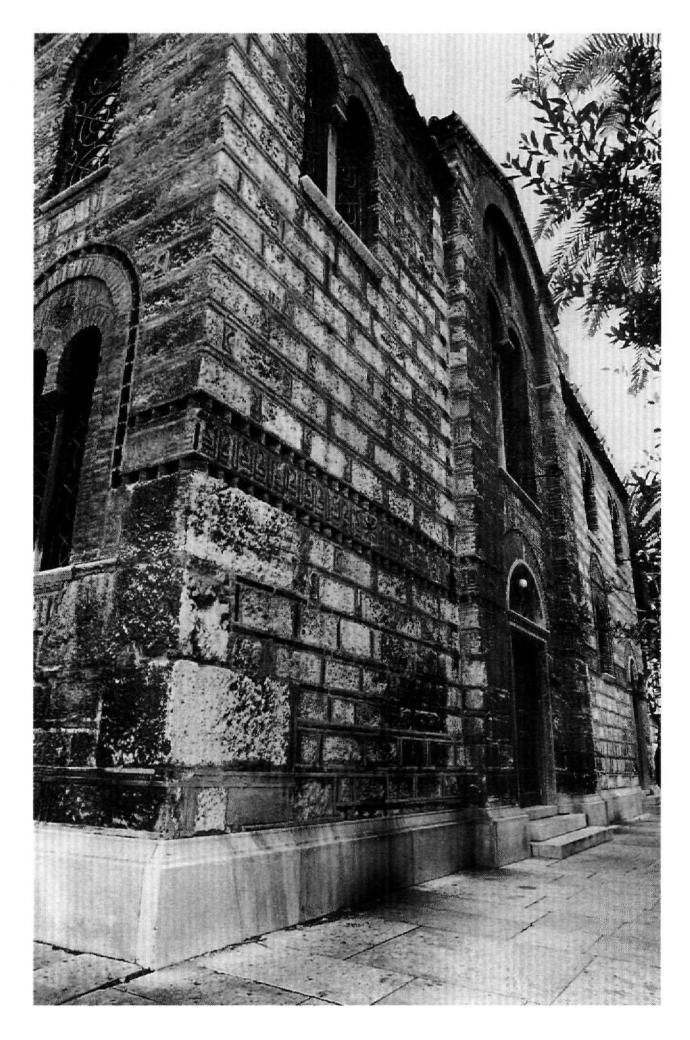
Fig. 1. The north façade looking west.

high chamfered marble crepis added by Vlasopoulos (Fig. 1) detracted from the monument's authenticity, and the old marble templon, the form of which is preserved by Lenoir<sup>33</sup>, appears to have been carried off before the work began<sup>34</sup>. The almost total destruction of the wall-paintings in the church (which will be discussed below) confirms the great scale of the removal of walls and vaults during Vlasopoulos's intervention.

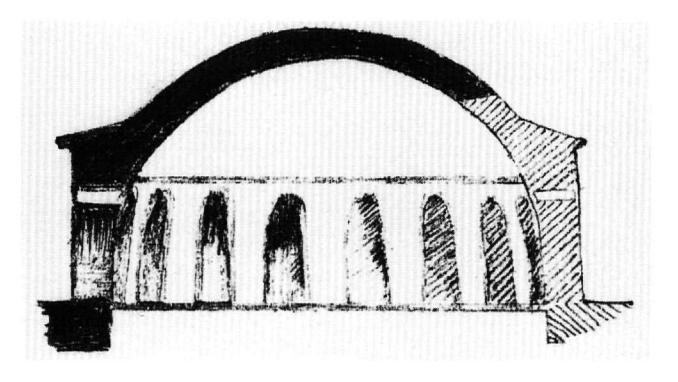
Fig. 2. Section of the original dome by T. Vlasopoulos, after Lambakis.

ing is confirmed by the reports submitted by a committee of technical experts (Smolens, Riedl, Kaftantzoglou and Schiodel (?) on 12th April 1847) and also by Kaftantzoglou himself, to the effect that "...the church, being in a very ruined state, must be razed to the foundations and erected anew...". This information is recorded for us forty years later by G. Lambakis<sup>21</sup>, who appears to have derived it from the military architect responsible for the work, Telemachos Vlasopoulos<sup>22</sup>, who was still alive in 1894 at least<sup>23</sup>. In the end, the church was fortunately not demolished but radically repaired, with parts of it being reconstructed. Lambakis, who was not even born at this time<sup>24</sup>, knew the plans that had been drawn up by Vlasopoulos, one of which – the section of the dome – he published (Fig. 2)<sup>25</sup>. The work was carried out between 1850 and 1855.

earthquake is based on the assumptions that the measured drawing of the original dome by T. Vlasopoulos<sup>52</sup> was accurate and that the reconstruction followed it faithfully. It is only by making these assumptions that it is possible to use as a base the much later drawings of the plan and section of the present form of the Soteira by R. Schultz and S. Barnsley<sup>53</sup>, which, when checked, proved to have a satisfactory degree of accuracy<sup>54</sup>.

The dome, then, did not have an internal tympanum, and the sixteen windows created around the edge of it penetrated its hemisphere. There was a low tympanum only on the exterior. From Durand's drawing 32/16 it can be calculated

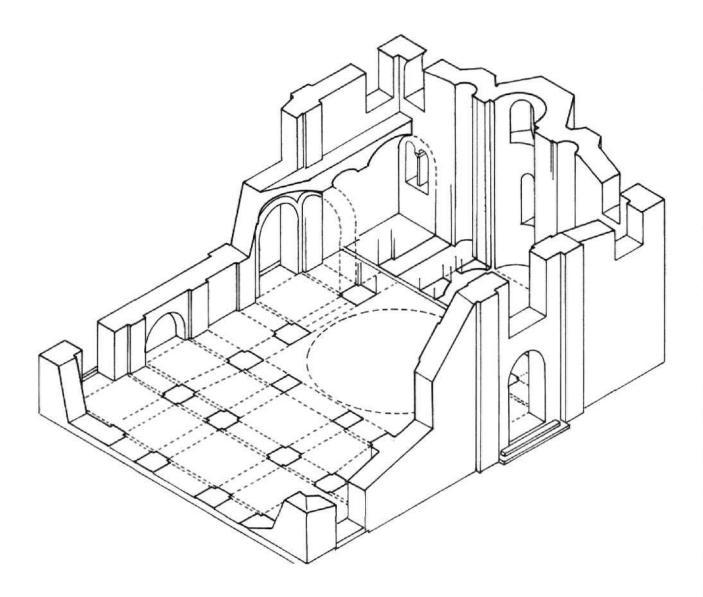
Fig. 3. Isometric section of the church, showing the existing original parts of the building, by C. Koliopoulos.

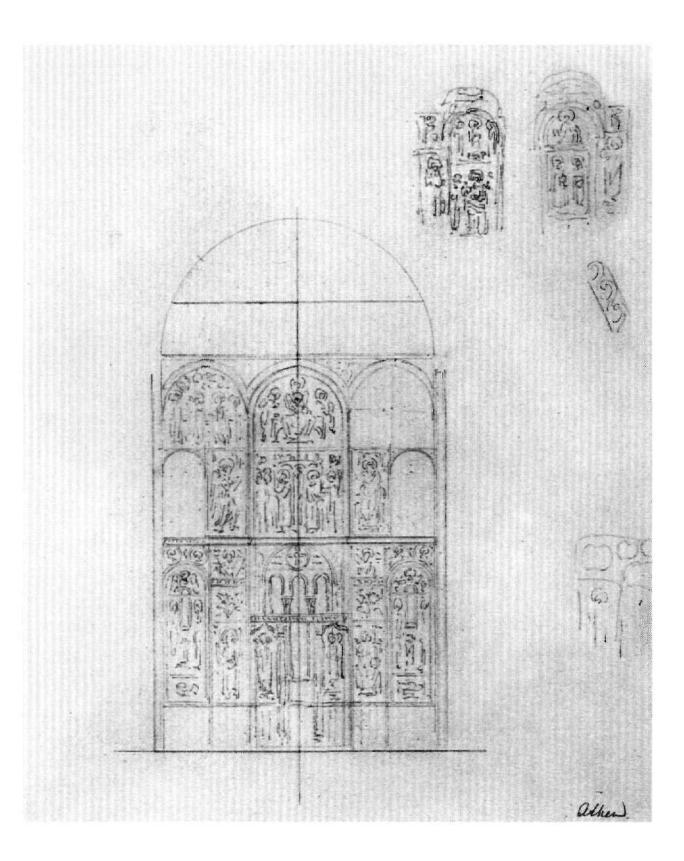
Fig. 4. M.G. Bindesbel. Athens, Byzantine Church, 1835. Library of the Copenhagen Academy of Fine Arts, G.B. 074.

The Danish architect M.G. Bindesbel<sup>41</sup> has bequeathed us a drawing of a transverse section and two rough sketches (Fig. 4), which bear the title "Byzantine church in Athens". The church is clearly the Soteira, since the drawing shows the two squinches either side of the east arm, the wide, low dome, and the templon with its two columns in front of the sanctuary. The two sketches depict the apses of the prothesis and

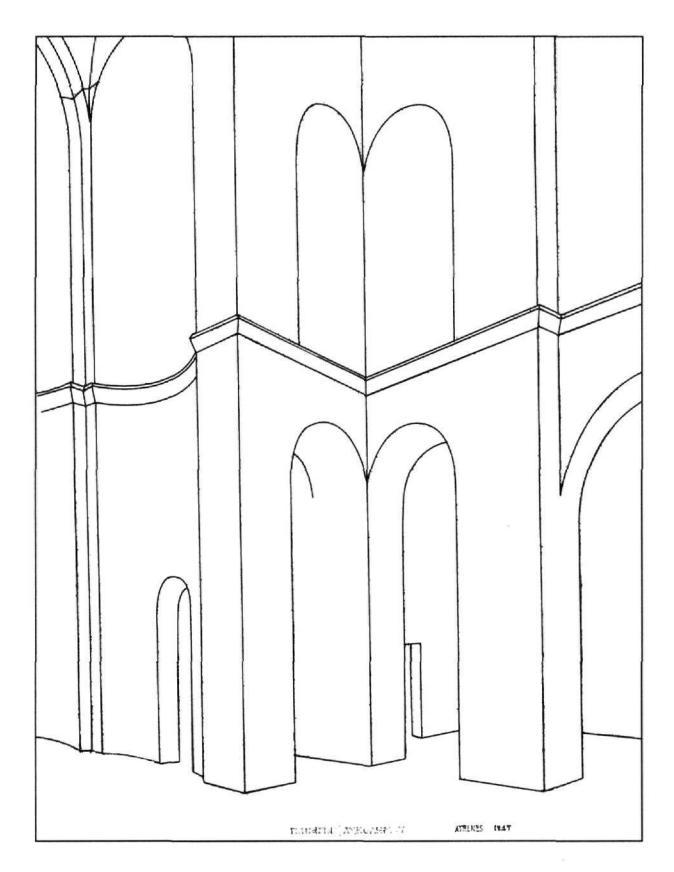
Fig. 6. Interior of naos facing south-east. P. Durand, no. 32.2, Hellenic Literary and Historic Archive (EAIA).

from the level of an observer at the lower level, looking to the south-east (Fig. 6). It depicts the south part of the sanctuary with its shallow apse and the corner of the nave. The second (32/16) was taken from the level of the galleries (Fig. 7) and depicts the south-west corner and parts of the ruined west arm and narthex, as well as the dome, which has partly collapsed. Both these drawings, and indirectly the 22 others depicting wall-paintings<sup>51</sup>, provide a great deal of information on the form of the Soteira after the Greek Uprising, which I shall try to exploit in what follows.

The major problem in the reconstruction is the precise form taken by the rest of the vaulting of the church. From Durand's drawing 32/2 it emerges that the east arm was covered by a cross-vault and from 32/16 that the west probably also had an elevated cross-vault or low domes carried on pendentives. All the other vaults in the drawings (8 and 9 are unaccompanied by any substantial information regarding the original form.

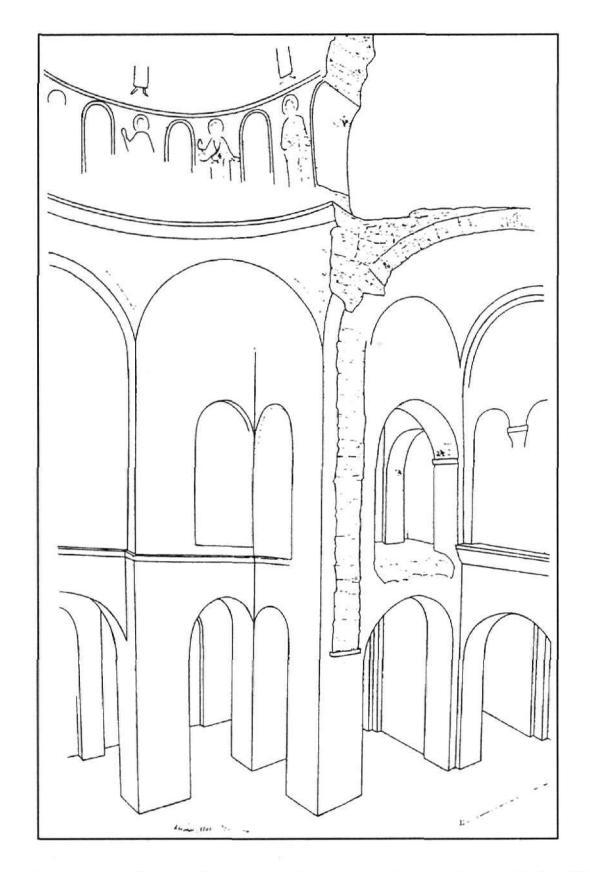
Fig. 7. Interior of naos facing north-west. P. Durand, no. 32.16, Hellenic Literary and Historic Archive (EAIA).

that the two main axes of the nave coincided at the dome not with windows but with a section of wall between two windows. This feature further reveals the similarity of the dome of the Soteira with that of the katholikon of the monastery of Hosios Loukas. The breach created by the bomb must have been above the south-west pillar and, according to Couchaud, it destroyed two thirds of the dome. There was a painted strip above the window arches. In Durand's drawings, the thickness of the face of the arches bearing the dome can be made out, as well as that of the unified surface of the circumscribed sphere above them. Both were probably equal to the length of a brick.

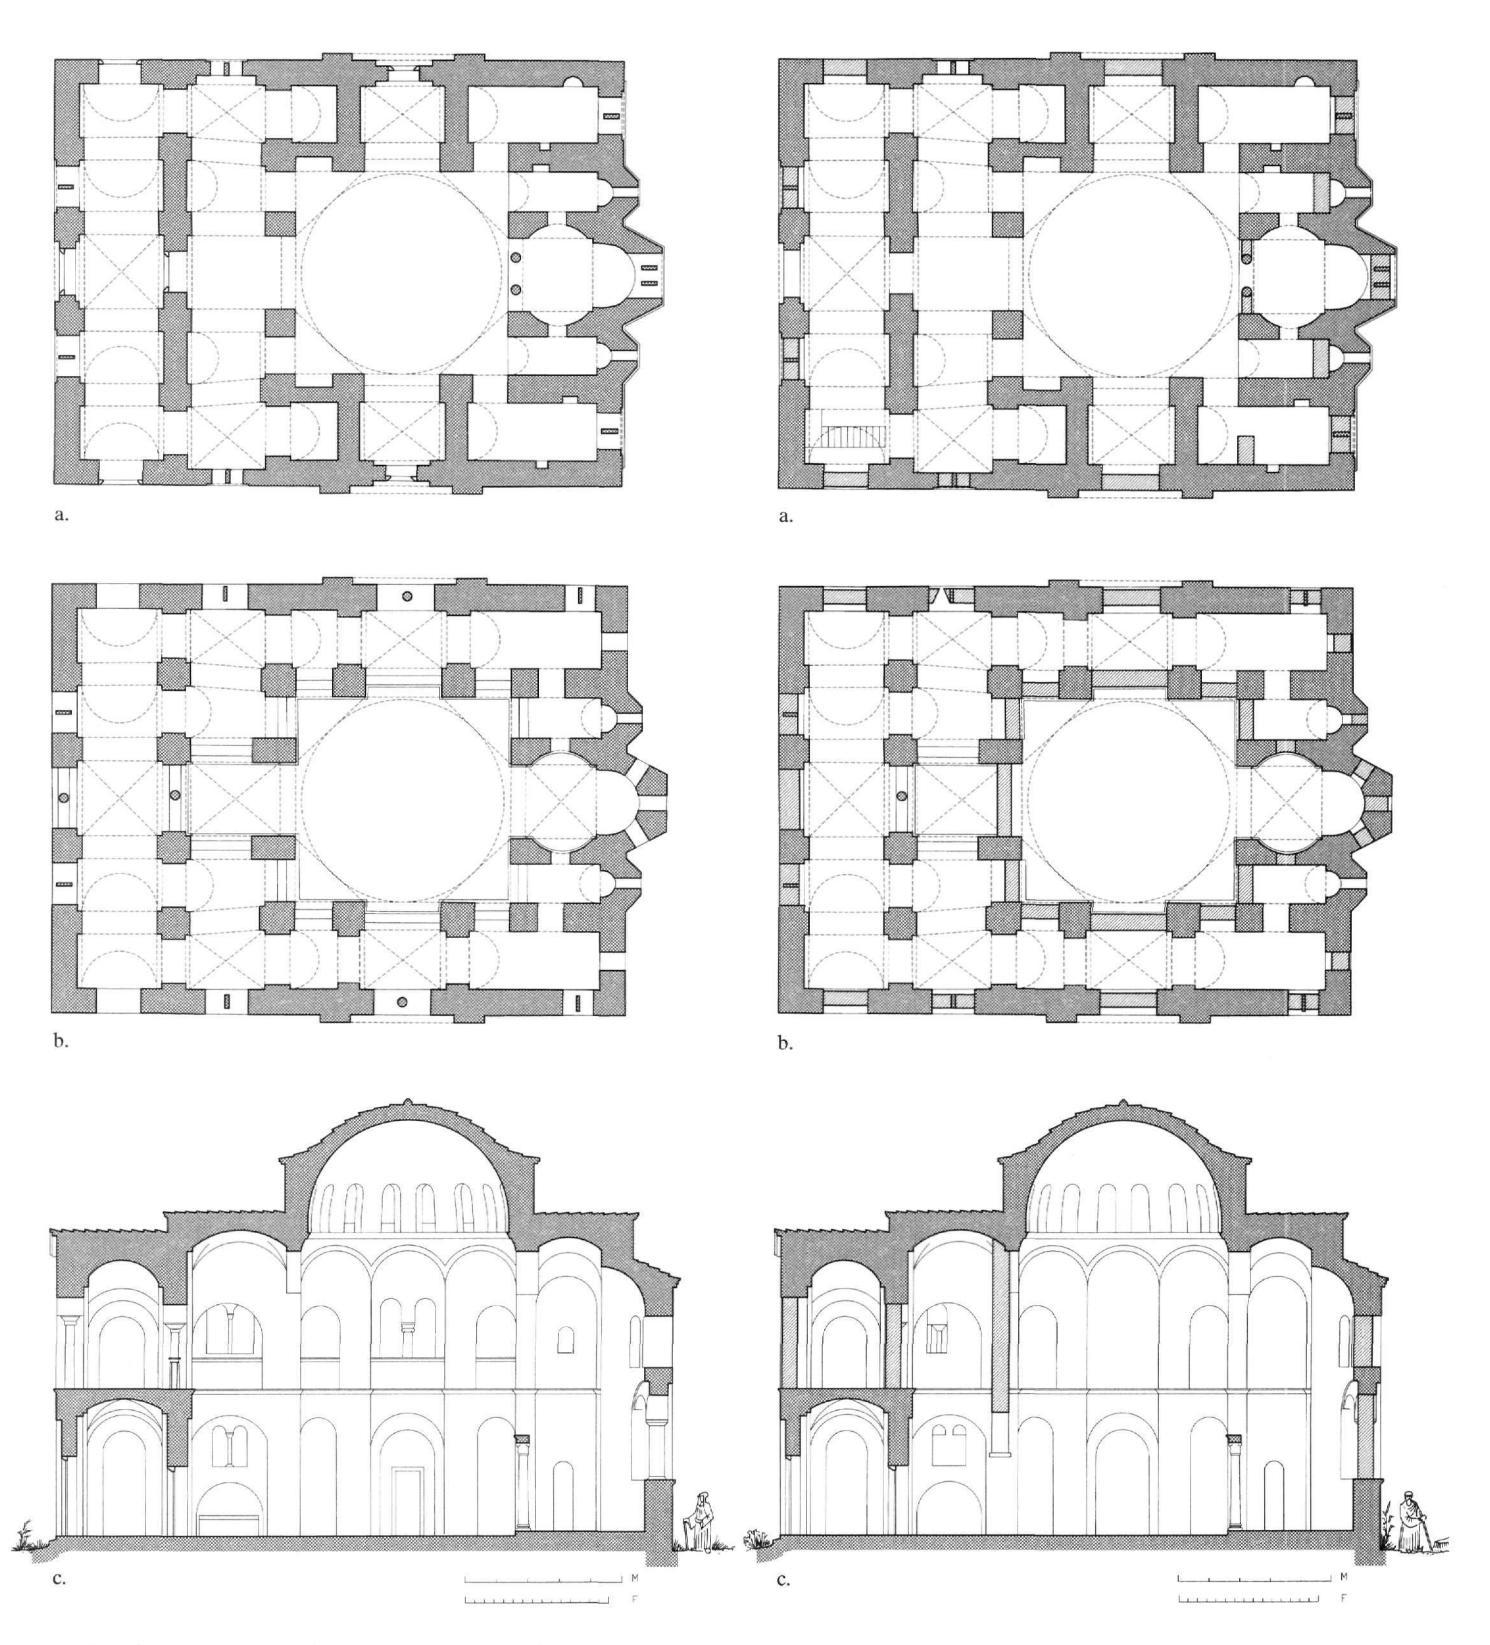
Fig. 8. Reconstruction of the church in its original form. a. Plan at ground level. b. Plan at gallery level. c. Longitudinal section.

Fig. 9. Reconstruction of the church as in 1820. a. Plan at ground level. b. Plan at gallery level. c. Longitudinal section.

The attempted restoration of the Soteira in the form it originally had (Fig. 8) and in the form it received after the 1705

All the roofs are assumed originally to have been tiled<sup>60</sup>. The reconstruction of the Soteira in the form it took after the repairs necessitated by the 1705 earthquake and before the Greek Uprising of 1821 (Fig. 9) is based on the same documentation, mainly on P. Durand's drawings.

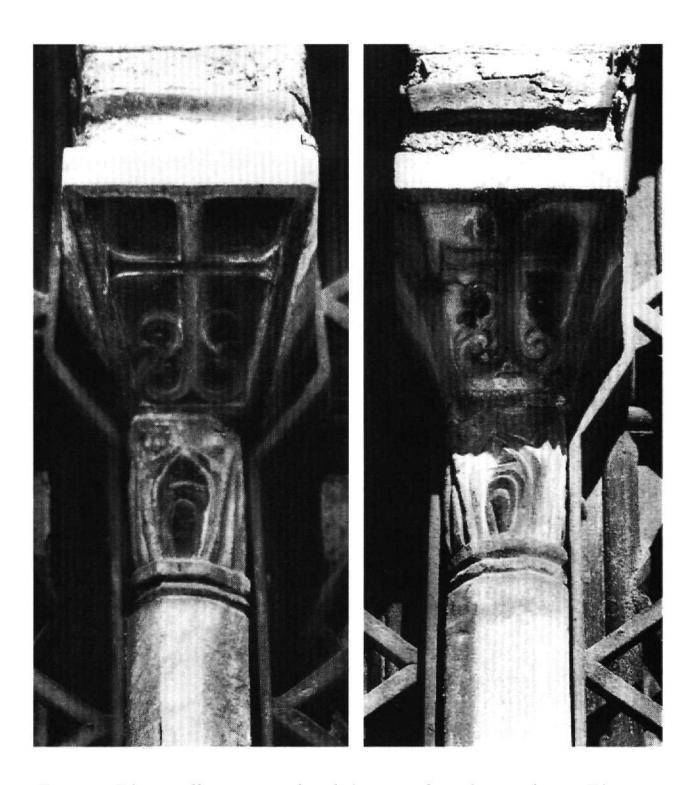
Fig. 10. The mullion capitals of the east façade windows. The imposts are modern (1850).

Very little survives of the sculptural decoration of the Soteira. Mullions are all that remain in situ of all the windows on the east side and of the two-light windows at the east end of the galleries (Figs. 10-11). As noted above, Vlasopoulos's restoration respected the axial column with its Ionic capital integral with the impost block (Fig. 12), a form common in the Early Christian period<sup>65</sup> though not unknown in the katholikon of the monastery of Hosios Loukas<sup>66</sup>. The decorative motifs of the capitals and impost blocks above the mullions are very simple and commonly found in the eleventh century (six-point rosettes and

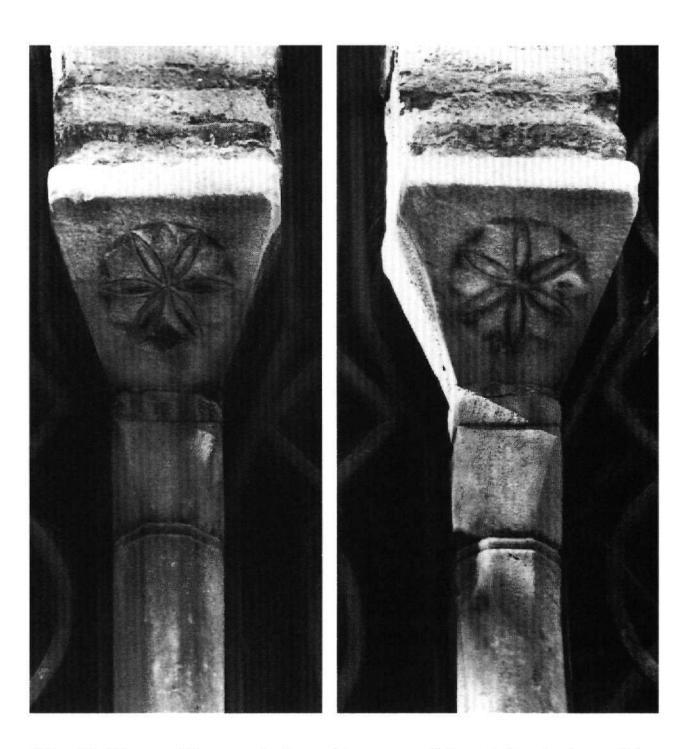
Fig. 11. The mullion capitals and imposts of the triple window of the bema apse.

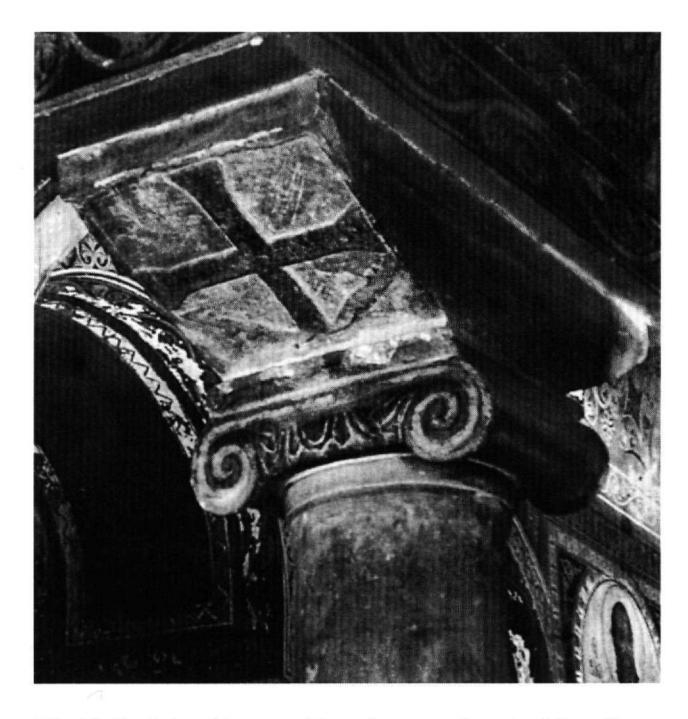
Fig. 12. Capital and impost of the colonette at the axis of the gallery.

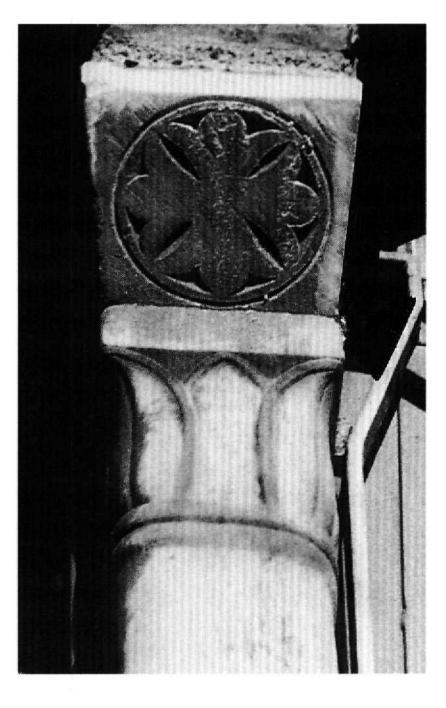
Fig. 13. Impost over a modern mullion on the south façade.

crosses) (Fig. 13). Unfortunately, none of the marble doorframes of the church survives. They were probably removed during the long period of its abandonment. The bowls in the tympana of the three-light window of the bema apse have been replaced by later small decorative disks.

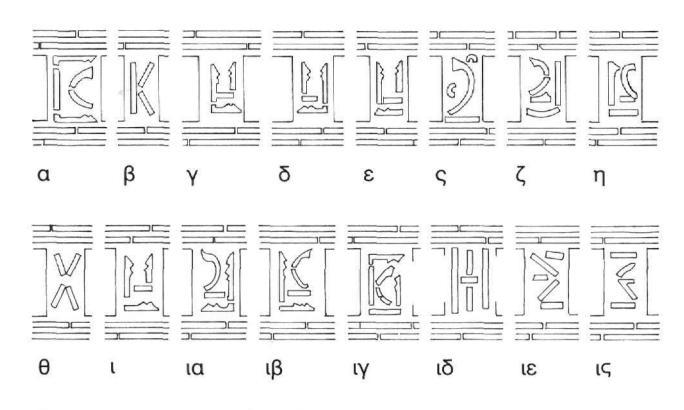
Fig. 14. Cut brick pseudo-cufic patterns.

The cufic and pseudo-cufic motifs on the walls of the Soteira have been treated directly or indirectly by G. Sotiriou<sup>75</sup>, A.H.S. Megaw<sup>76</sup>, G. Miles<sup>77</sup>, P. Vocotopoulos<sup>78</sup>, A. Frantz<sup>79</sup> and N. Nikonanos<sup>80</sup>. Depictions of them have already been published by Chr. Hansen<sup>81</sup>, A. Lenoir<sup>82</sup> and G. Lambakis<sup>83</sup>. Despite the destruction of a large part of the ceramic decoration, it is immediately apparent that the motifs of the individual cufic patterns and the system by which they were ap-

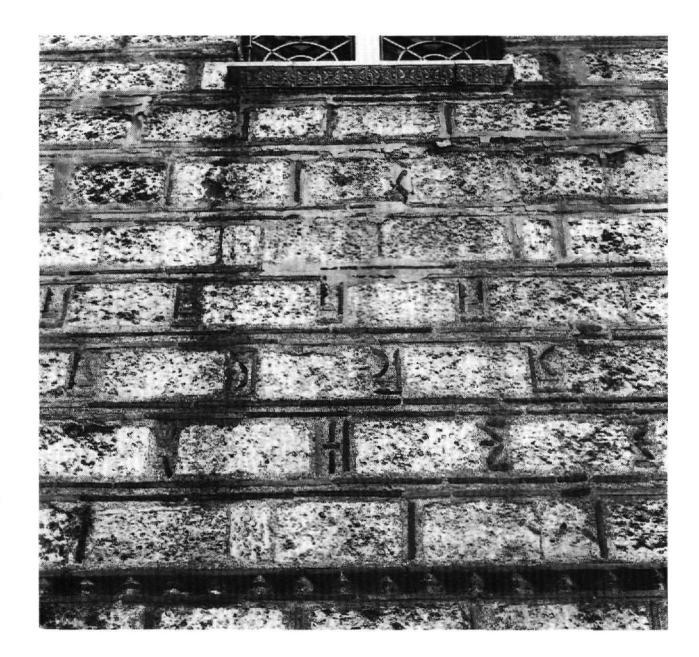
Fig. 15. Detail of the masonry on the south façade.

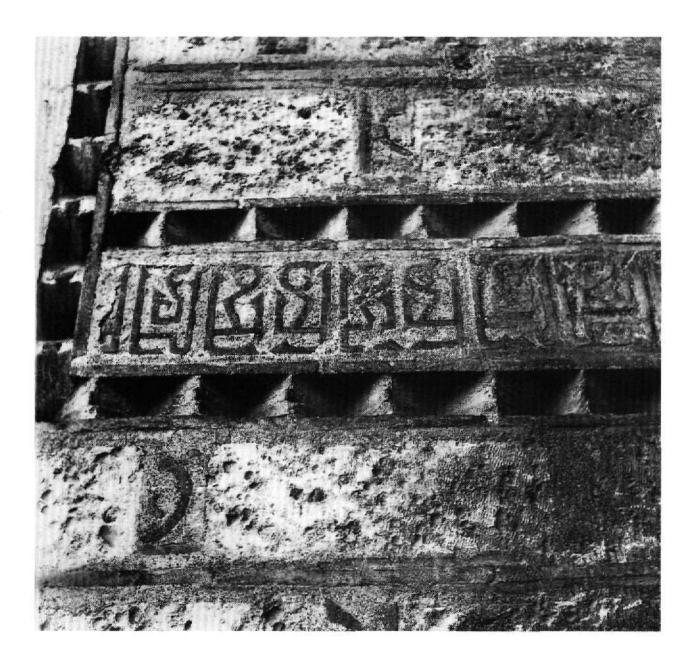
Fig. 16. North façade. Detail of the frieze.
