GROUND FAILURE DUE TO GYPSUM DISSOLUTION

Eleftheria Poyiadji¹, Nikolaos Nikolaou¹, Petros Karmis²

¹ Division of Engineering Geology, Institute of Geology and Mineral Exploration ² Division of Geophysics, Institute of Geology and Mineral Exploration

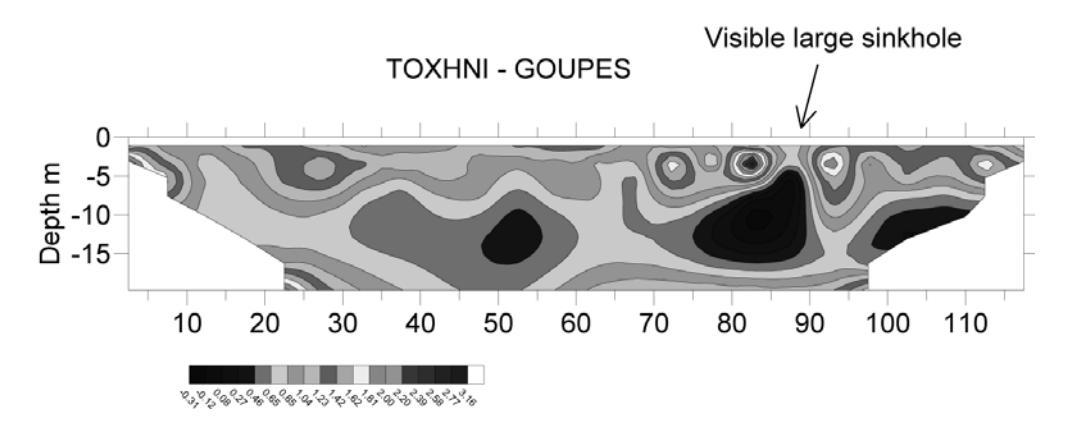
Fig. 1: Example of resistivity anomaly obtained over visible large sinkhole.

In Figure 1 an example is presented of the typical anomaly pattern of ERT obtained over an open sinkhole. The cavity is filled with clayey material with resistivity values smaller than 2 Ohm*m.

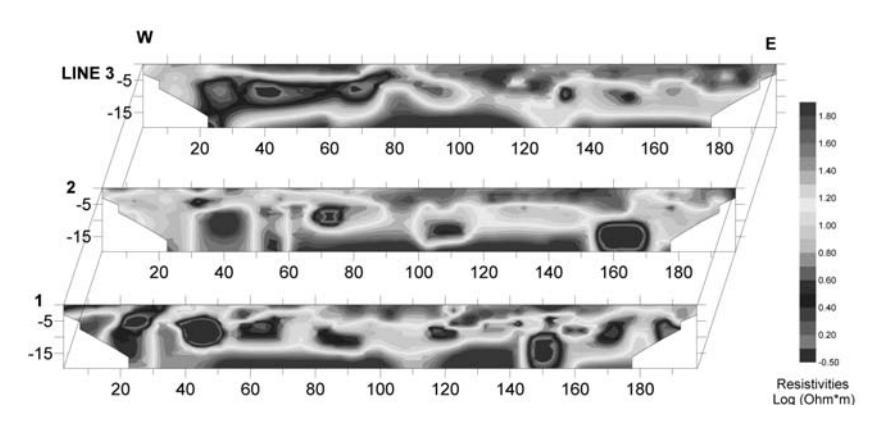
Fig. 2: Inverted resistivity sections of lines 1 to 3 at Pera Chorio, Cyprus.

The method was applied on grids with parallel lines at a distance of 10 m. In Figure 2 the results of 3 parallel lines are presented. The lines were located within the banks of a river and this resulted to a large number of anomalies possibly associated with sinkholes.

A layer of coarse grained sediments is shown near surface to a depth of 3 to 5 m with resistivity val-

ues between 20 and 60 Ohm*m (1.25 to 1.8 in log scale). The layer of gypsum marl is detected at that depth, with resistivity values in the range of 5 to 12 Ohm*m ($0.6 - 1.2 \log scale$). The presence of possible sinkholes is identified by the characteristic circular or funnel shale conductive anomalies with values between 1 to 3 Ohm*m.

In certain cases, the presence of a sinkhole is been evidenced by a conductive lineament migrating and reaching the surface.

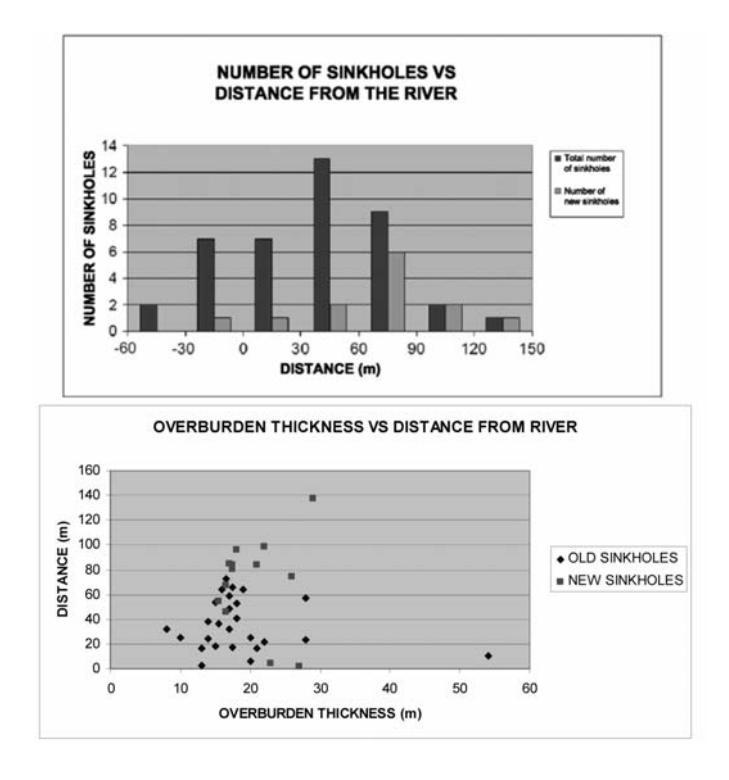
Fig. 3: a) left – Number of sinkholes versus distance from the river, b) right – Overburden thickness versus distance from the river

The greater number of sinkholes occurs in the zone of 30-60 m, an area that coincides with the riverbed (Fig. 3a). The distance from the river of younger sinkholes, tend to increase (Fig. 3b). This can be explained by the theory that the mechanical action of the water washes out filling materials and progressively can reach more remote areas.

The distance from the river is determinative factor while the overburden thickness also affects the development of sinkholes. Another controlling factor for the development of sinkholes is the depth of groundwater table as the mechanical action of river water decreases when entering in the regional water table because of the reduction of its velocity.

The greater recorded distance of a sinkhole from the river was 137 m (Fig. 3a) and the greater overburden thickness 54m (Fig. 4a).

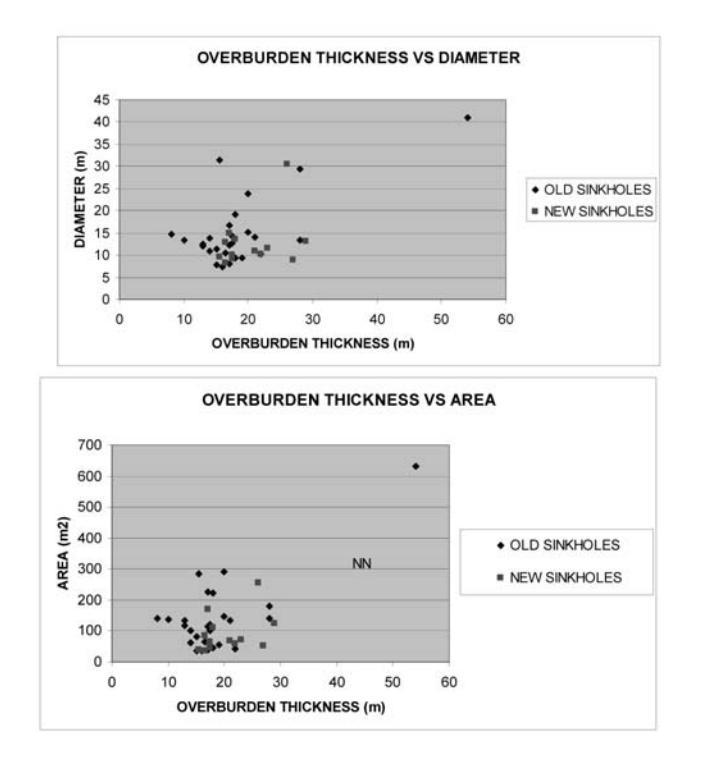
Fig. 4: a) left – Overburden thickness versus diameter of sinkholes, b) right – Overburden thickness versus area of the sinkholes

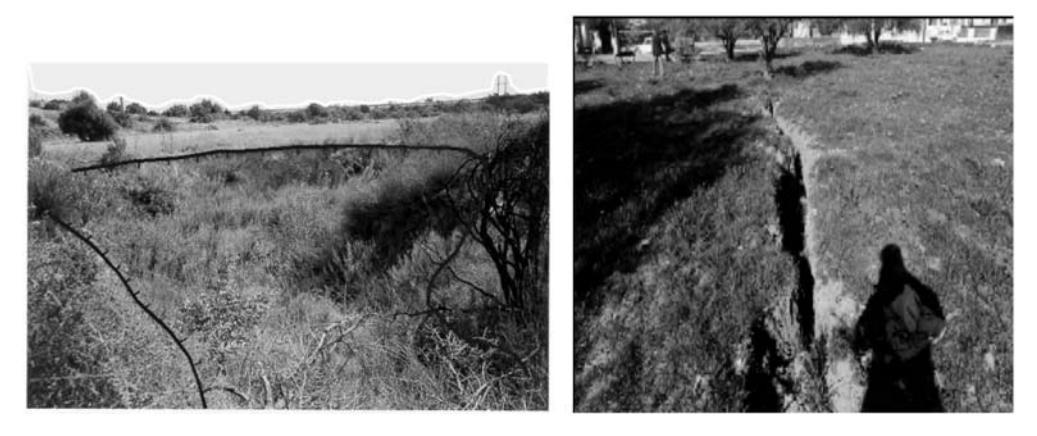
Fig. 5: a) left – An old sinkhole in a riverbed , b) right – Linear ground cracks.

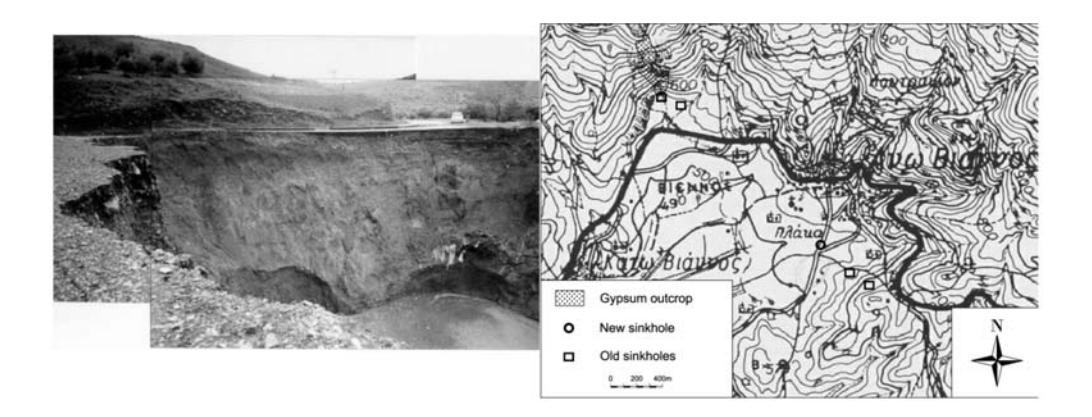
Fig. 6: a) left - A sinkhole in Viannos village (May 2000), Crete , b) Topographical map of Viannos village area.

In May 2000 a large sinkhole developed in an agriculture area south of Ano Viannos village in Crete, causing the collapse of a local road. The sinkhole had a conical shape with 50m diameter and depth (Fig. 6).

outcrops were mapped in the greater area and two old sinkholes were directly related to them (Fig. 6b). The geophysical investigation in the vicinity of the sinkhole confirmed the existence of gypsum in the form of dome, exactly under the sinkhole. The estimated depth of the gypsum dome roof was about 130 m. The projection of the gypsum dome on the surface had an elongated shape with max diameter of approximately 180 m in a NNE-SSW direction and min, which fluctuated between 30 and 90 m.

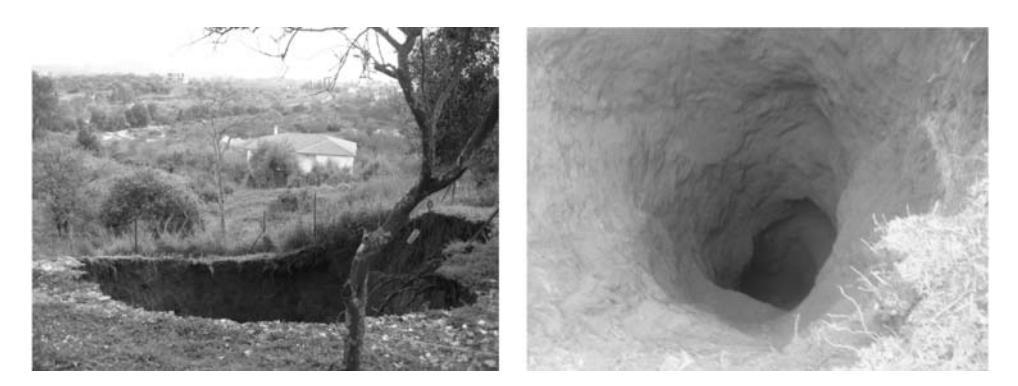
Fig. 7: The sinkhole in Temploni are.

Near the town of Corfu (Temploni area) a large sinkhole was developed in May 2008 (Fig. 7). IGME conducted a hydrogeological, engineering geological and geophysical survey for the study of the phenomenon. The region is a typical karstic area from the dissolution of gypsum with characteristic morphological features like dolines, karstic shafts and generally karstic geo-forms. Geologically the area consists of Triassic breccia (limestone fragments with gypsum as cemented material) and Triassic gypsum.

The sinkhole under study has a symmetrical cylindrical form, inclined towards North, with 11m diameter. The depth of it was estimated 40m, using stratigraphic and hydrogeological data. The area of this ground failure geologically consists from Triassic breccia covered by clayey marly material with thickness at least 7m.

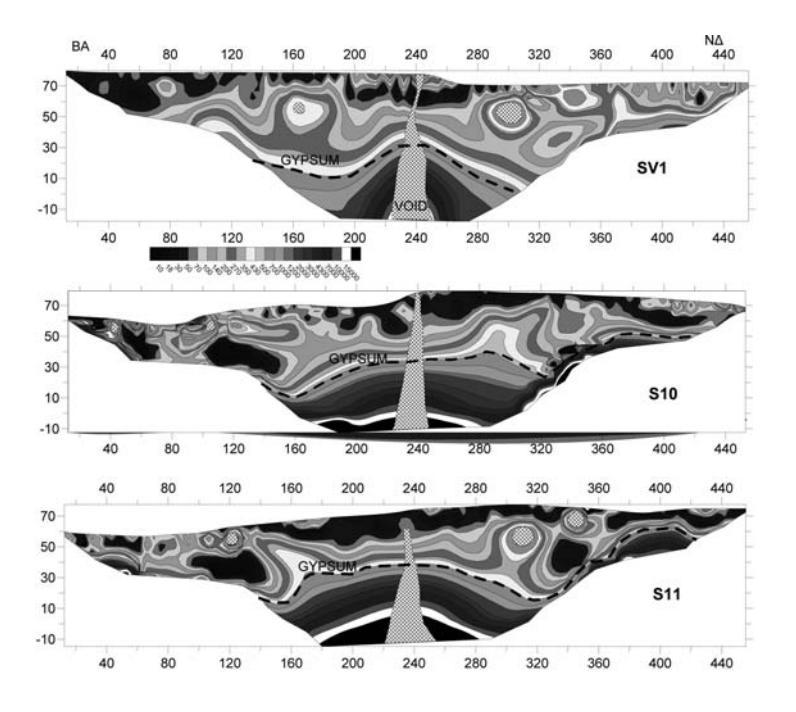
Fig. 8: 2D Inversion results of lines SV, S10, S11. Line SV1 is running over the sinkhole.

The Electrical Resistivity Tomography technique was also utilized in Corfu study with excellent results. A number of 15 lines were surveyed at 2 orthogonal orientations and spacing of 5 and 10m. As can be seen in Figure 8 a large resistivity anomaly is recorded over the void, with a characteristic funnel shape. The gypsum is easily distinguished from the overlying breccias sediments, with high resistivity values in the range of 500 to 700 Ohm*m. The effect of 3D geometry is evident in the interpreted 2D sections. The void which is easily detected on line SV1 is not seen on lines S10 and S11. A large resistive layer is seen instead and the resolution is lost. The large number of available data enabled the 3D processing and interpretation of the surveys. This was effected with the use of the program DC_3Dpro by Junh-Ho Kim and Mywong-Jong Yi of the Korean Institute of Geosciences and Mineral resources. In conclusion the application of ERT has proved the effectiveness of the method and the relative merits of using 3D interpretation schemes. Sinkholes are 3D targets and they require 3D processing and interpretation approach.

As it was described in the aforementioned paragraphs the geophysical investigations revealed the existence of an underground cavity under the sinkhole. The cavity is unfilled and was formed in gypsum formations. The elevation of upper part of cavity is estimated at absolute altitude +55 with overburden thickness 10m of rock formations (gypsum and Triassic breccias) and 13m of soil materials (clayey marly materials). The creation of the sinkhole derived from the partial failure of the roof of the cavity, which created a passage for the overburden loose soil materials.
