Ερευνητικό πρόγραμμα Αμυκλών: Εργασίες 2005-2010

STAVROS VLIZOS

Amykles Research Project: Excavation Works 2005-2010

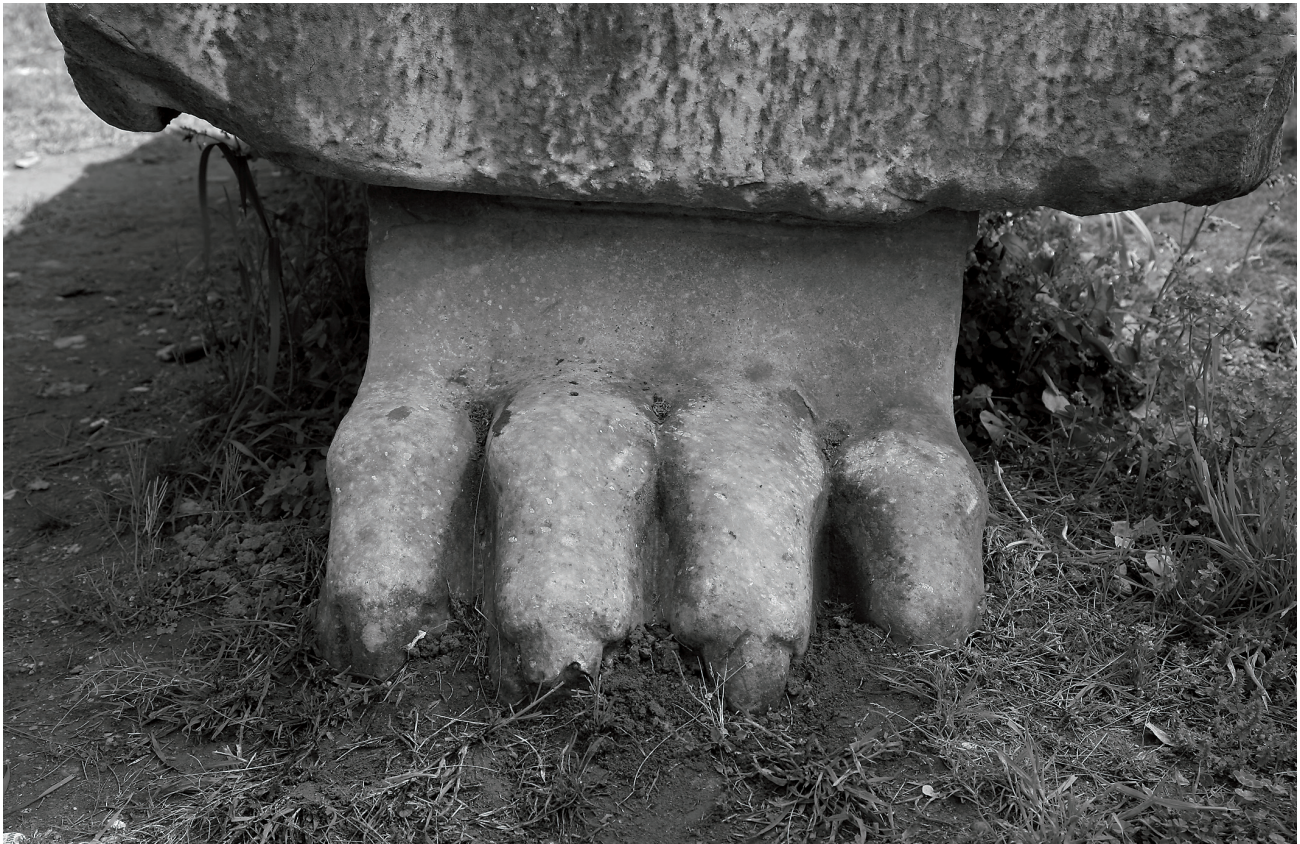
Fig. 3. Bases in the form of a lion's paw (photo: S. Vlizon).

Manolis Korres located and made measured drawings of two monumental bases from the Throne in the form of a lion's paw, which supported the lid of a Roman sarcophagus in the garden of the Sparta Archaeological Museum (fig. 3). These new discoveries reinforced the indications deduced from other architectural members that the temple/Throne designed by Bathykles was in the form of a monumental seat.
