Ερευνητικό πρόγραμμα Αμικλών: Εργασίες 2005-2010

STAVROS VLIZOS

Amykles Research Project: Excavation Works 2005-2010

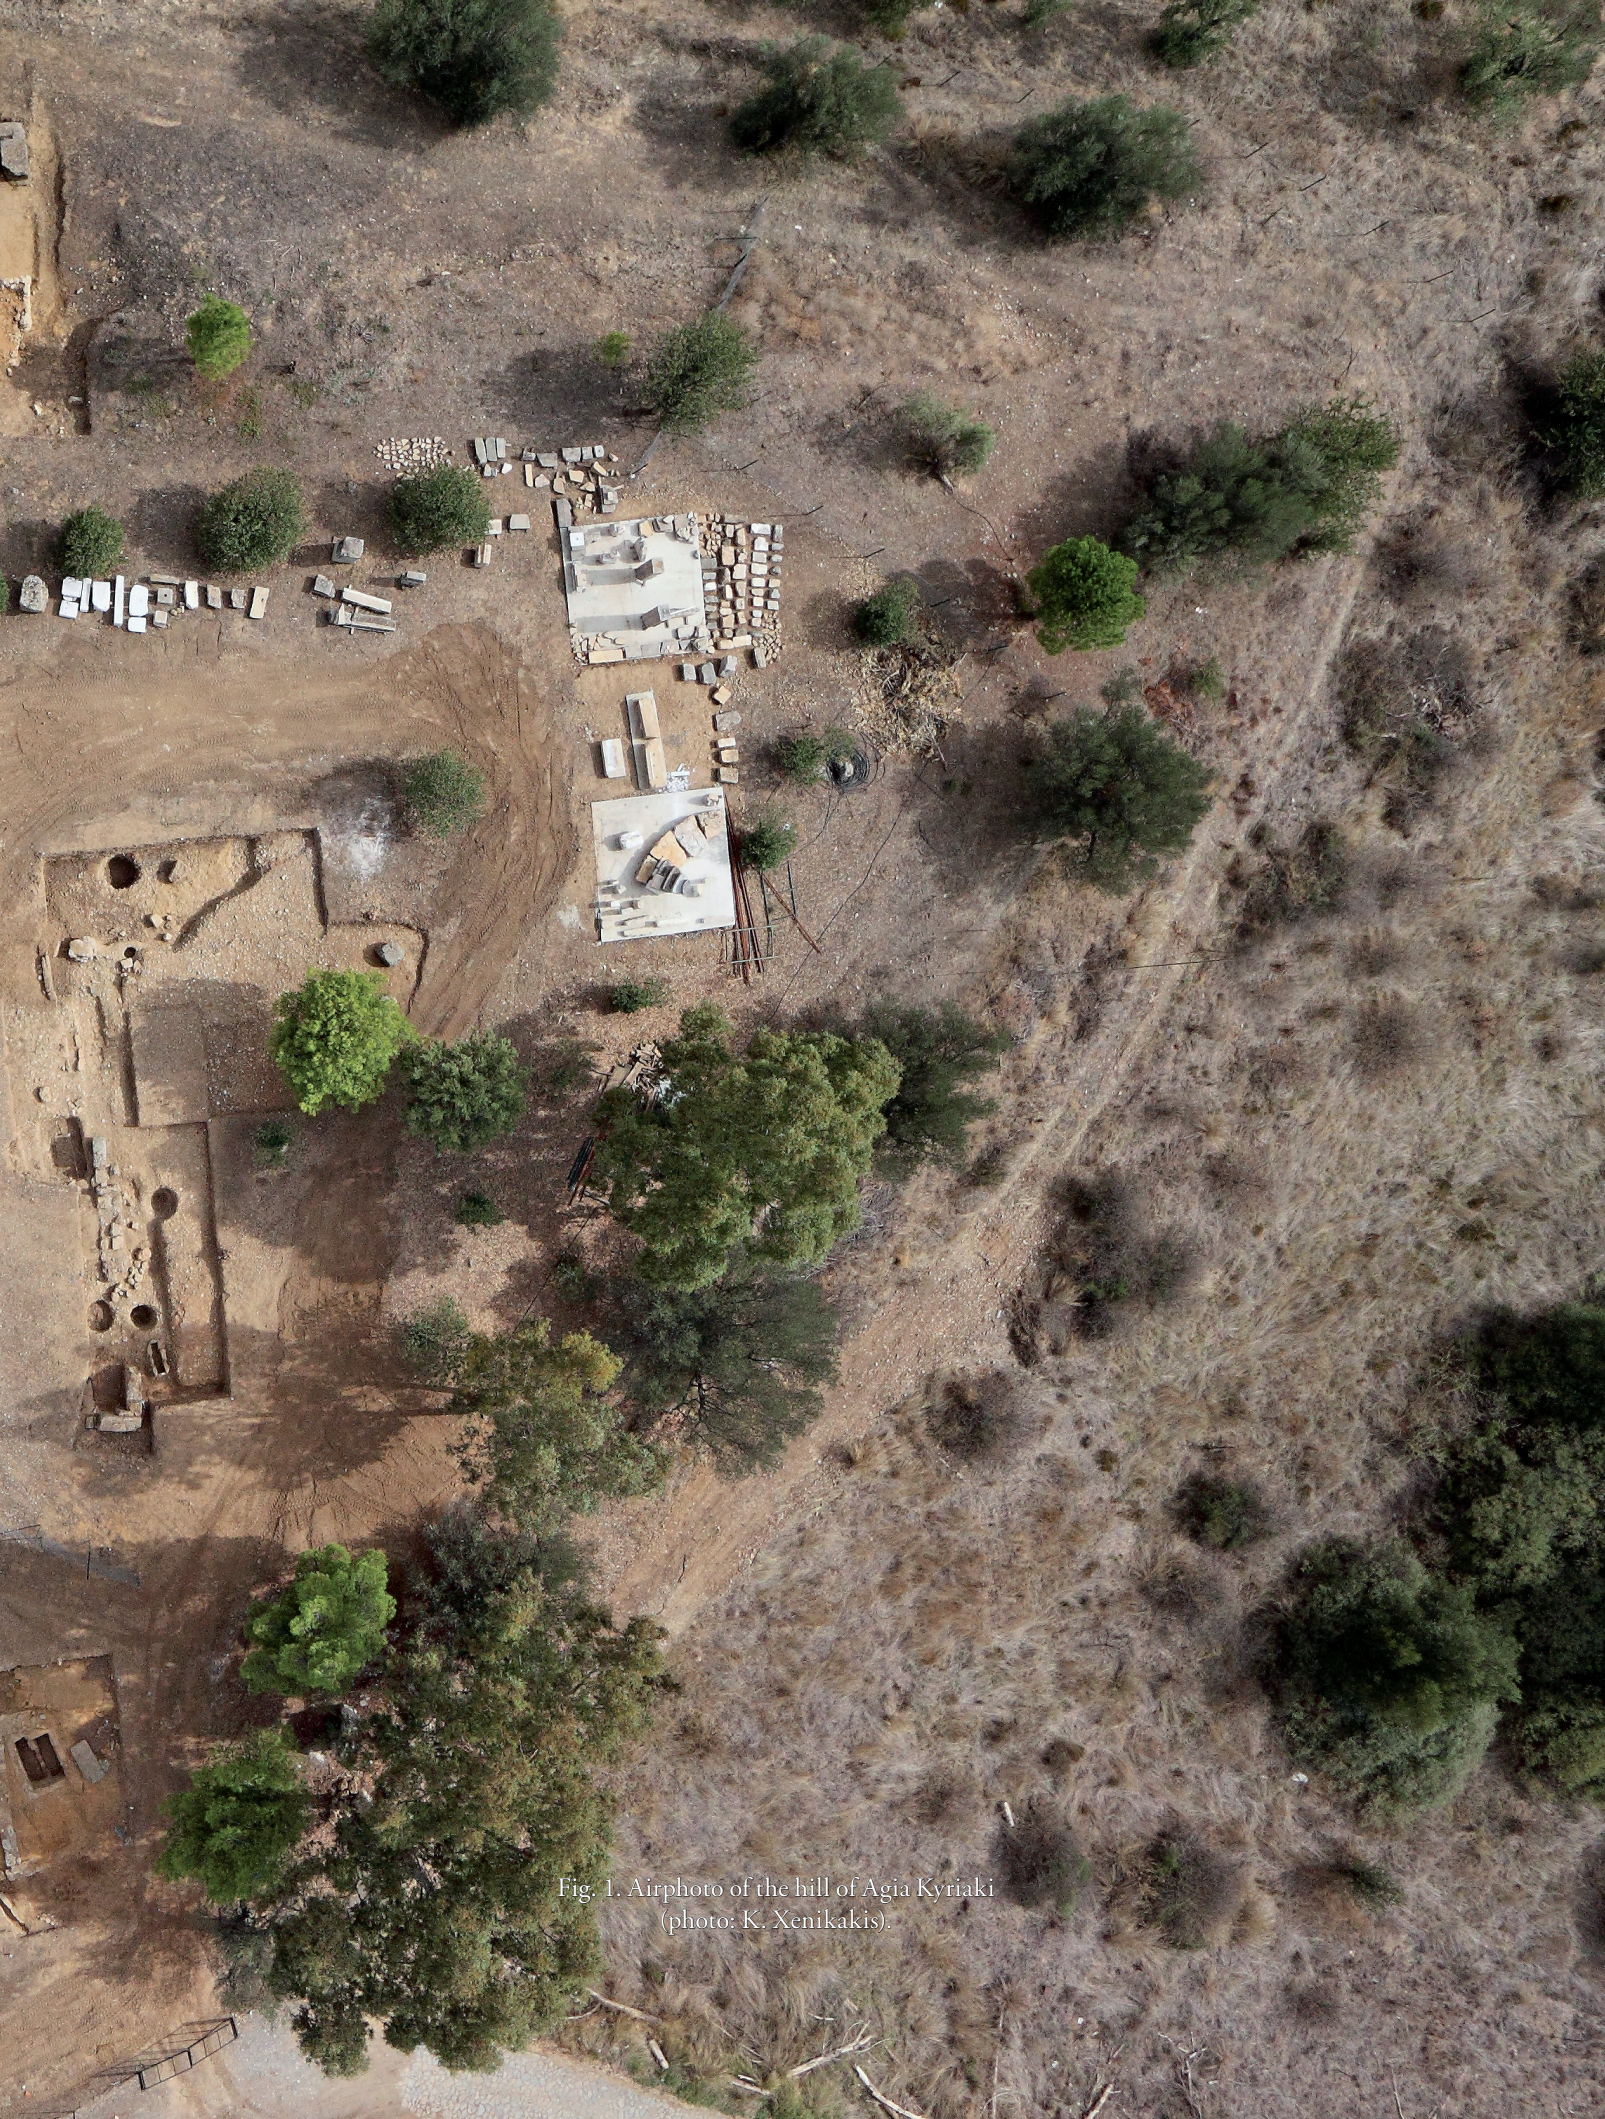
Fig. 1. Airphoto of the hill of Agia Kyriaki
(photo: K. Xenikakis).

IN 11 SEPTEMBER 111111 STUDIES AND RESEARCH in the Spartan Sanctuary of Apollo Amyklaios commenced (fig. 1). One of the urgent tasks of the project was to survey the Agia Kyriaki hill and the surrounding area in detail and to record in the new plans the evidence surviving from previous research carried out by Ch. Tsountas (1890/91), A. Furtwängler (1904), E. Fiechter (1907) and E. Buschor (1925). The existing condition of the archaeological site was mapped and the surviving parts of the krepis of the temple/Throne, of the Peribolos as well as the later church of St Kyriaki were documented by measured drawings.

For a more integrated mapping of the archaeological site and the works completed so far, the aerial photographing of Agia Kyriaki hill and the surrounding area was carried out by the photographer Kostas Xenikakis (see fig. 1).

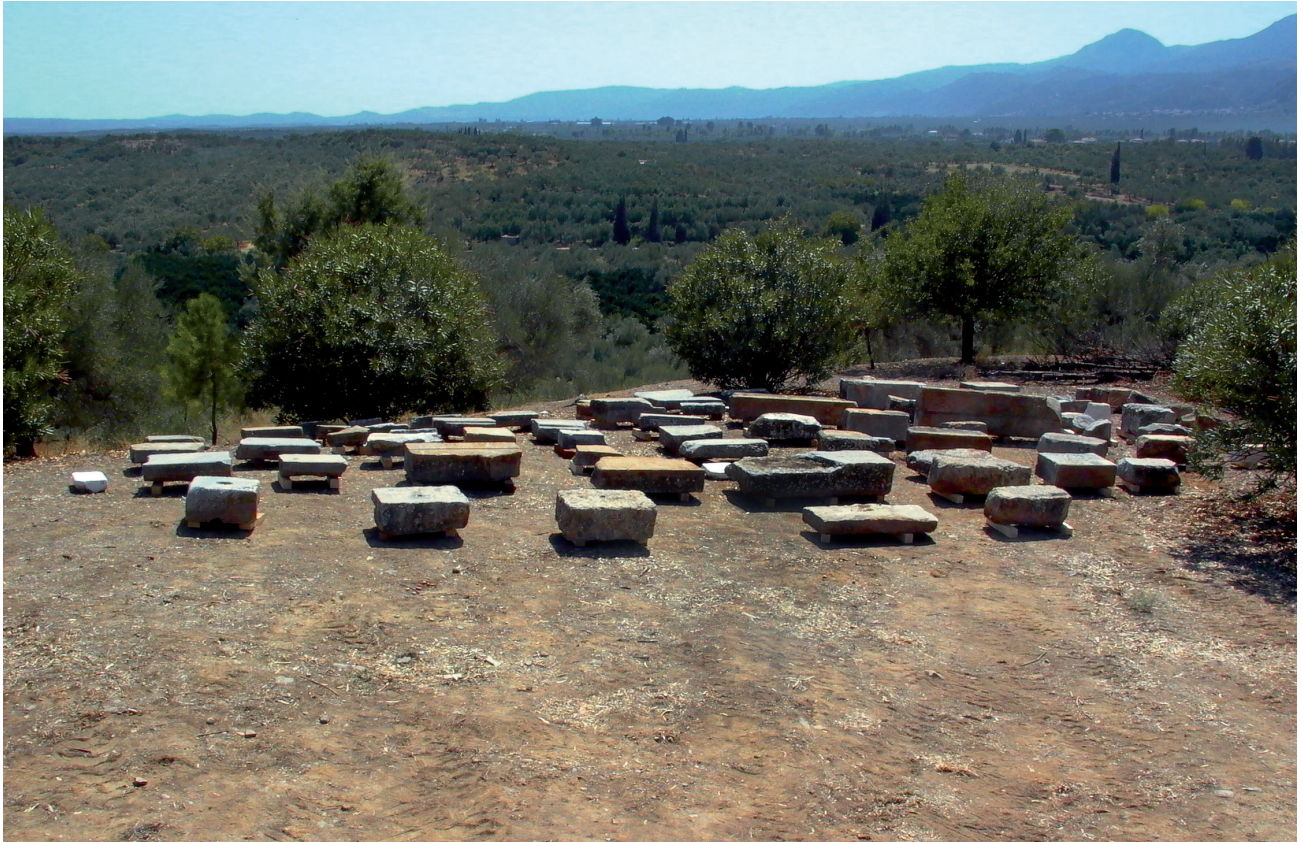
Fig. 2. Fenced area with architectural members (photo: S. Vlizon).

All the architectural members from the monuments of the Sanctuary were gathered, sorted into categories and fenced inside the archaeological site and the already expropriated area (fig. 2). Thus, any further deterioration of the marbles' surface had been avoided and their protection was secured.

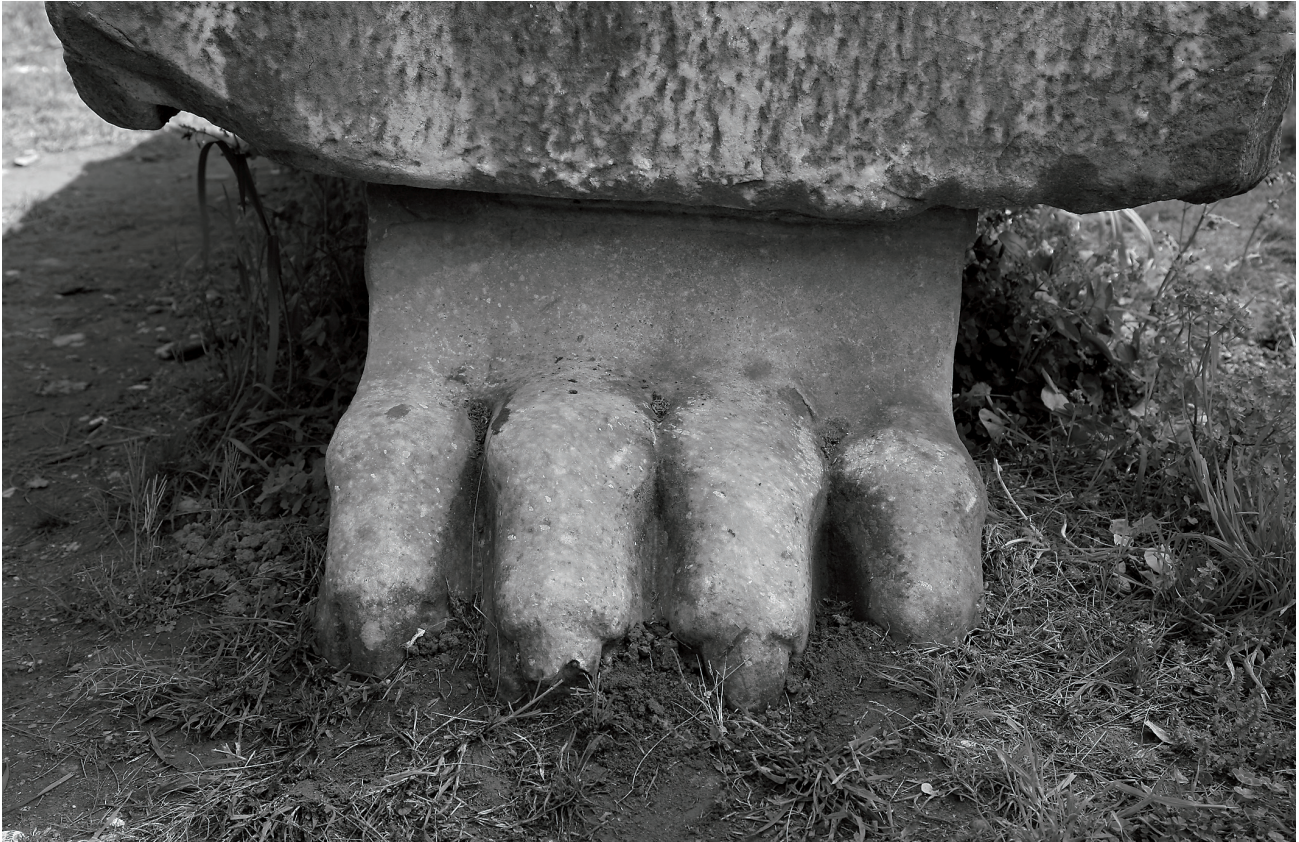
Fig. 3. Bases in the form of a lion's paw (photo: S. Vlizon).

Manolis Korres located and made measured drawings of two monumental bases from the Throne in the form of a lion's paw, which supported the lid of a Roman sarcophagus in the garden of the Sparta Archaeological Museum (fig. 3). These new discoveries reinforced the indications deduced from other architectural members that the temple/Throne designed by Bathykles was in the form of a monumental seat.

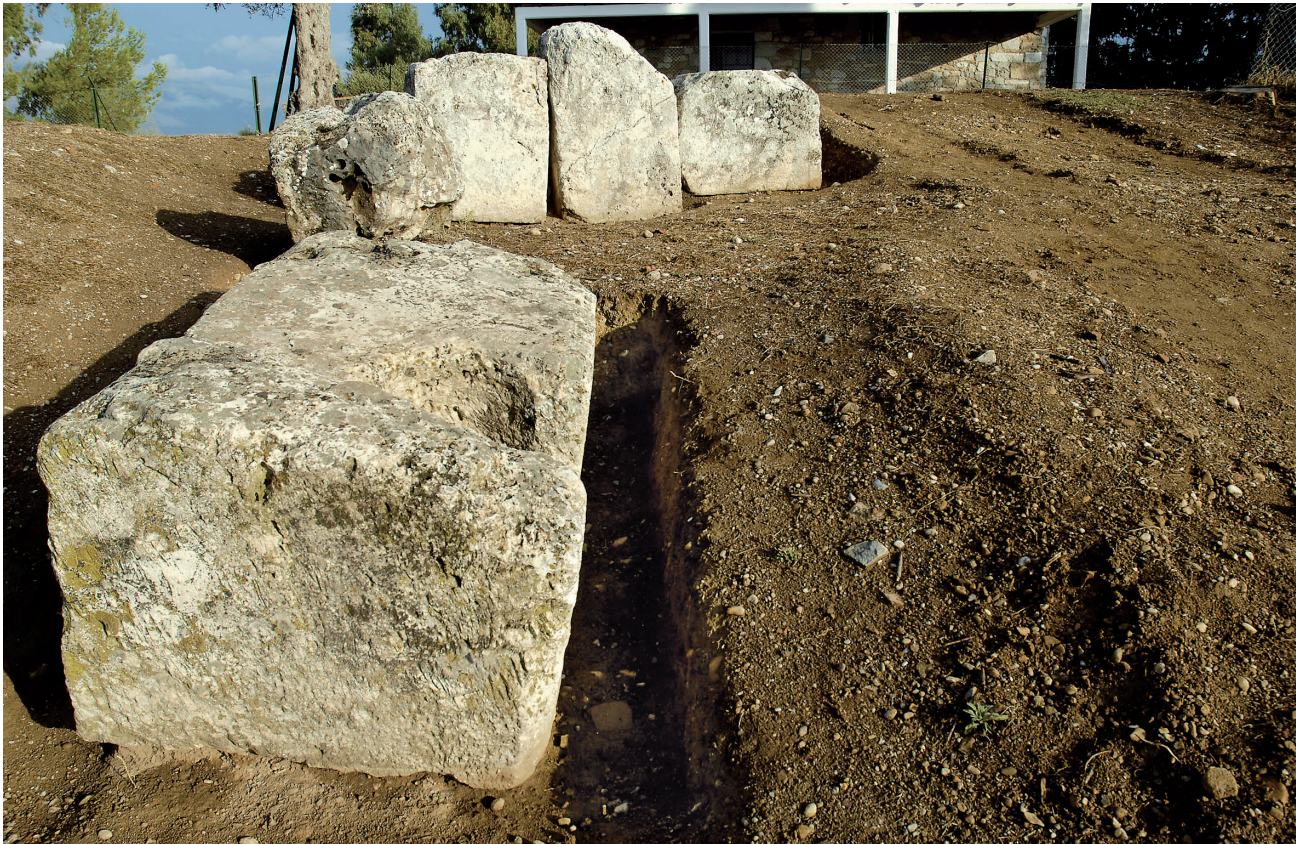
Fig. 4. Limestone blocks of the colossal pedestal of the cult statue of Apollo (photo: S. Vlizon).

During the study of the limestone blocks of the colossal pedestal that supported the 13m-high cult statue of Apollo which had been reused in a later building (Sectors Δ-E 4, 6-7), bronze nails that held in place the metal plates which adorned the exterior of the construction were located. The stones were drawn in large scale, resulting in the more detailed approach to the form of the dismembered pedestal of the cult statue (fig. 4).

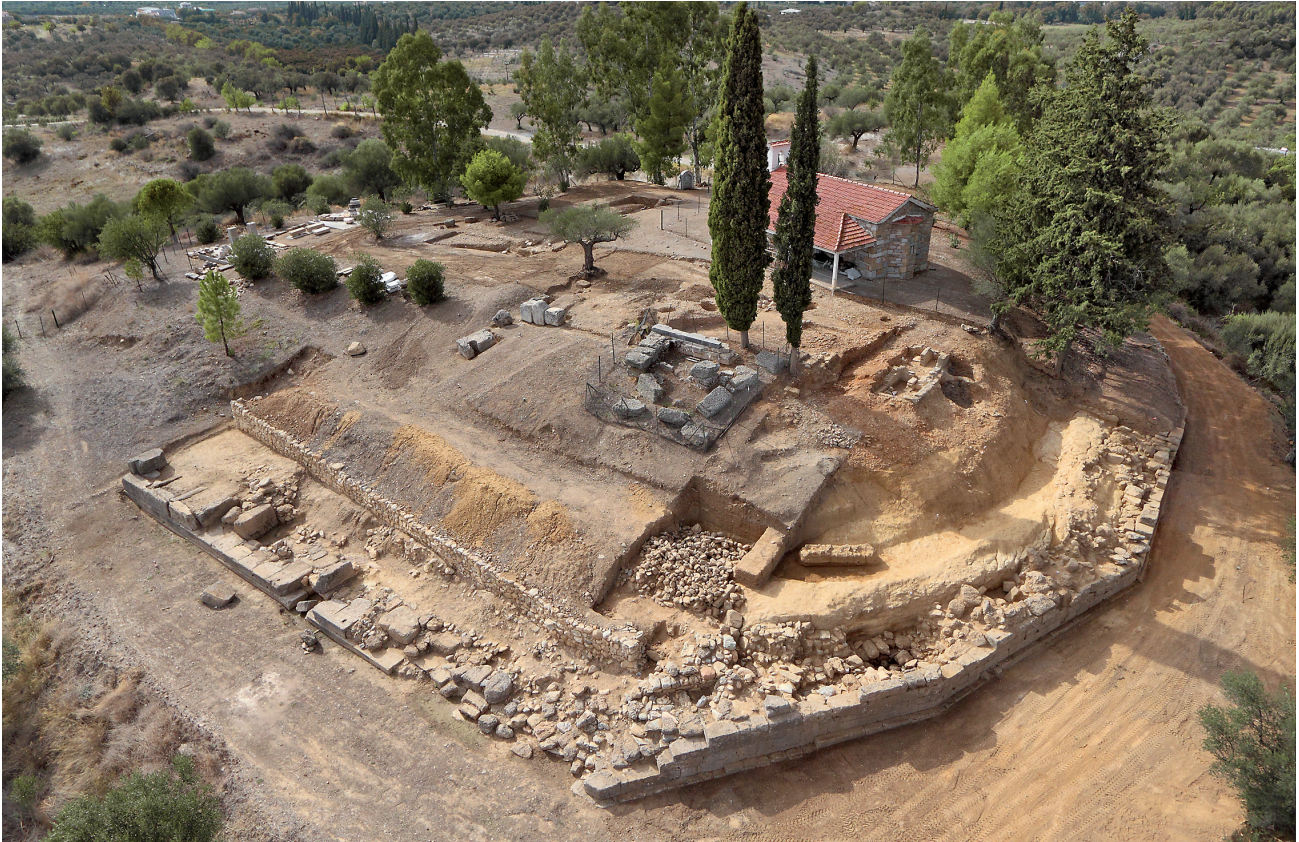
Fig. 5. The terraces at the SE corner of the hill (photo: K. Xenikakis).

The construction of the two Periboloi at the lower level of the hill should be linked with all the interventions made in Antiquity, in order to create terraces, which are connected with its similarly formed south side (fig. 5). The two terraces surrounding the hill in a semicircle from south and east to north are approx. 5 m. wide and the maximum difference in height is 2 m. On the lower is the foundation of the later Peribolos with conglomerate blocks. Along the upper terrace ran a shallow ditch, 0.40m. wide and 0.17m. deep, from where a thin layer of yellowish grey clayey soil was removed, along with a large quantity of Early Helladic pottery and one intact, two-handled cup of the same period. The remaining excavated area was covered by a layer of contemporary fill, with characteristic sherds of Late Geometric pottery decorated with representations of human figures, a fragment of an Archaic cup with incised letters, an Archaic bas-relief ivory leg of a male figure with greave and holes for its attachment to a wooden surface, terracotta figurines of animals and other objects.

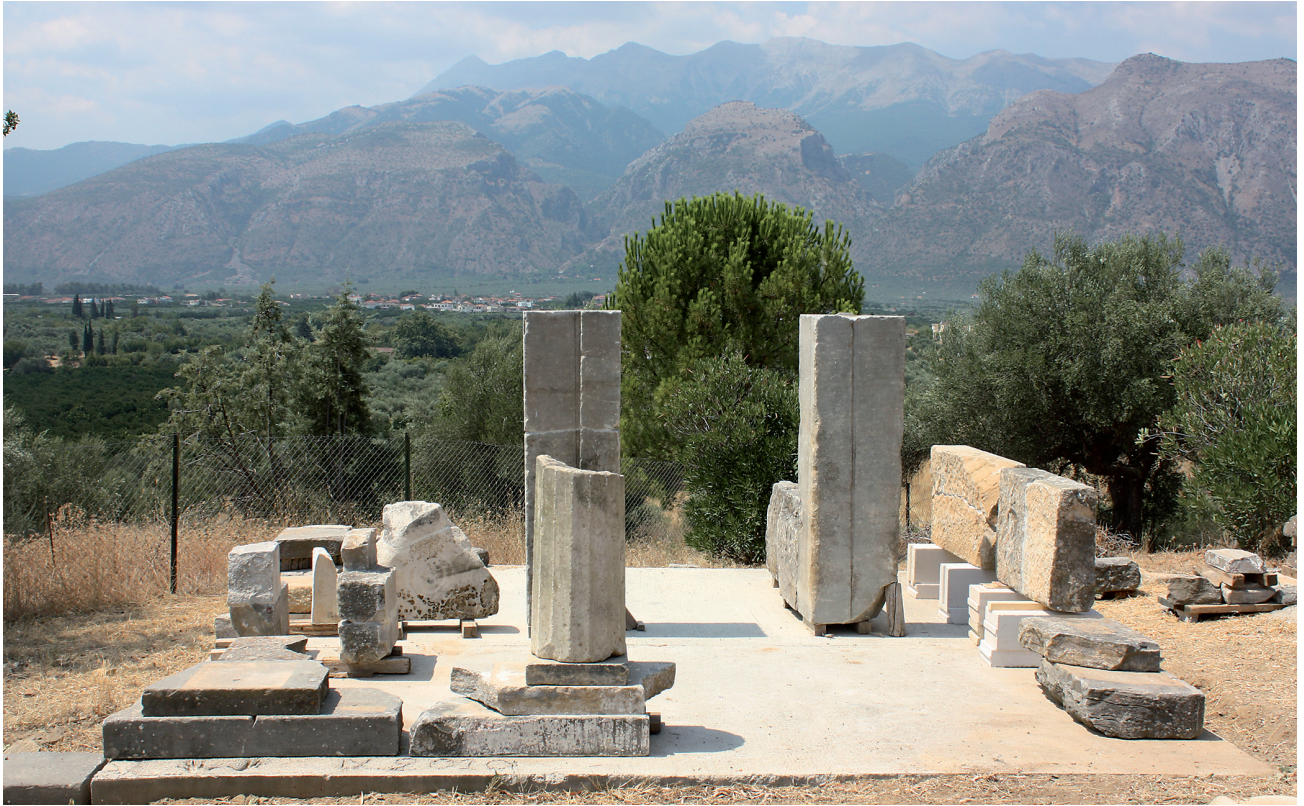
Fig. 6. The Throne-Platform (photo: St. Vlivos).

Gathered on one platform was material that constituted the temple/Throne (fig. 6). Placed on the same platform were stones from an entrance, from the steps of a stylobate with the contiguous internal floor, and from a wall with its *eythynteria*. The restoration of a wall entablature comprising numerous stones, most probably from the east wall of the Throne, took place in the storeroom of the 5th EPCA. In order to correlate the walls and the colonnades of the Throne's wings (*ptera*), the traces from the contact of the small beams with the wall entablature and the cornices

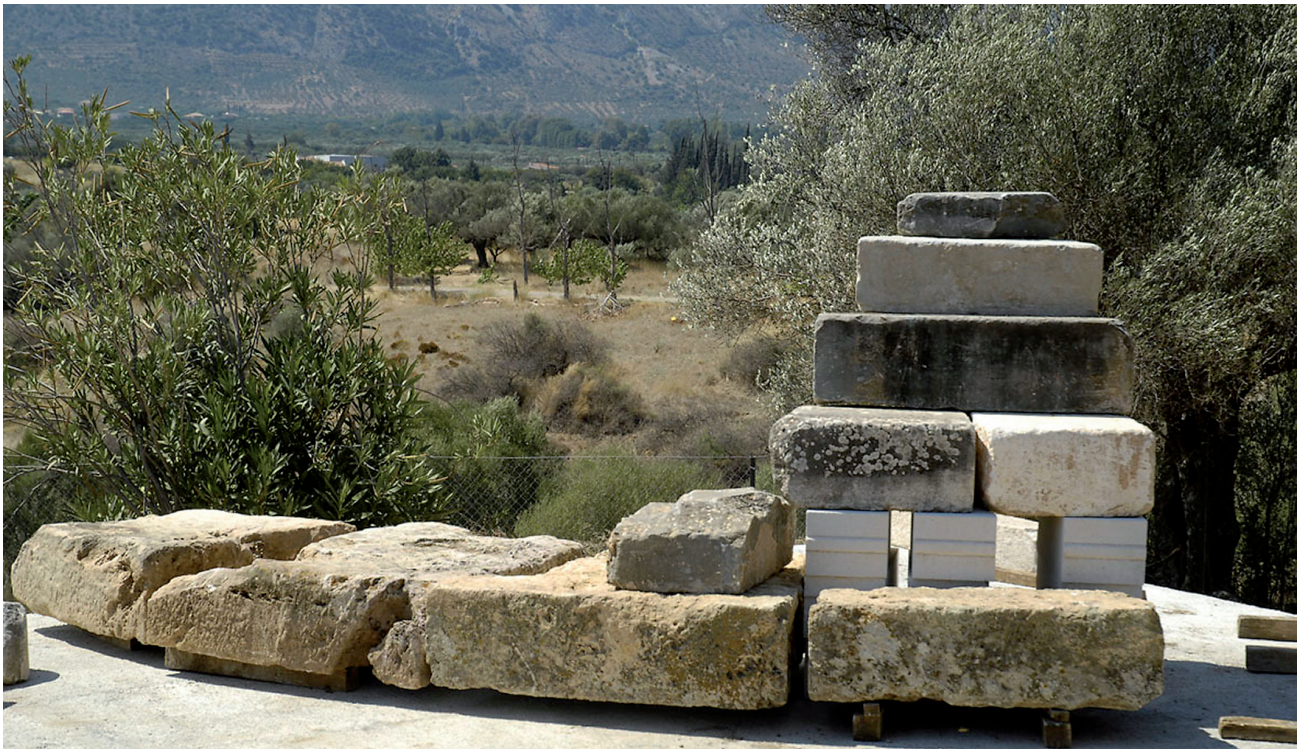
Fig. 7. The Altar-Platform (photo: St. Vlivos).

were detected, investigated and interpreted. This work will allow us to calculate the width of one of the wings of the Throne, as well as to proceed to the graphic restoration of at least one of the groups of small beams, for which we do not have the initial length. Gathered on the second platform and assembled in test placement were some of the correlated stones of the circular stepped altar (fig. 7).
