### Ερευνητικό πρόγραμμα Αμυκλών: Εργασίες 2005-2010

*Stavros Vlizos*

## Amykles Research Project: Excavation Works 2005-2010

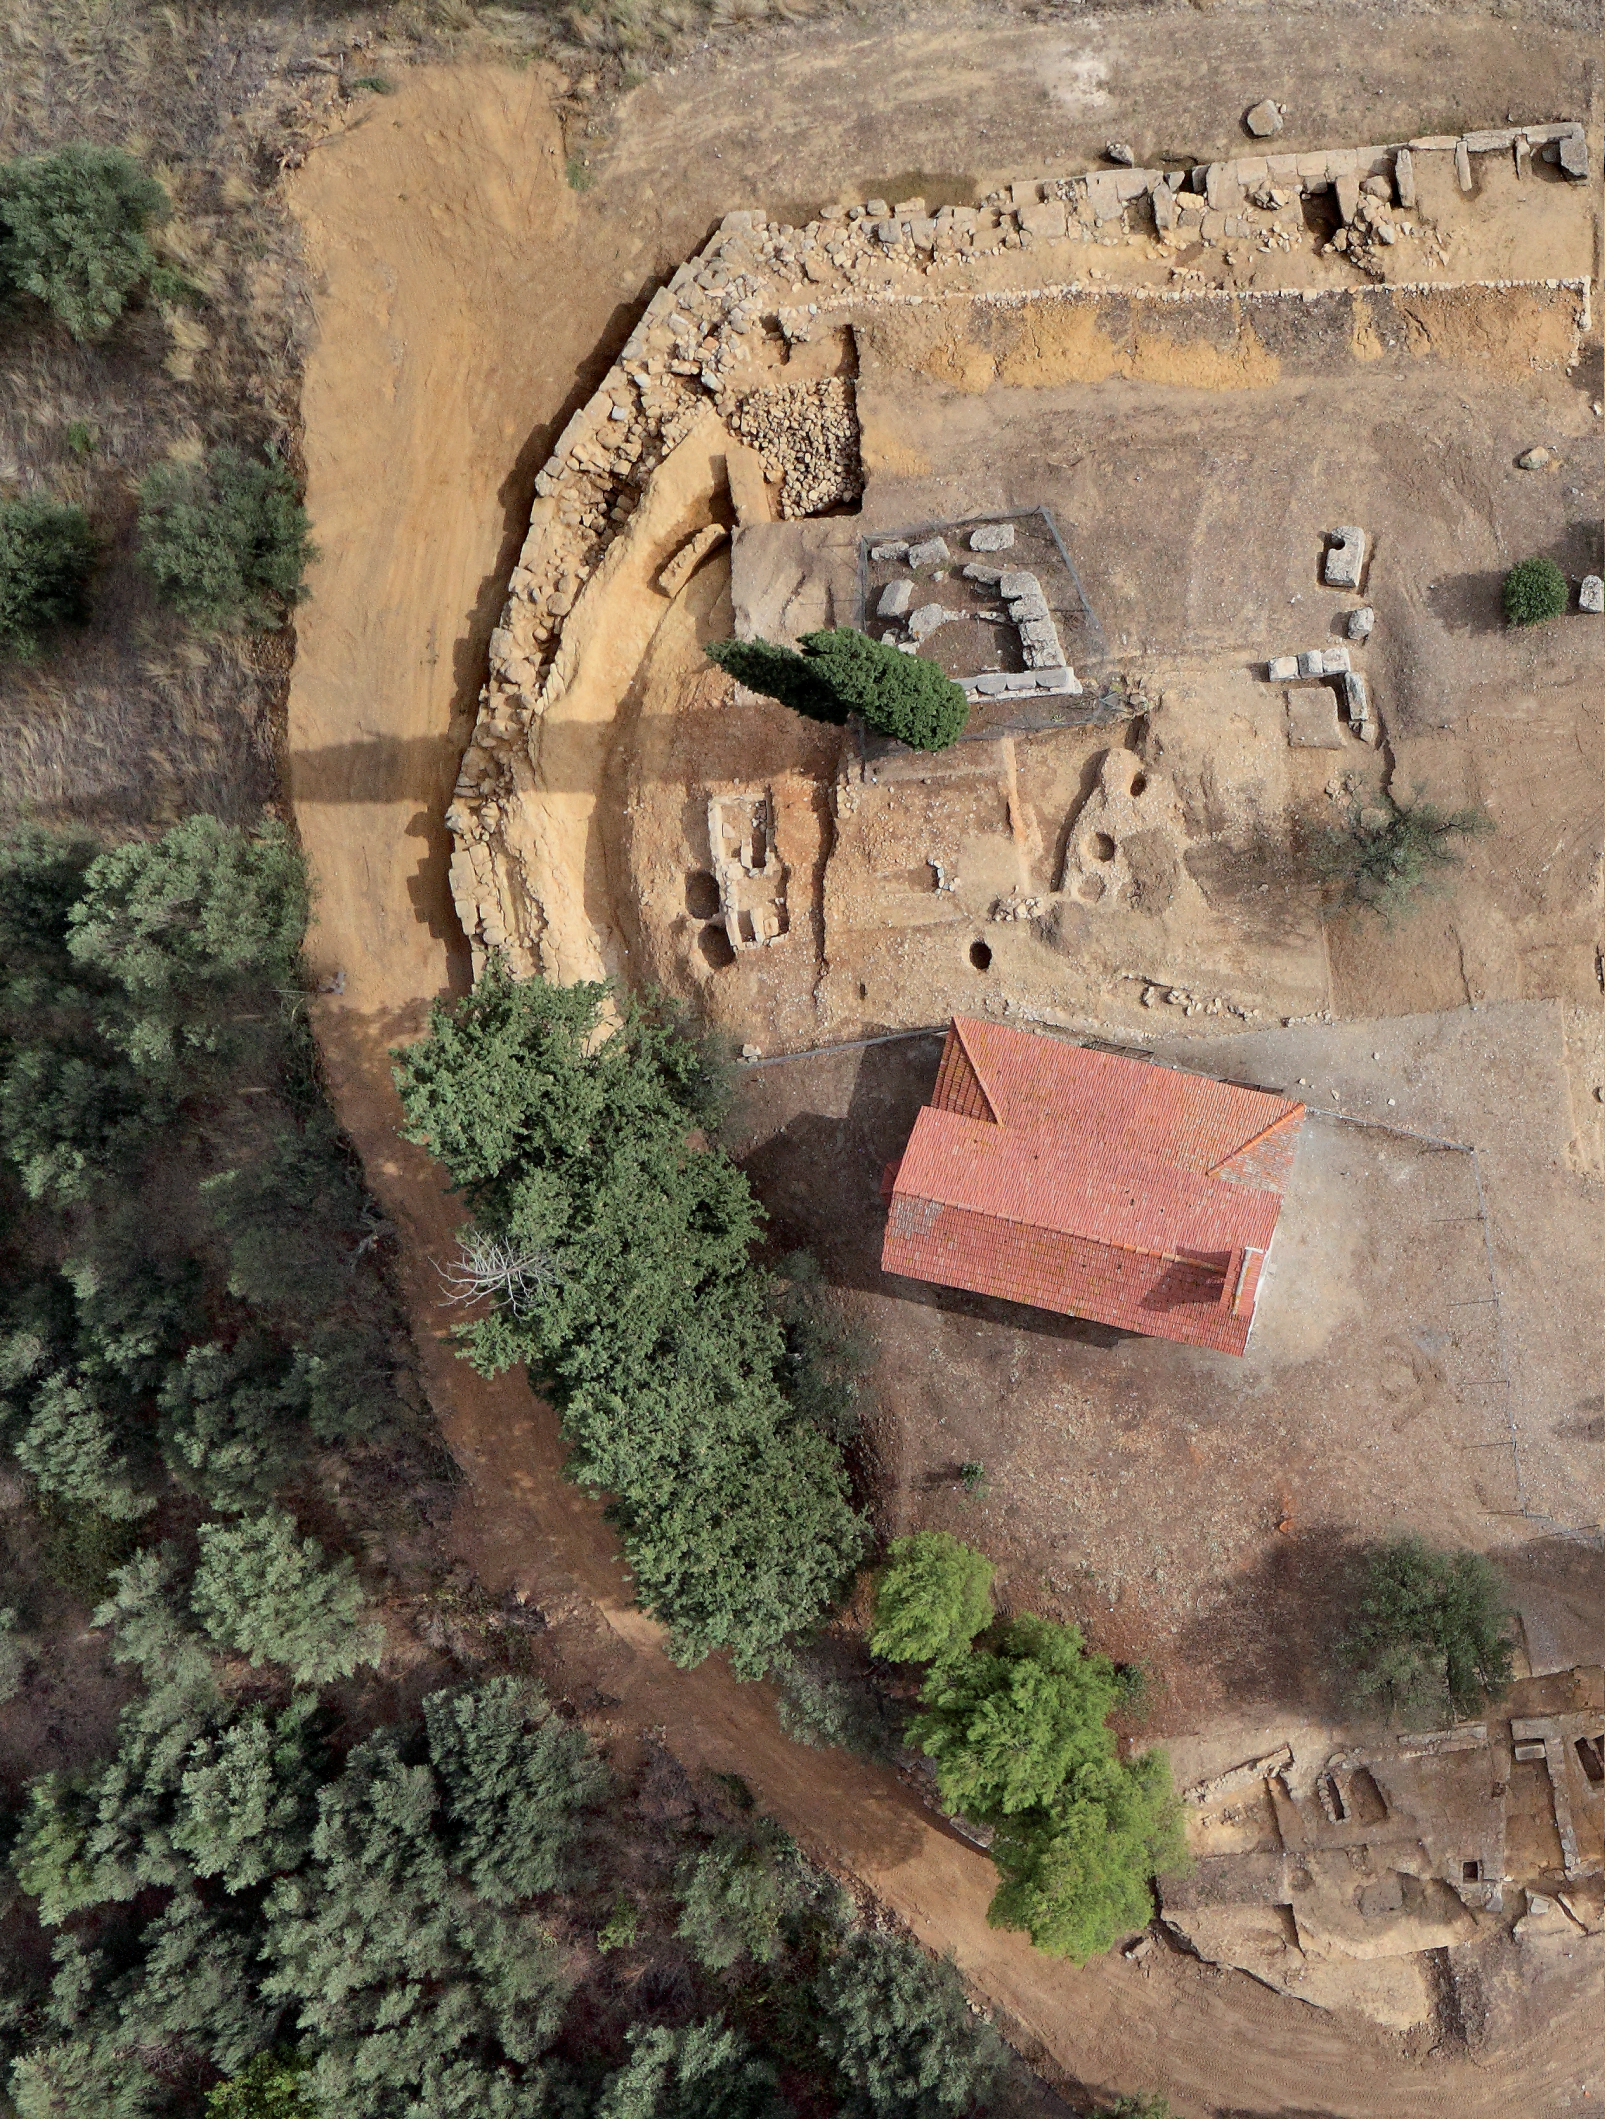
Fig. 1. Airphoto of the hill of Agia Kyriaki  
(photo: K. Xenikakis).

IN SEPTEMBER 2005 STUDIES AND RESEARCH in the Spartan Sanctuary of Apollo Amyklaios commenced (fig. 1). One of the urgent tasks of the project was to survey the Agia Kyriaki hill and the surrounding area in detail and to record in the new plans the evidence surviving from previous research carried out by Ch. Tsountas (1890/91), A. Furtwängler (1904), E. Fiechter (1907) and E. Buschor (1925). The existing condition of the archaeological site was mapped and the surviving parts of the krepis of the temple/Throne, of the Peribolos as well as the later church of St Kyriaki were documented by measured drawings.

For a more integrated mapping of the archaeological site and the works completed so far, the aerial photographing of Agia Kyriaki hill and the surrounding area was carried out by the photographer Kostas Xenikakis (see fig. 1).

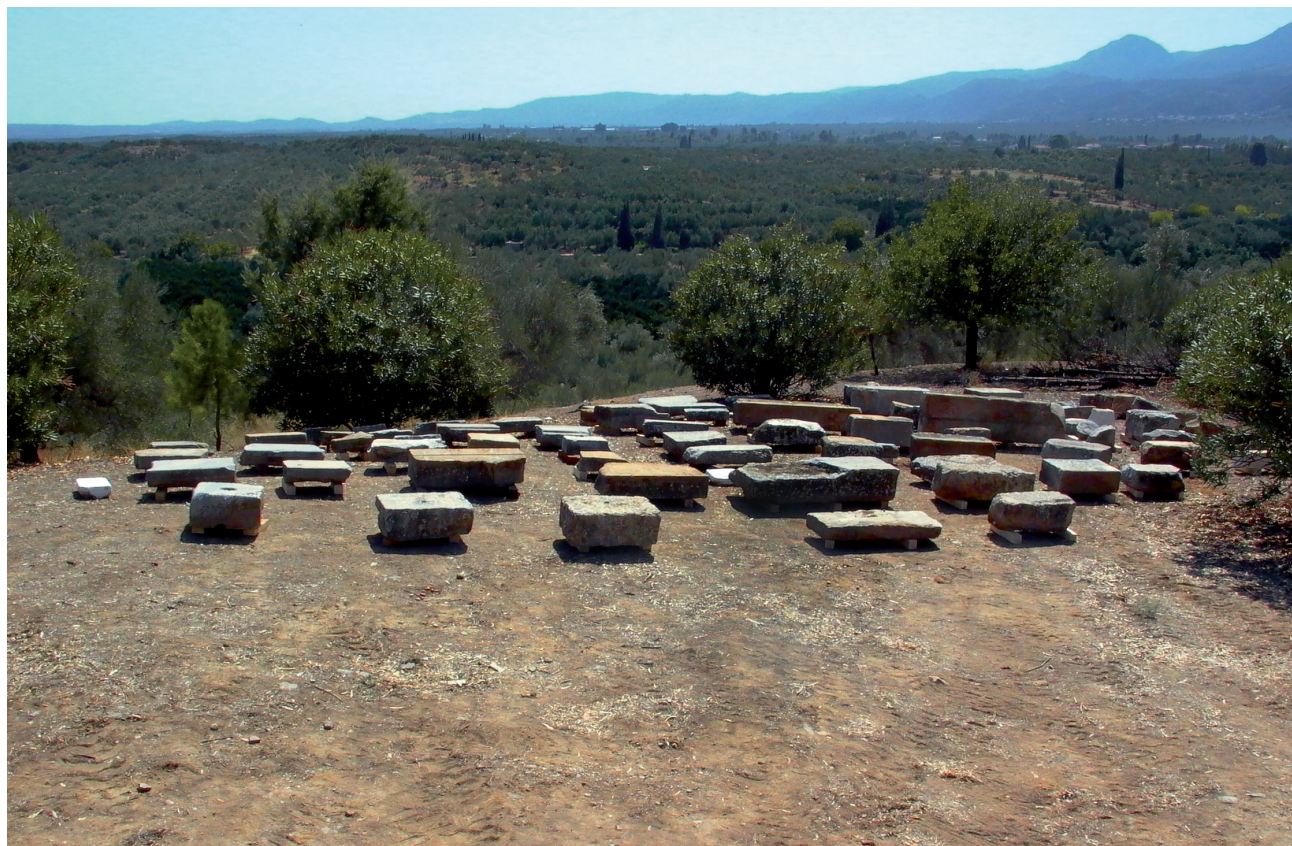
Fig. 2. Fenced area with architectural members (photo: S. Vlzos).

All the architectural members from the monuments of the Sanctuary were gathered, sorted into categories and fenced inside the archaeological site and the already expropriated area (fig. 2). Thus, any further deterioration of the marbles' surface had been avoided and their protection was secured.

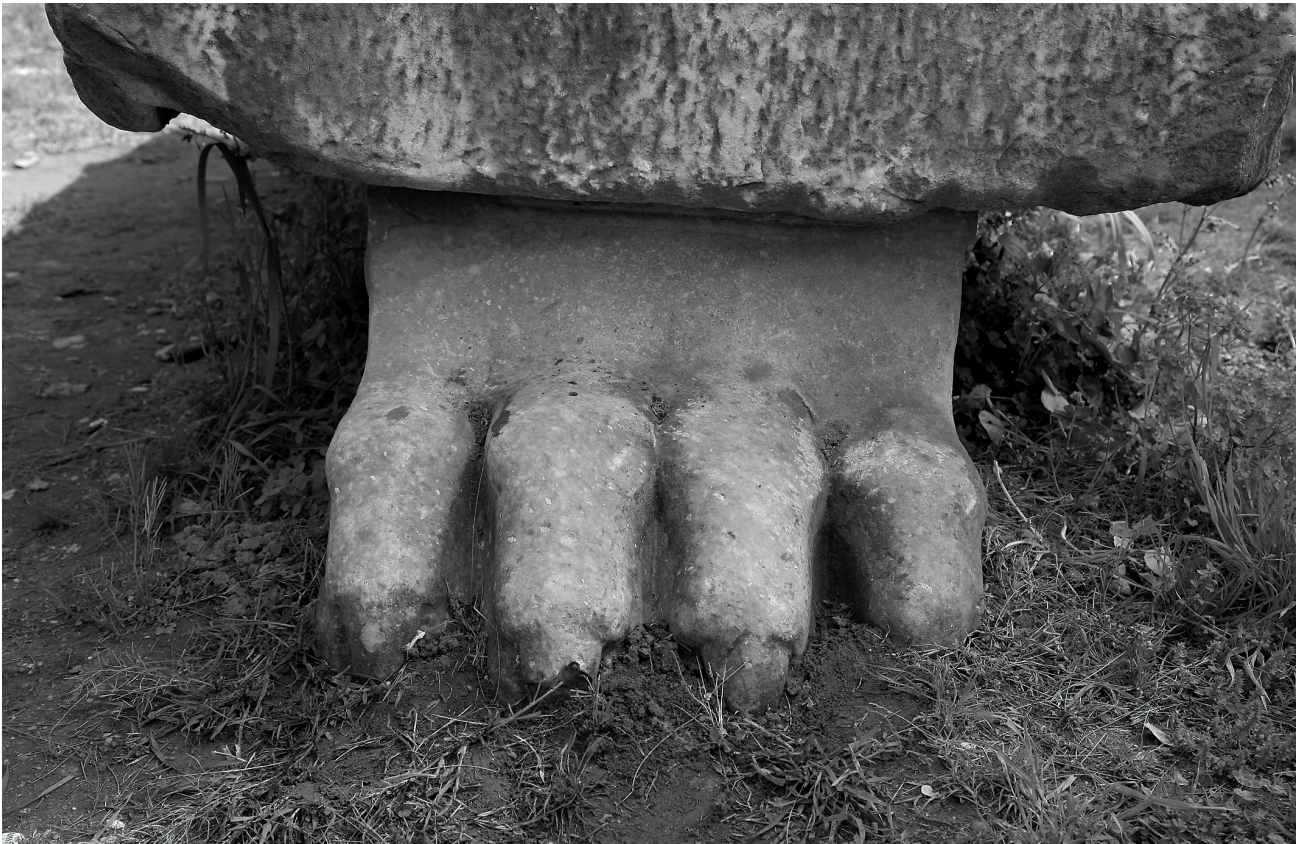
Fig. 3. Bases in the form of a lion's paw (photo: S. Vlizon).

Manolis Korres located and made measured drawings of two monumental bases from the Throne in the form of a lion's paw, which supported the lid of a Roman sarcophagus in the garden of the Sparta Archaeological Museum (fig. 3). These new discoveries reinforced the indications deduced from other architectural members that the temple/Throne designed by Bathykles was in the form of a monumental seat.

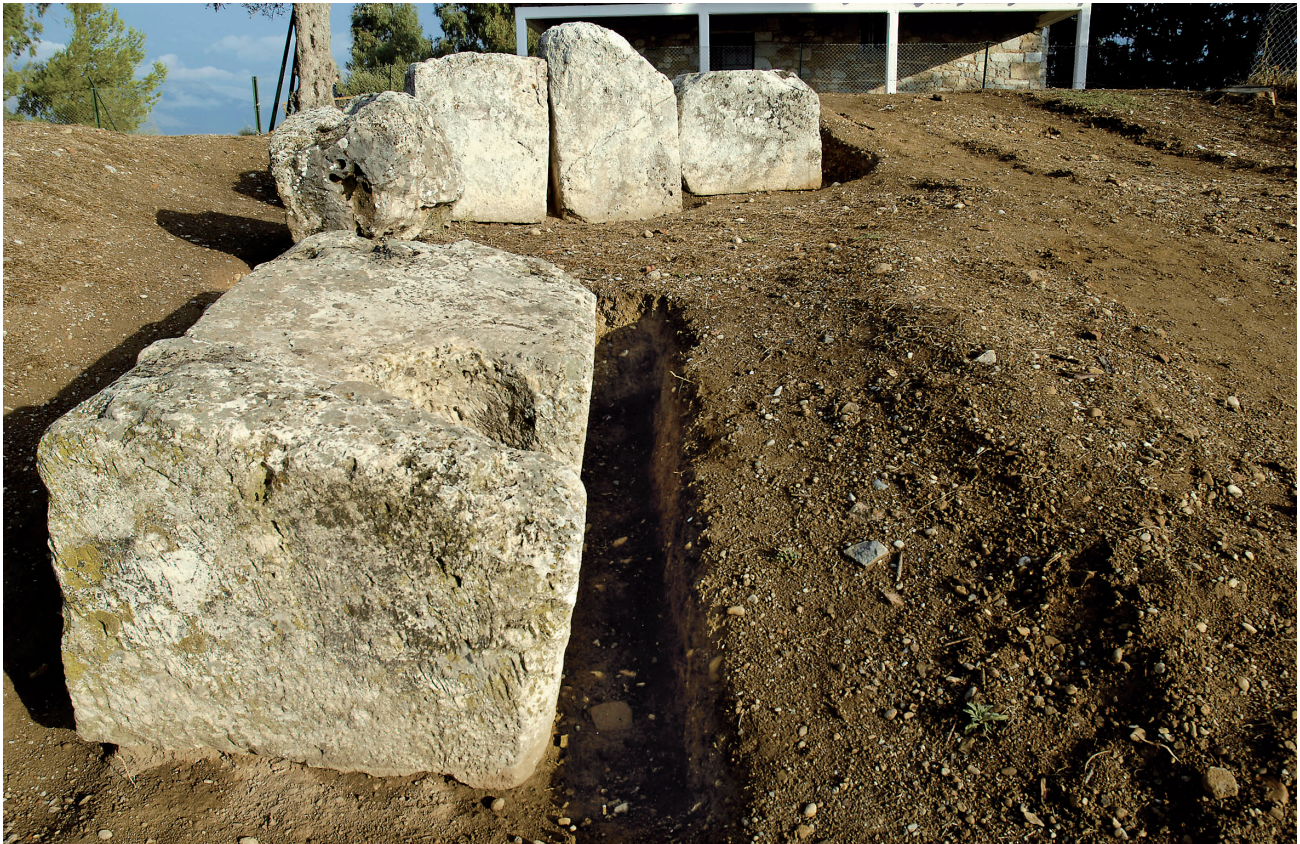
Fig. 4. Limestone blocks of the colossal pedestal of the cult statue of Apollo (photo: S. Vlizos).

During the study of the limestone blocks of the colossal pedestal that supported the 13m-high cult statue of Apollo which had been reused in a later building (Sectors Δ-E 4, 6-7), bronze nails that held in place the metal plates which adorned the exterior of the construction were located. The stones were drawn in large scale, resulting in the more detailed approach to the form of the dismembered pedestal of the cult statue (fig. 4).

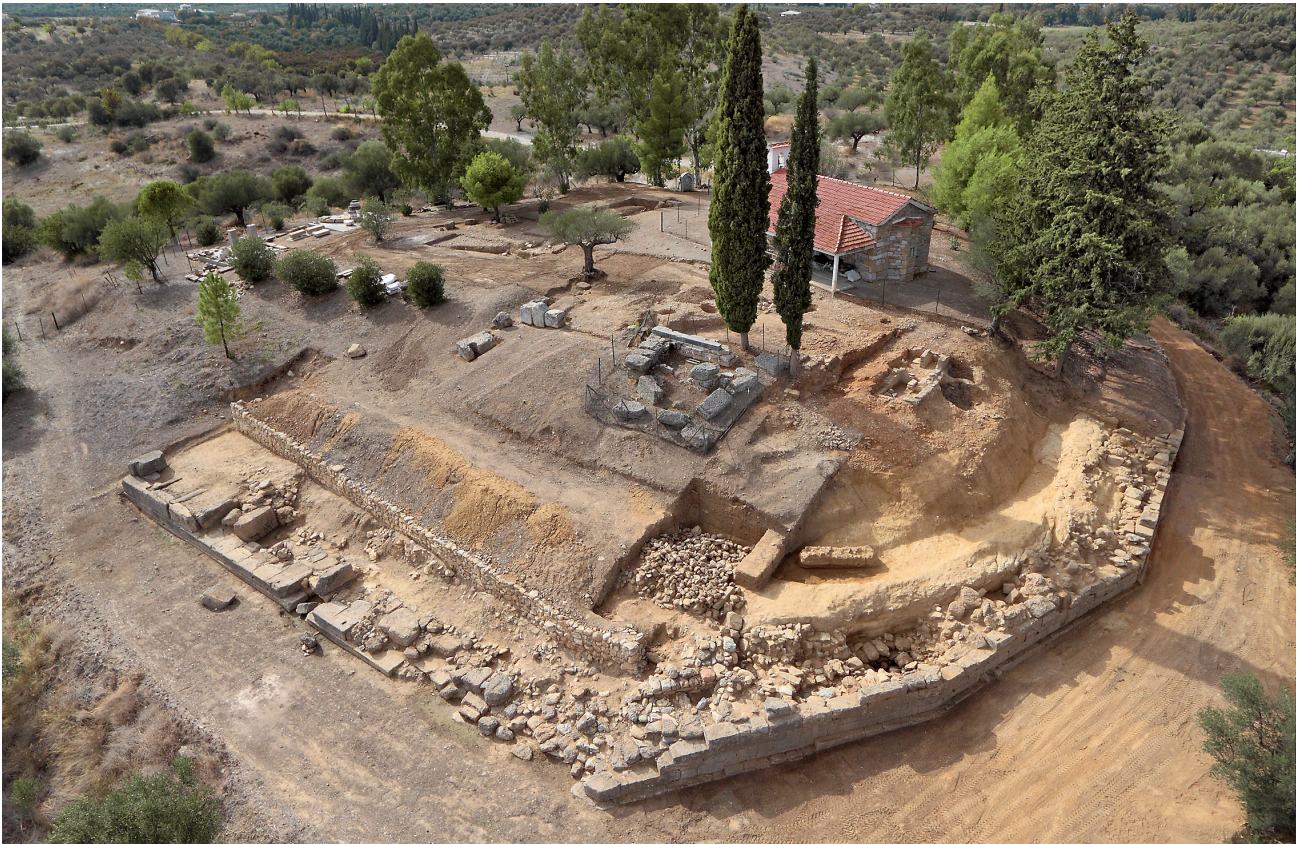
Fig. 5. The terraces at the SE corner of the hill (photo: K. Xenikakis).

The construction of the two Periboloi at the lower level of the hill should be linked with all the interventions made in Antiquity, in order to create terraces, which are connected with its similarly formed south side (fig. 5). The two terraces surrounding the hill in a semicircle from south and east to north are approx. 5 m. wide and the maximum difference in height is 2 m. On the lower is the foundation of the later Peribolos with conglomerate blocks. Along the upper terrace ran a shallow ditch, 0.40m. wide and 0.17m. deep, from where a thin layer of yellowish grey clayey soil was removed, along with a large quantity of Early Helladic pottery and one intact, two-handled cup of the same period. The remaining excavated area was covered by a layer of contemporary fill, with characteristic sherds of Late Geometric pottery decorated with representations of human figures, a fragment of an Archaic cup with incised letters, an Archaic bas-relief ivory leg of a male figure with greave and holes for its attachment to a wooden surface, terracotta figurines of animals and other objects.

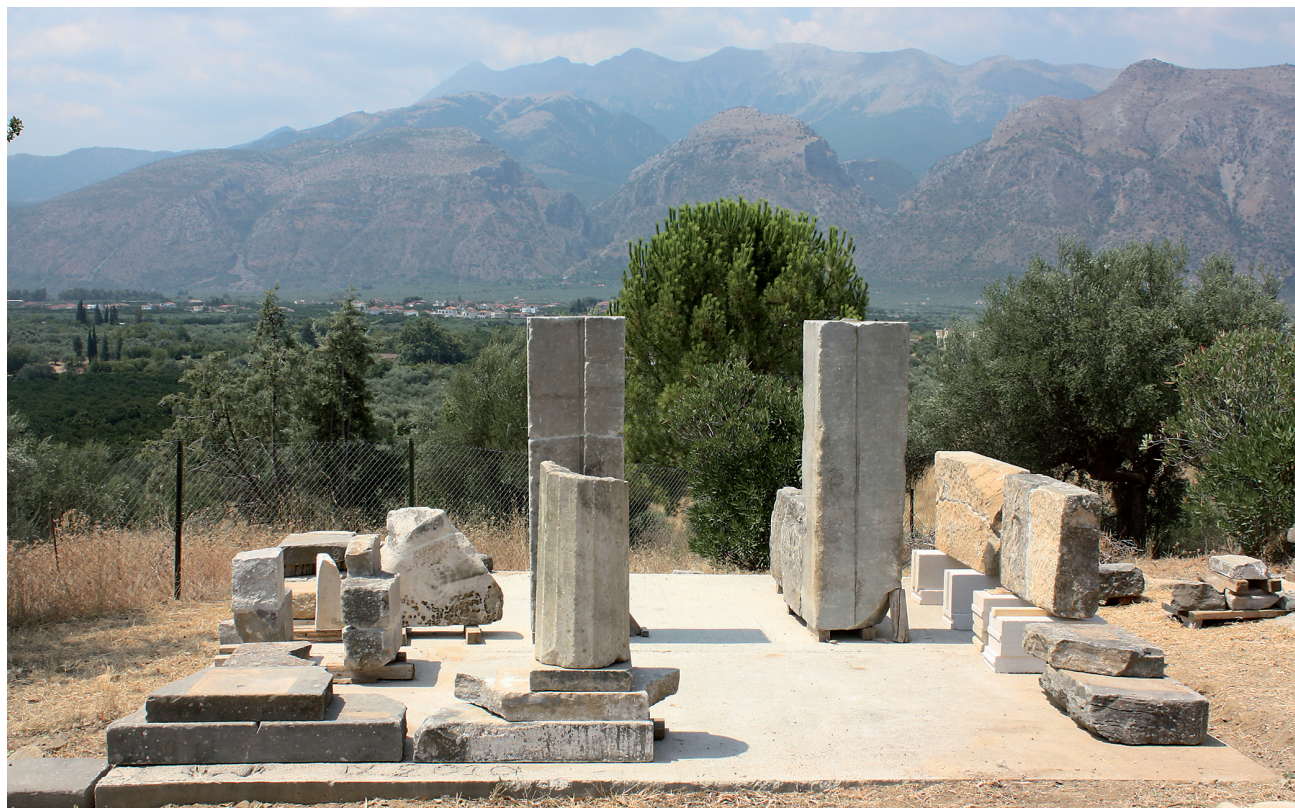
Fig. 6. The Throne-Platform (photo: St. Vlzos).

Gathered on one platform was material that constituted the temple/Throne (fig. 6). Placed on the same platform were stones from an entrance, from the steps of a stylobate with the contiguous internal floor, and from a wall with its *eythynteria*. The restoration of a wall entablature comprising numerous stones, most probably from the east wall of the Throne, took place in the storeroom of the 5th EPCA. In order to correlate the walls and the colonnades of the Throne's wings (*ptera*), the traces from the contact of the small beams with the wall entablature and the cornices

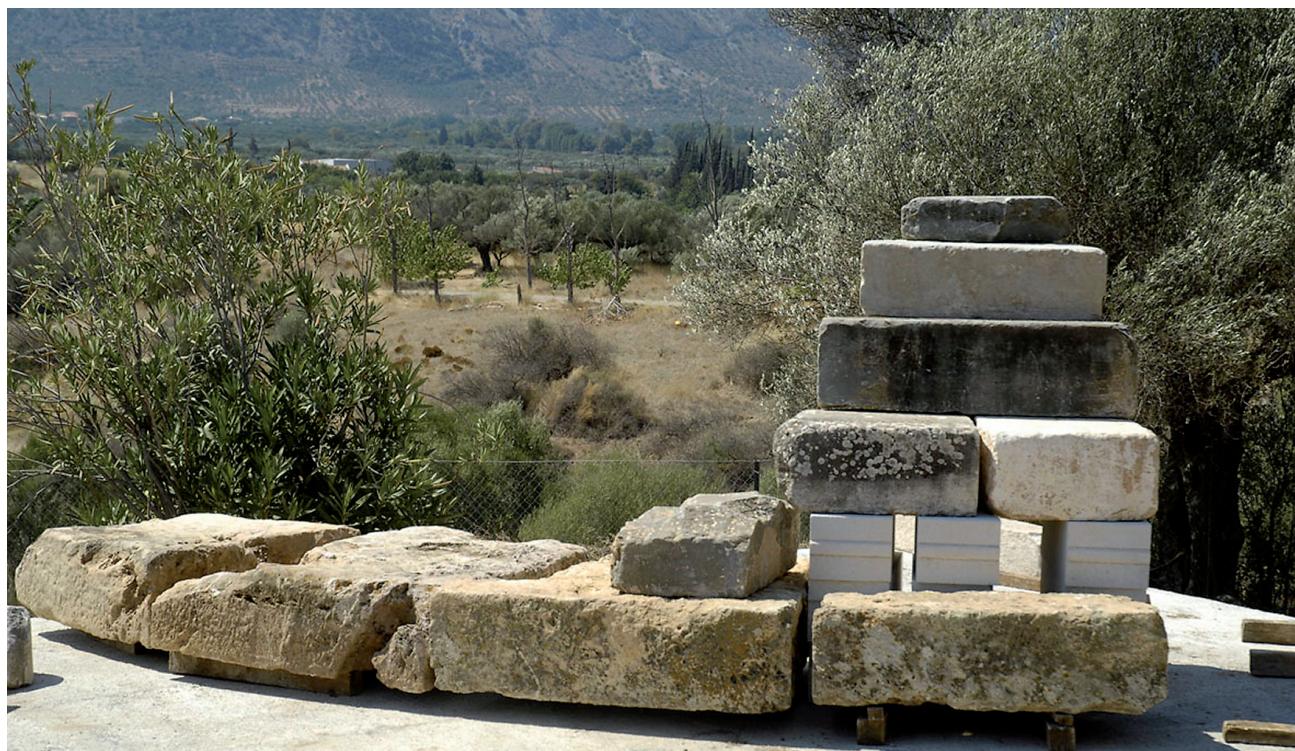
Fig. 7. The Altar-Platform (photo: St. Vlzos).

were detected, investigated and interpreted. This work will allow us to calculate the width of one of the wings of the Throne, as well as to proceed to the graphic restoration of at least one of the groups of small beams, for which we do not have the initial length. Gathered on the second platform and assembled in test placement were some of the correlated stones of the circular stepped altar (fig. 7).
