Ερευνητικό πρόγραμμα Αμικλών: Εργασίες 2005-2010

STAVROS VLIZOS

Amykles Research Project: Excavation Works 2005-2010

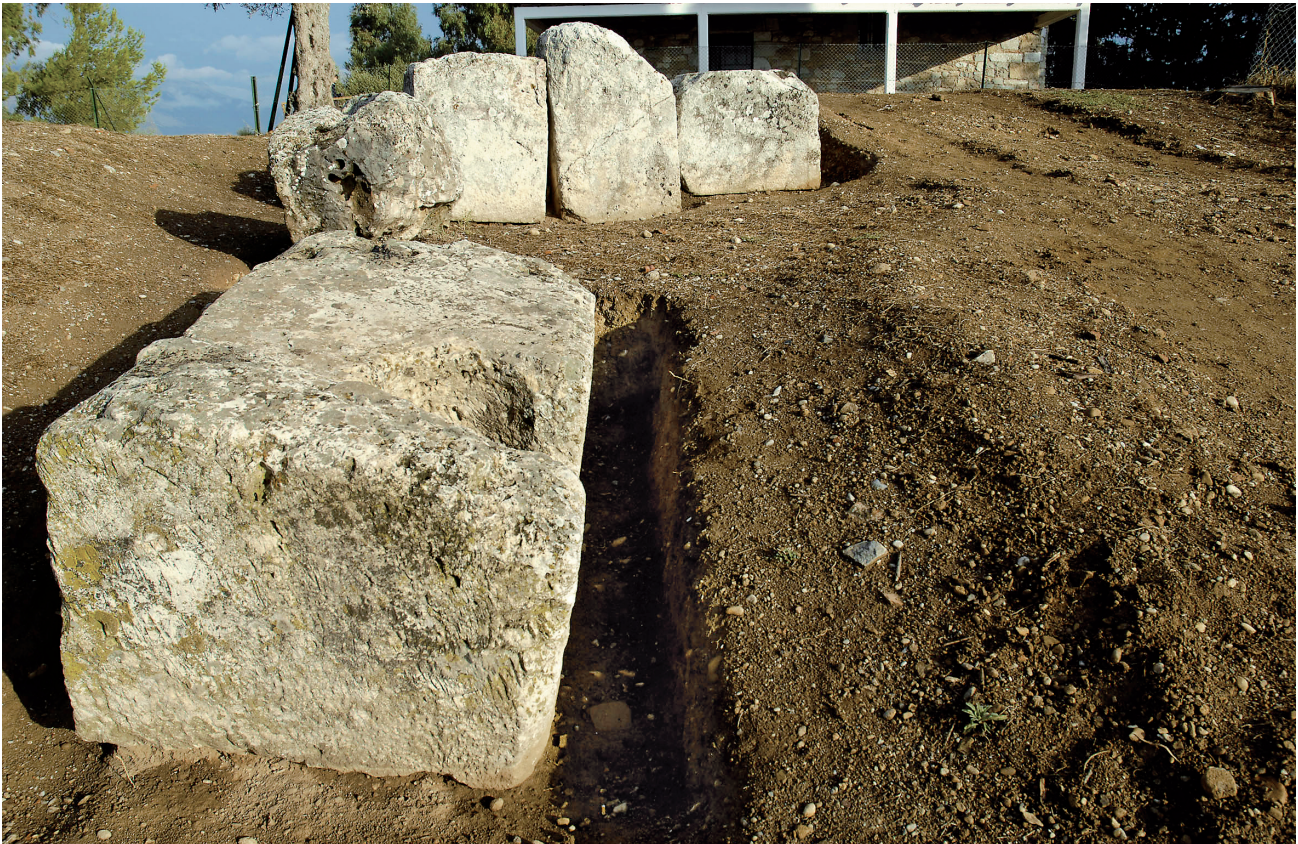
Fig. 4. Limestone blocks of the colossal pedestal of the cult statue of Apollo (photo: S. Vlizon).

During the study of the limestone blocks of the colossal pedestal that supported the 13m-high cult statue of Apollo which had been reused in a later building (Sectors Δ-E 4, 6-7), bronze nails that held in place the metal plates which adorned the exterior of the construction were located. The stones were drawn in large scale, resulting in the more detailed approach to the form of the dismembered pedestal of the cult statue (fig. 4).
