Επανεξέταση του ναού του Αγίου Κωνσταντίνου στη λίμνη της Απολλωνίας στη Βιθυνία

*Michalis KAPPAS (Μιχάλης ΚΑΠΠΑΣ), Stavros
MAMALOUKOS (Σταύρος ΜΑΜΑΛΟΥΚΟΣ)*

THE CHURCH OF ST. CONSTANTINE ON LAKE APOLLONIA, BITHYNIA, REVISITED

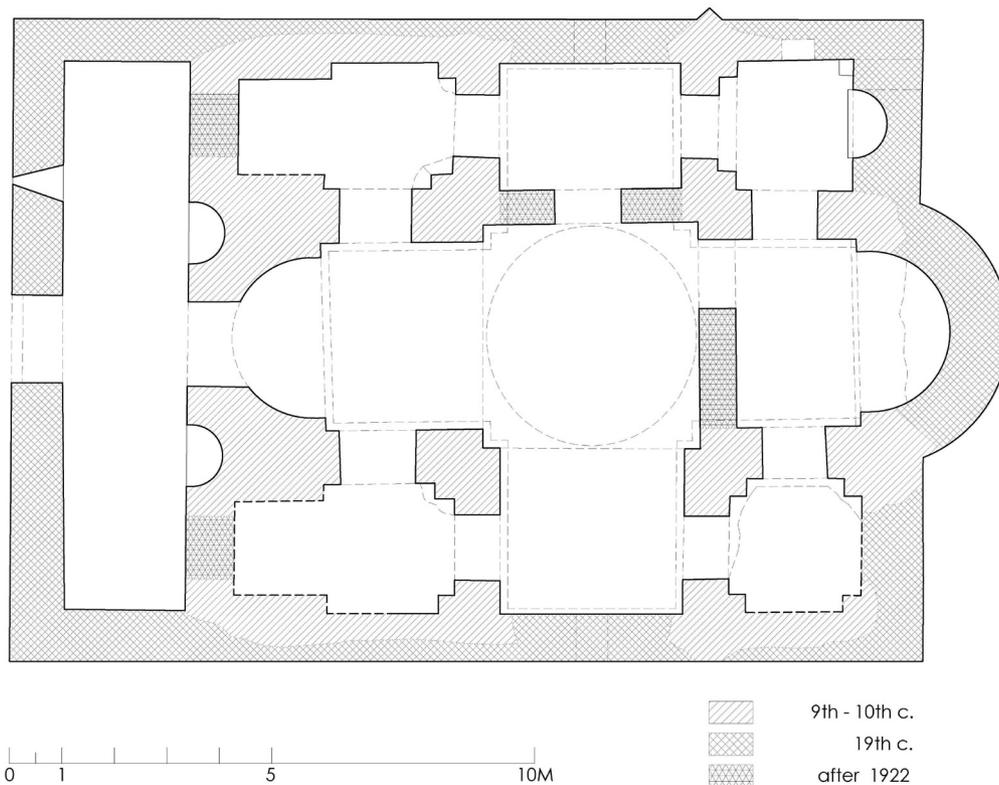
Fig. 1. Apollonia Lake. Monastery of St. Constantine. Katholikon. Present state. Plan after the drawing of C. Mango and recent evidence.

A semicircular, both on the interior and the exterior, sanctuary apse projected from the eastern end of the respective cross-arm, which is largely missing today (Figs 1, 11, 4, 12). The form of this apse before its collapse was mostly the result of the partial rebuilding of the monument in later years; the greater part of its semicircular walls had been completely rebuilt, while the new apse had a much lower height than the original. During this phase, a tympanum with an oculus had been constructed over the apse, incorporating the cornice of the

The square space underneath the dome was expanded via recesses on its four corners (Figs 1, 8, 9, 11). This practice of widening the central compartment of cruciform type buildings was widespread in the architecture of Late Antiquity, and survived in Byzantine architecture until the 10th and –on rare occasions– the 11th and 12th centuries or even later¹¹.

A narthex that as wide as the main church was attached on the west side; a large portion of this narthex had been rebuilt in later years (Figs 1, 2, 11), while its later roofing is completely destroyed. The vaulting of the original narthex must have consisted of a barrel vault placed on the transverse axis of the building. Two small vaulted spaces were formed over the passageways between the narthex and the west corner bays; these spaces were accessible through small arched openings on the semicylindrical wall of the west conch. The exact shape of the roofing over the narthex cannot be safely reconstructed. It may have been a lean-to roof inclined towards the west. The existence of galleries over the narthex, and probably even over the west corner bays cannot be excluded either. In any case, the confirmation or dismissal of this hypothesis will require a more detailed archaeological documentation of the monument.

Small conches were inscribed into the thickness of the east narthex wall, on either side of the central doorway (Figs 1, 11) intended to serve liturgical functions¹². It appears that the sole entrance door to the church was located on the central axis of the west wall of the narthex. In later years, a new doorway was constructed in its place, with distinct elements of Ottoman architecture such as a pointed brick arch (Fig. 2), which was recently destroyed after the collapse of a large part of the west wall of the church.

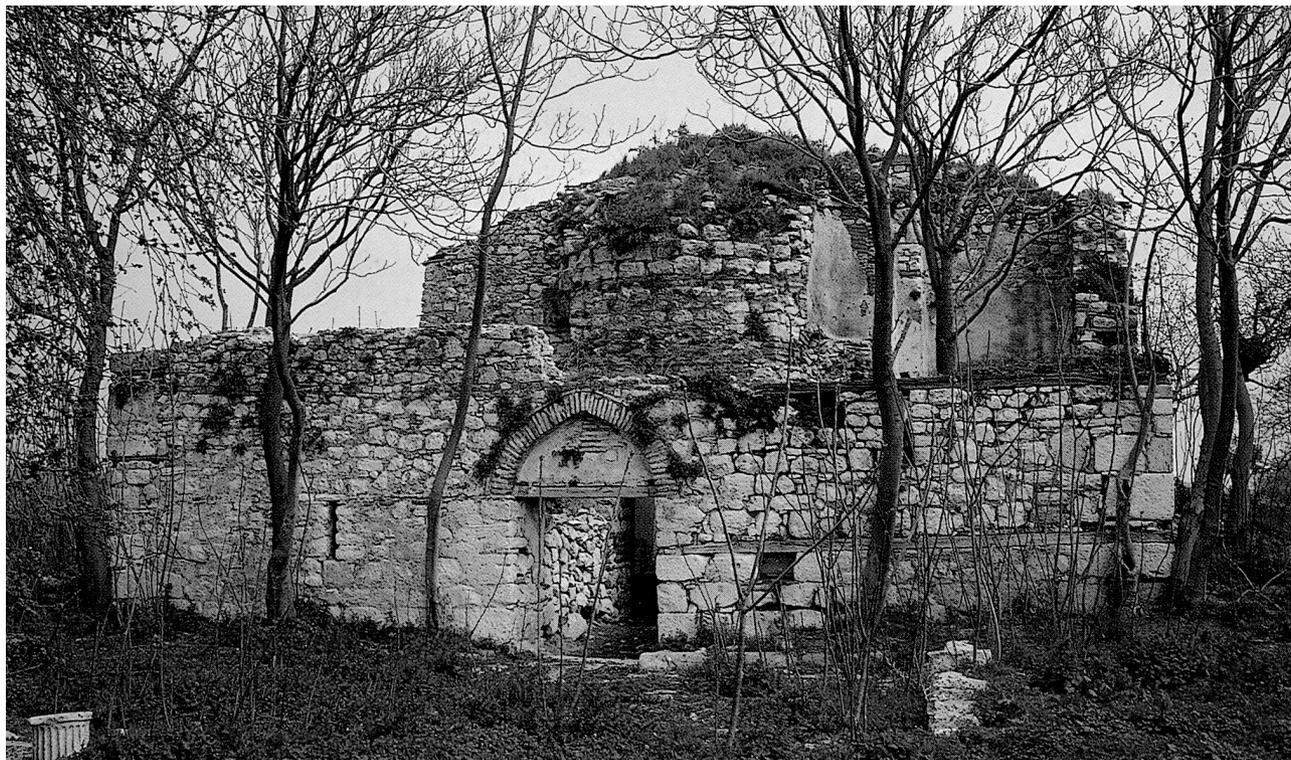
Fig. 2. Apollonia Lake. Monastery of St. Constantine. Katholikon. View from the southwest.

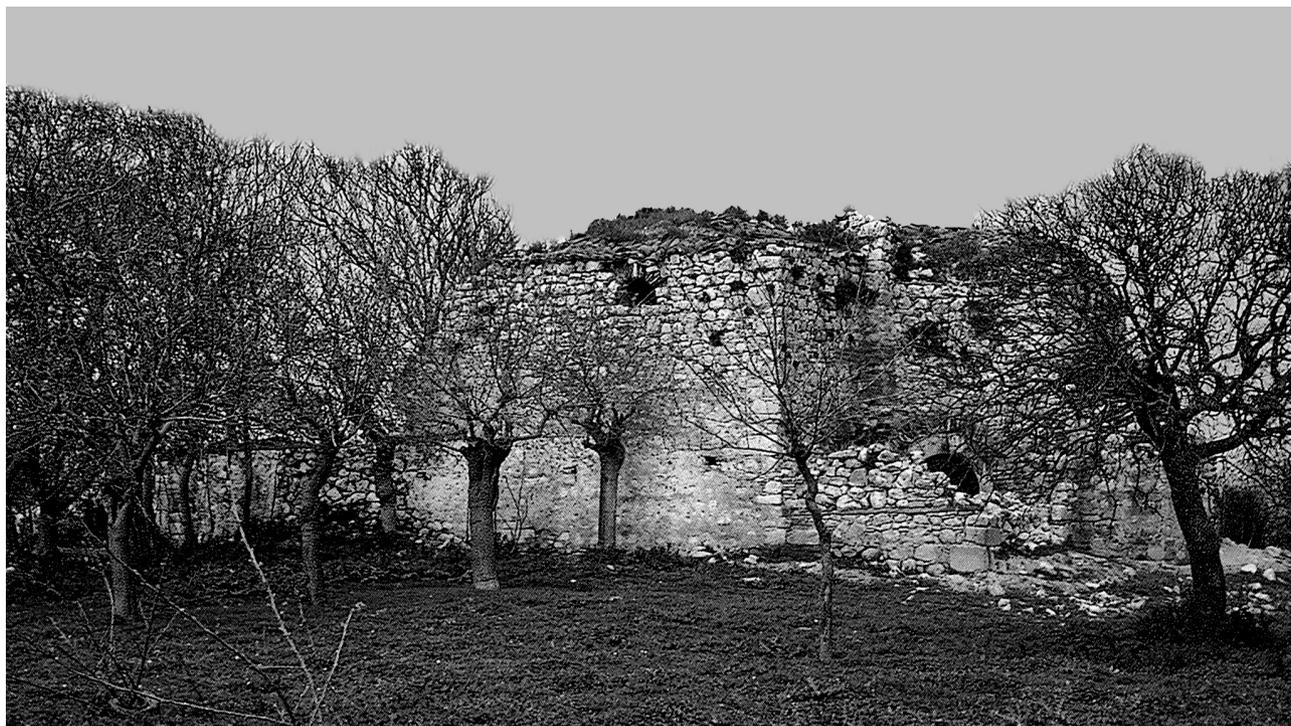
Fig. 3. Apollonia Lake. Monastery of St. Constantine Katholikon. View from the southeast.

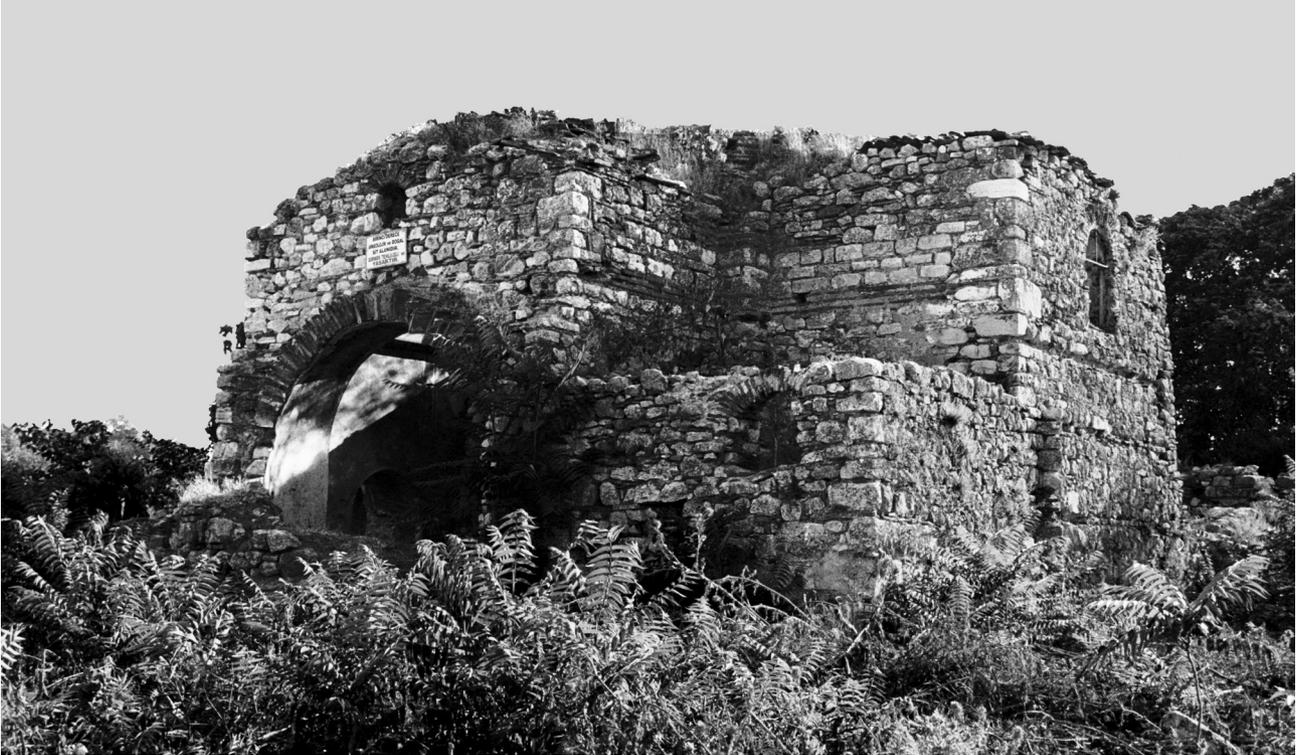
Fig. 4. Apollonia Lake. Monastery of St. Constantine. Katholikon. View from the northeast.

The original walls of the church of St. Constantine were constructed out of alternating bands of stone and brick masonry¹³ (Figs 4, 6, 7, 16). This construction system, also known as “opus mixtum” is the quintessential masonry building system encountered in the architecture of the capital throughout the Byzantine period¹⁴. The ratio of alternate material bands together with the thickness of bricks that does not exceed 4 cm. set the church of St. Constantine apart from early Constantinopolitan examples, such as the land walls of Theodosius, and rather associate it with later monuments in the capital¹⁵, or the areas within its immediate sphere of influence¹⁶. The arches and vaults of the surviving earlier parts of the monument are built entirely of bricks (Figs 8, 17), while bricks have also been used, albeit in a more haphazard manner, in the rebuilt later parts (Figs 7, 8, 12). The original building mortar is an off-white color, with coarse aggregates, while the joints are finished with the application of a thin, pressed, hydraulic jointing mortar which includes a large amount of crushed brick (Figs 16, 17).

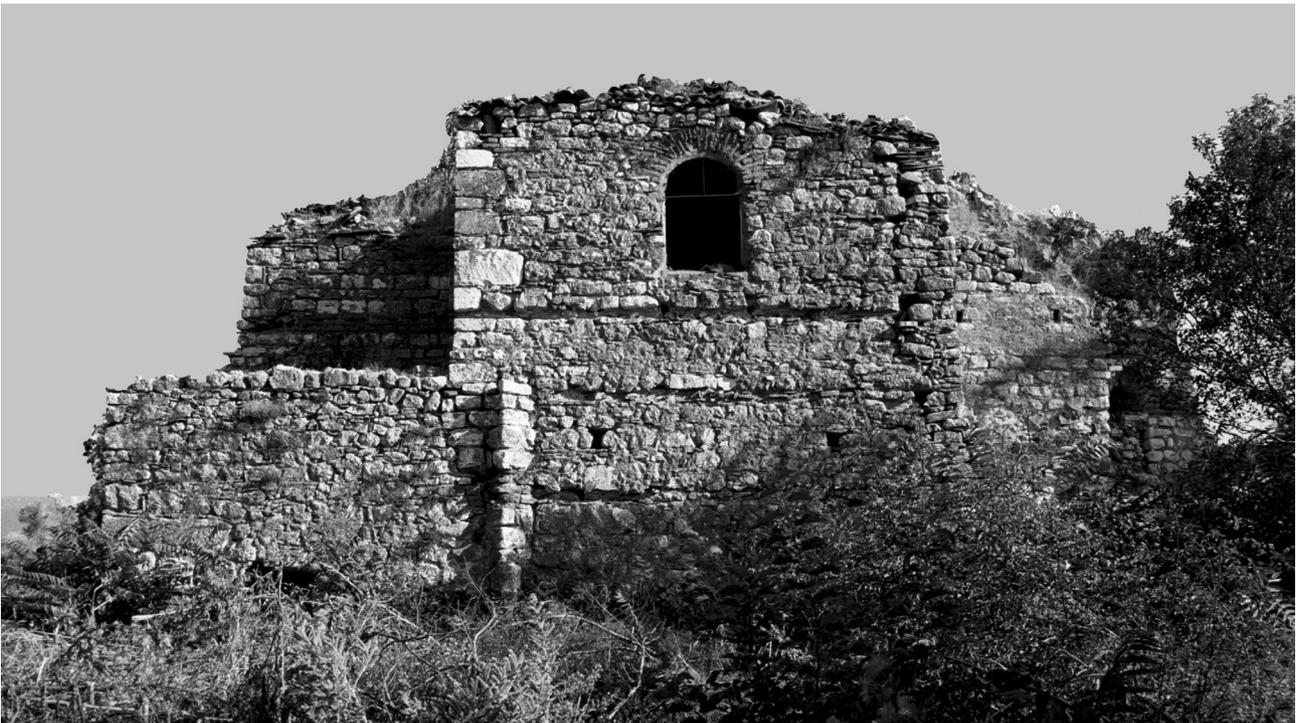
Fig. 5. Apollonia Lake. Monastery of St. Constantine. Katholikon. View from the north.

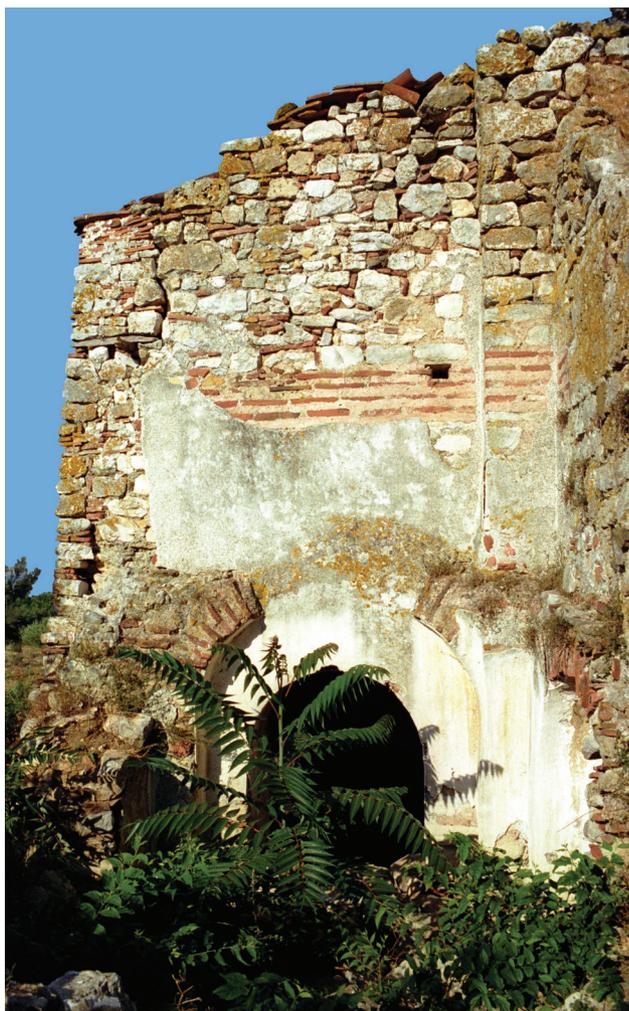
Fig. 6. Apollonia Lake. Monastery of St. Constantine. Katholikon. View of the northwest corner bay from the west.

The corner bays of the church were in the form of contracted cross-shaped rooms covered with calottes. The cross-arms took the form of arches 0.30 m. deep, except for the western cross-arms of the west compartments, which were about 1.80 m. deep (Figs 1, 6, 11).

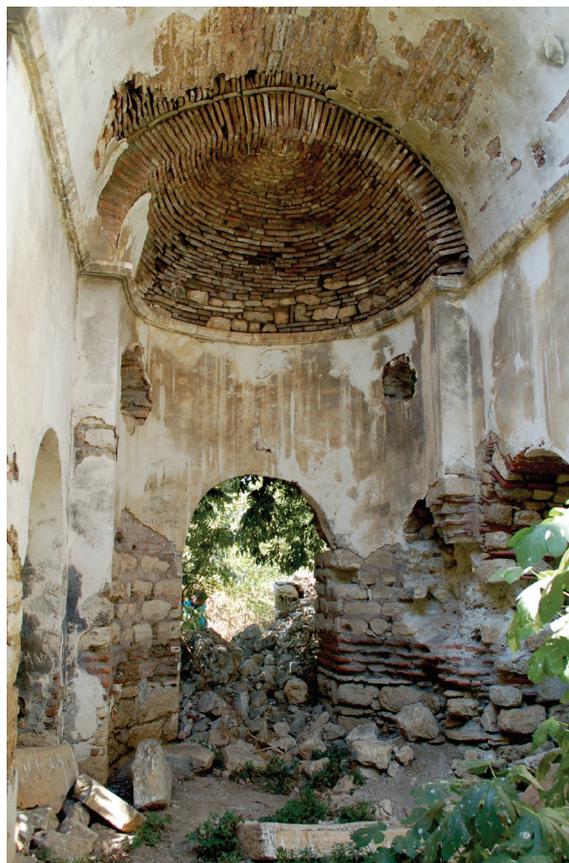
Fig. 7. Apollonia Lake. Monastery of St. Constantine. Katholikon. Interior view towards the west.

original phase. Another apse stood at the western end of the respective cross-arm, which survives almost intact today. Its lower part was inscribed into the western wall of the main church, while the upper part was semicircular on the exterior (Figs 1, 7, 8, 11).

Originally, a dome stood on the spot where the two cross-arms intersect; this dome had apparently already collapsed before the church's desertion in 1922 and subsequent ruination. The circular opening that was left behind after the dome's collapse was most probably covered with some wooden structure, no trace of which survives today (Figs 1, 8, 9). The circular base of the dome was outlined with a marble cornice, with a profile in the shape of a shallow concave moulding (cavetto) terminating with a rectangular recess at its lower end. The cornice was identical to the one that run around the cross-arm portion of the building at the level of the vaults' springing (Figs 7-9, 12-14).

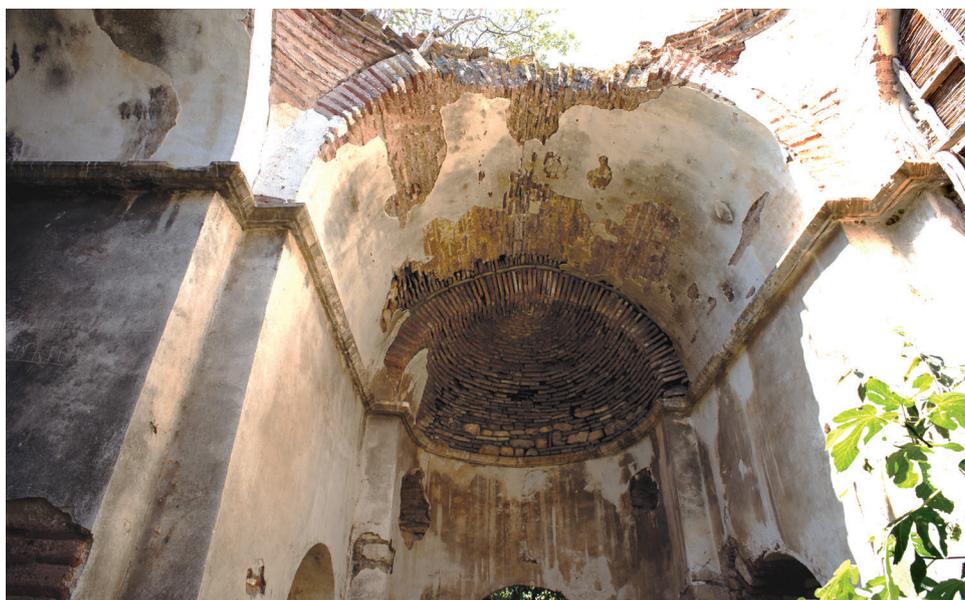
Fig. 8. Apollonia Lake. Monastery of St. Constantine. Katholikon. Interior view towards the west.

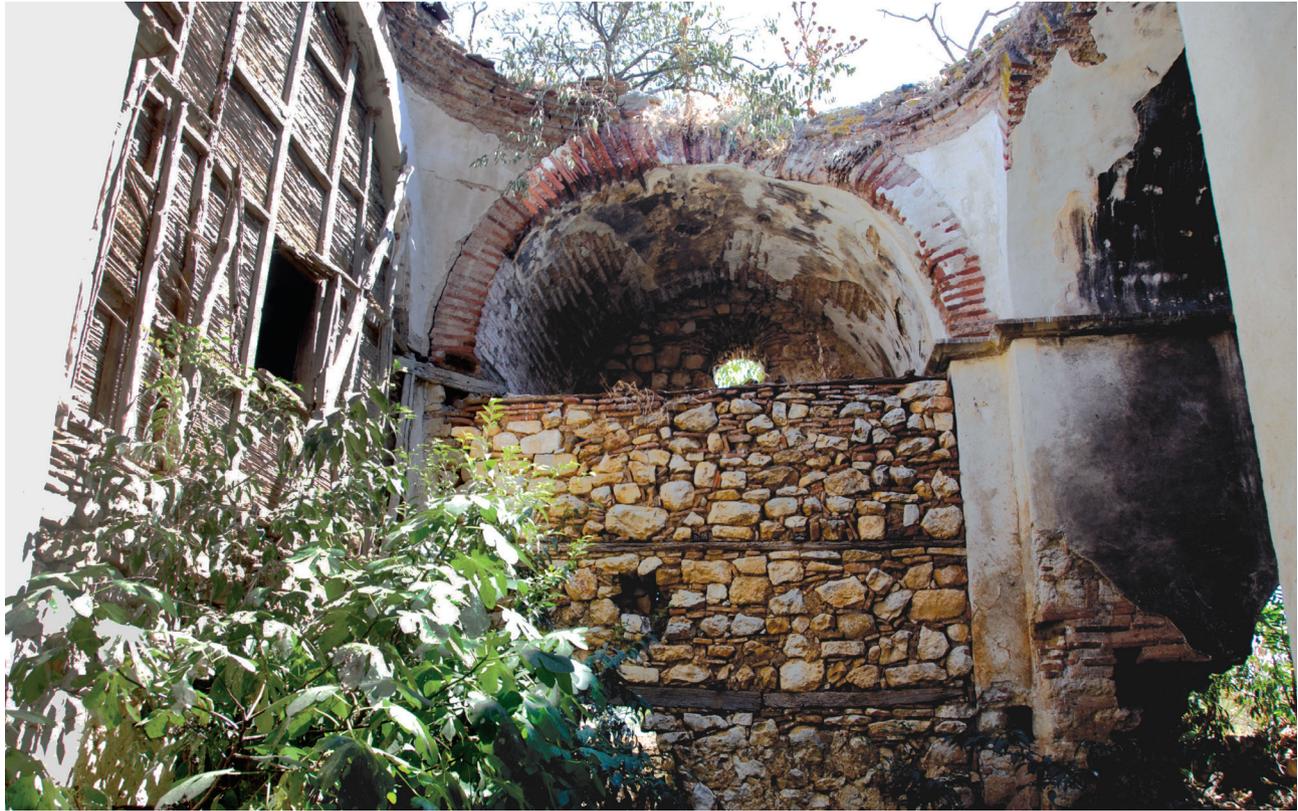
Fig. 9. Apollonia Lake. Monastery of St. Constantine. Katholikon. Interior view towards the east.

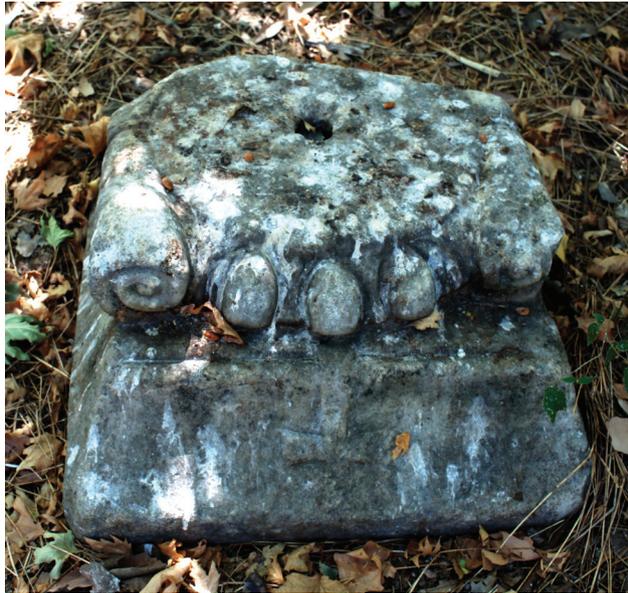
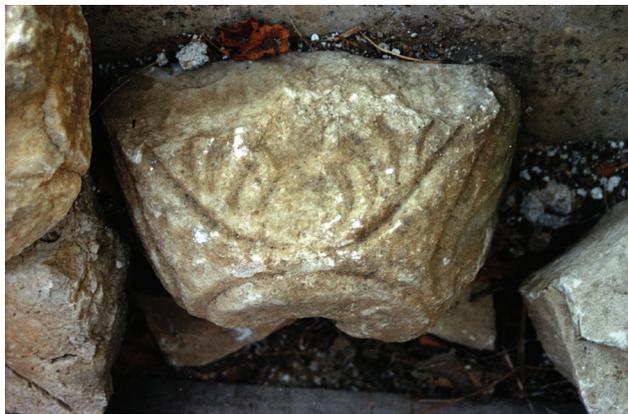
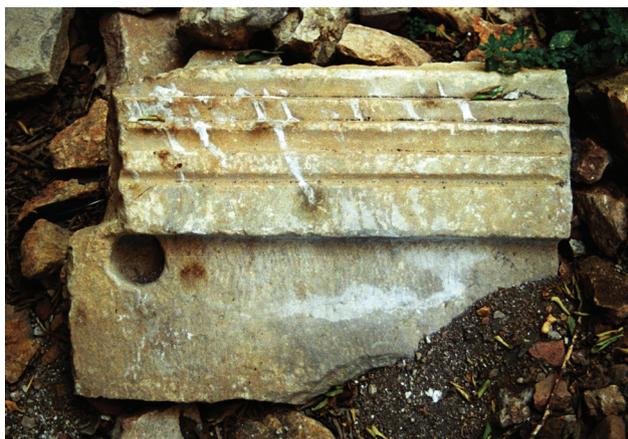
Fig. 10 (a, b, c). Apollonia Lake. Monastery of St. Constantine. Katholikon. Architectural members.

The church of St. Constantine, initially the Katholikon of a small male monastery until the population exchange of 1922, survives today in a derelict state, enveloped by overgrown vegetation, exposed to the elements and to the whims of treasure-hunters (Figs 2-5). After it was deserted, the church appears to have been used for storage. The edifice's several compartments were separated by rudimentary stone-masonry and timber-framed walls that still stand, obstructing all efforts to study the building's history. Recently a large portion of the west façade collapsed, while other parts of the monument are in a state of imminent collapse as well. Only a few of the architectural members mentioned in Mango's publication⁶ still remain

in the area (see below Fig. 10). No trace of the rest of the monastic buildings can be discerned.

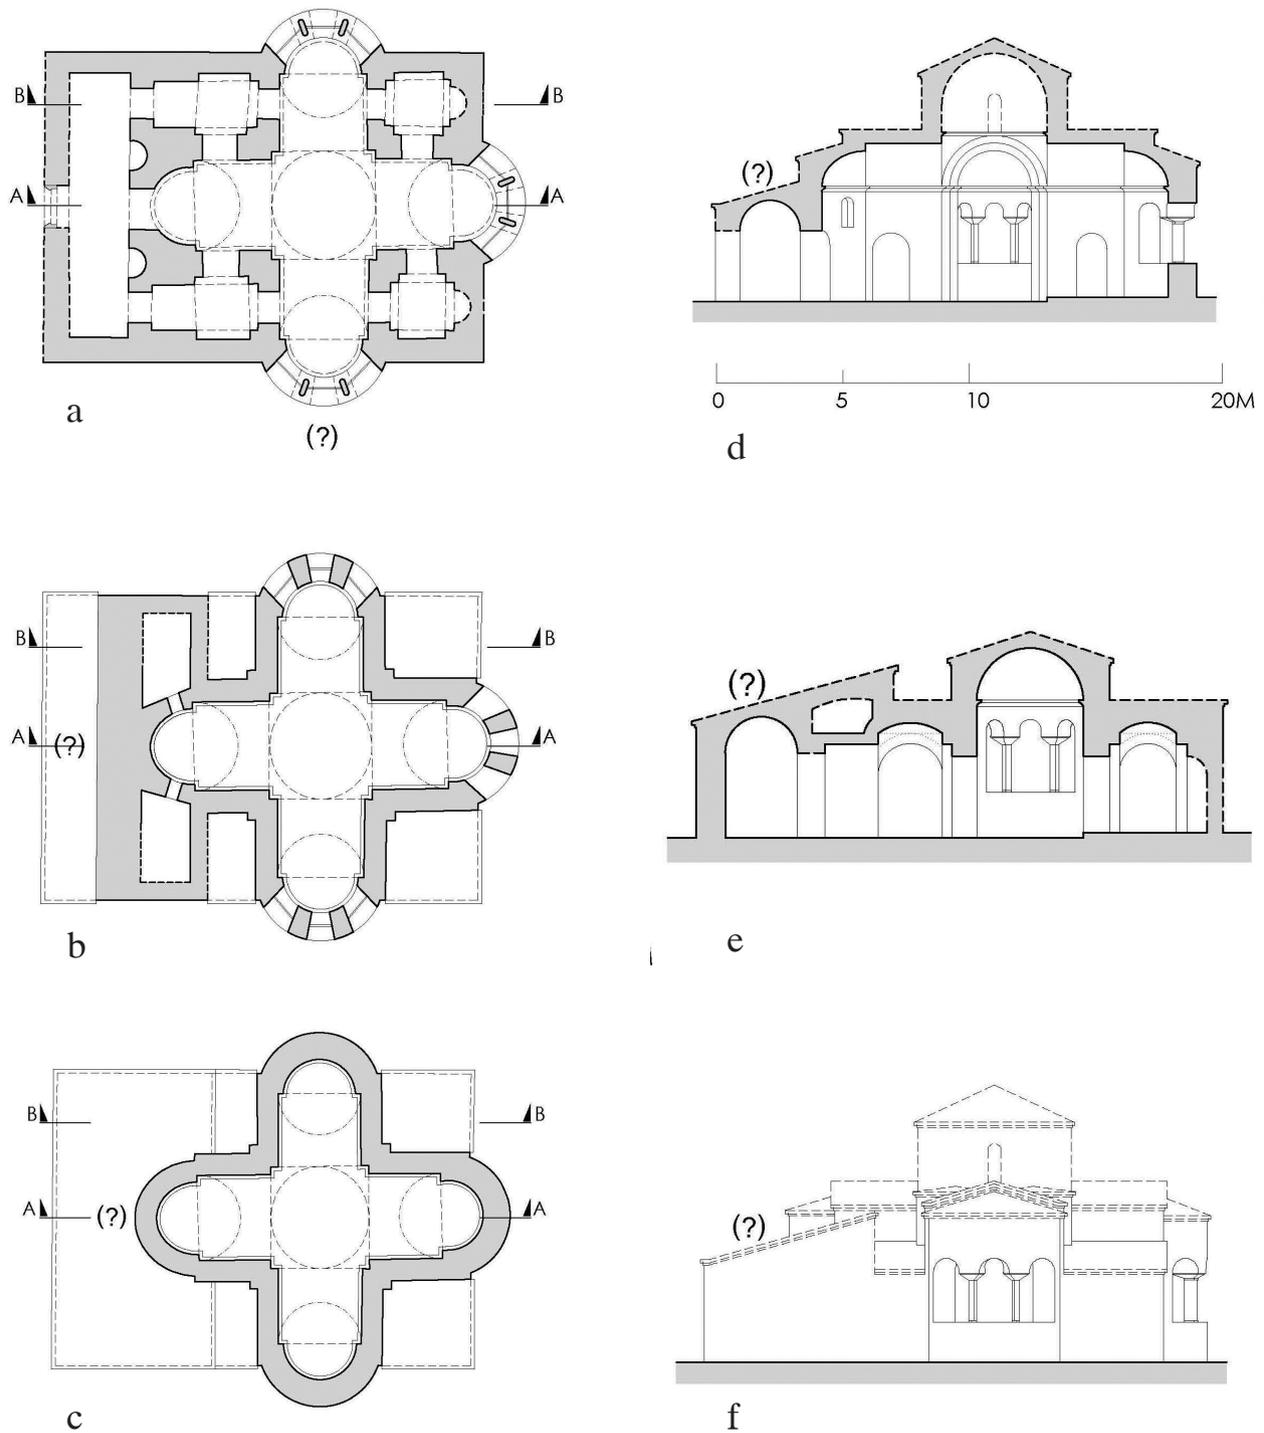
Fig. 11. Apollonia Lake. Monastery of St. Constantine. Katholikon. Reconstruction. (a) Plan A, (b) Plan B, (c) Plan C, (d) Section AA, (e) Section BB, (f) South elevation.

The corner bays' vaulting was at a much lower height than that of the barrel vaulted cross-arms, so that the volume of the latter would be prominently visible on the exterior (Fig. 11).

the jambs of which survive today (Fig. 11). It is not clear whether or how the corner compartments received any natural light. Three doorways, one on the central axis of the west conch and two more in the center of the western walls of the west corner bays, allowed access to the main church from the narthex (Fig. 11). Only the first one of those three doors remains open today.

The east and side façades of the church (Fig. 11.f) are strongly articulated, a feature that is commonly

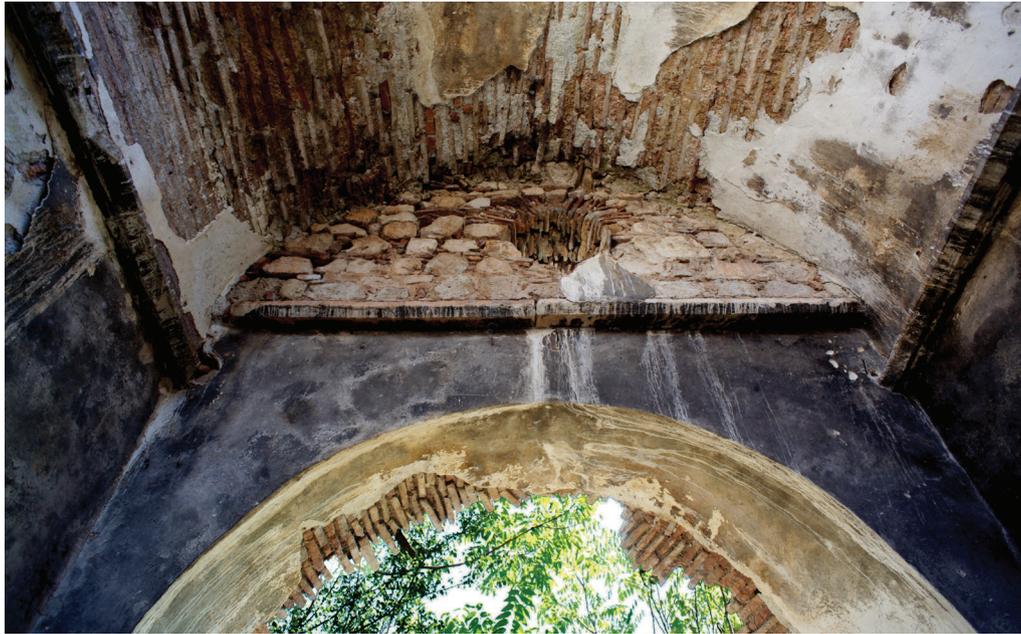
Fig. 12. Apollonia Lake. Monastery of St. Constantine. Katholikon. Interior view of the sanctuary towards the east.

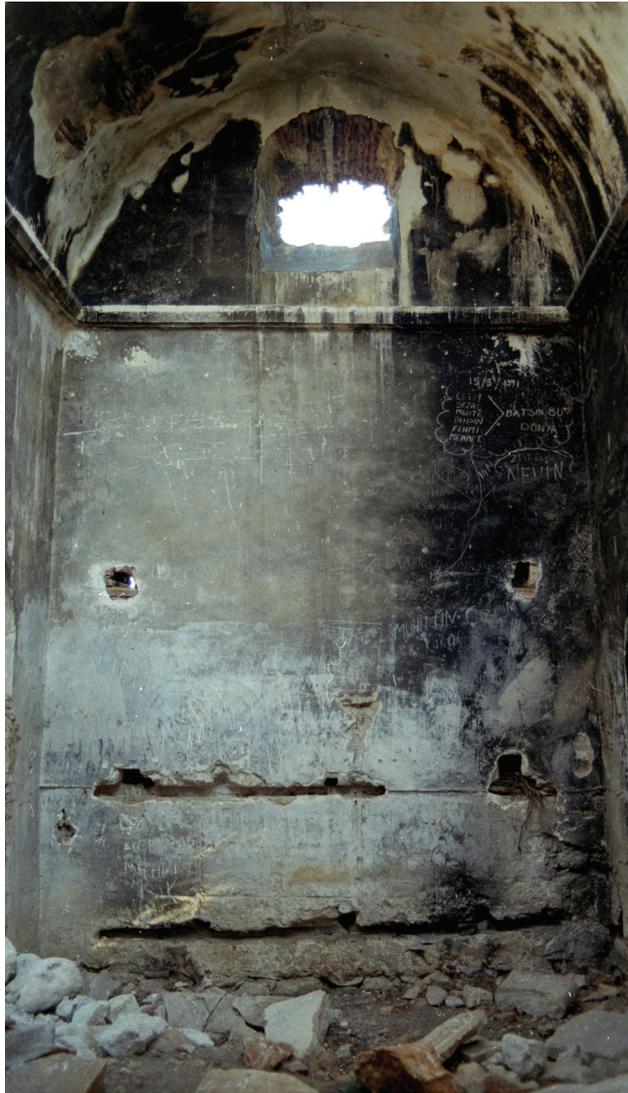
Fig. 13. Apollonia Lake. Monastery of St. Constantine. Katholikon. Interior view towards the south.

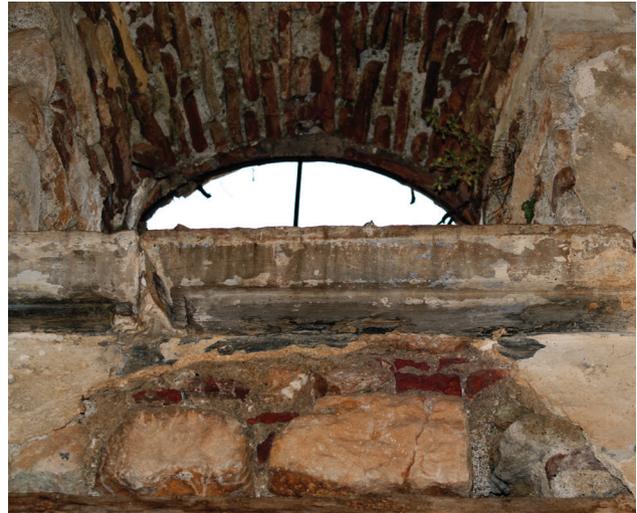
Fig. 14. Apollonia Lake. Monastery of St. Constantine. Katholikon. Cornice detail on the tympanum of the north cross-arm.

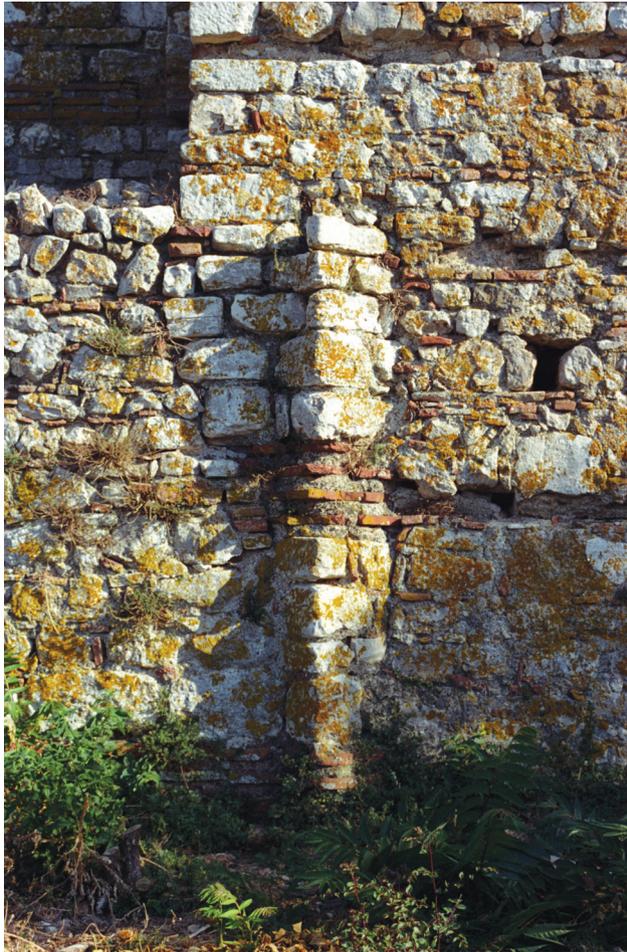
Fig. 15. Apollonia Lake. Monastery of St. Constantine. Katholikon. North elevation detail.

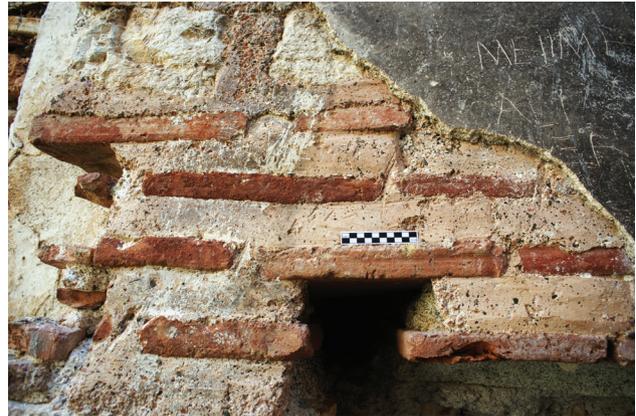
Fig. 16. Apollonia Lake. Monastery of St. Constantine. Katholikon. Masonry detail.

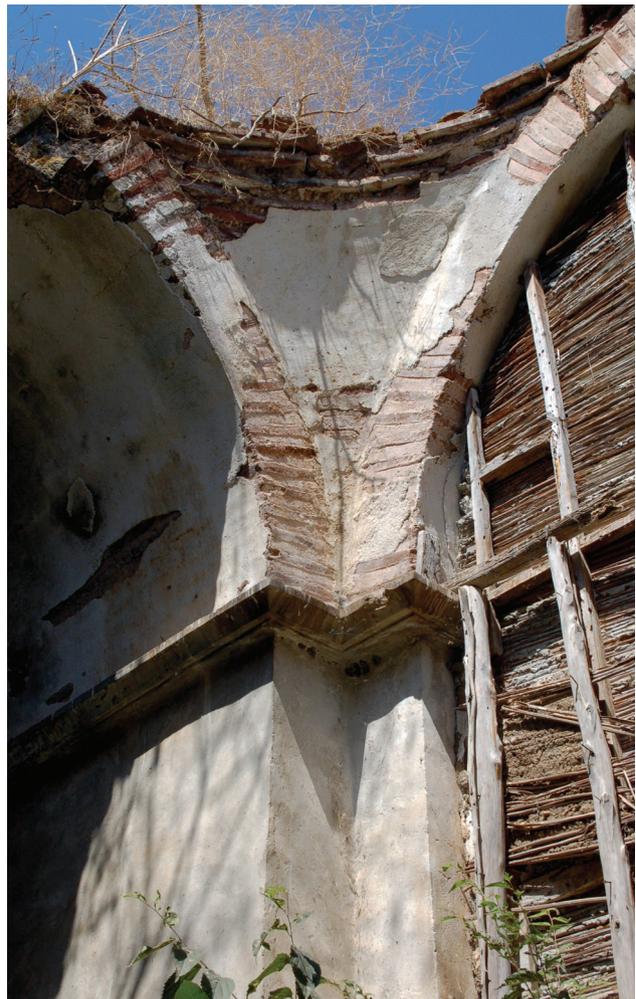
Fig. 17. Apollonia Lake. Monastery of St. Constantine. Katholikon. Interior view towards the northwest.
