Δελτίον ΧΑΕ 38 (2017), Περίοδος Δ'

Επανεξέταση του ναού του Αγίου Κωνσταντίνου στη λίμνη της Απολλωνίας στη Βιθυνία

THE CHURCH OF ST. CONSTANTINE ON LAKE APOLLONIA, BITHYNIA, REVISITED

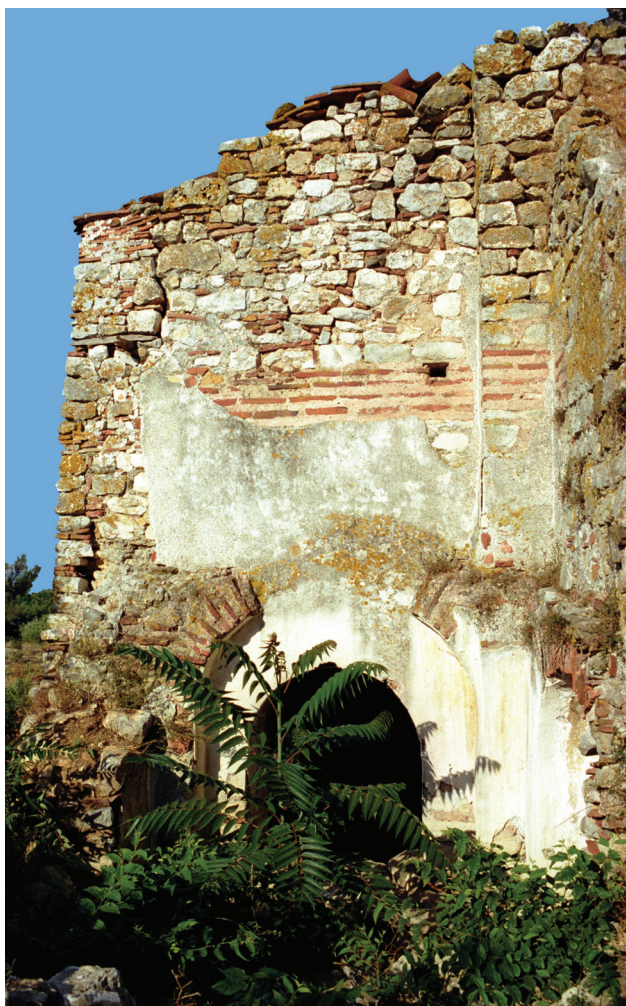
Fig. 6. Apollonia Lake. Monastery of St. Constantine. Katholikon. View of the northwest corner bay from the west.

The corner bays of the church were in the form of contracted cross-shaped rooms covered with calottes. The cross-arms took the form of arches 0.30 m. deep, except for the western cross-arms of the west compartments, which were about 1.80 m. deep (Figs 1, 6, 11).

The original walls of the church of St. Constantine were constructed out of alternating bands of stone and brick masonry¹³ (Figs 4, 6, 7, 16). This construction system, also known as “opus mixtum” is the quintessential masonry building system encountered in the architecture of the capital throughout the Byzantine period¹⁴. The ratio of alternate material bands together with the thickness of bricks that does not exceed 4 cm. set the church of St. Constantine apart from early Constantinopolitan examples, such as the land walls of Theodosius, and rather associate it with later monuments in the capital¹⁵, or the areas within its immediate sphere of influence¹⁶. The arches and vaults of the surviving earlier parts of the monument are built entirely of bricks (Figs 8, 17), while bricks have also been used, albeit in a more haphazard manner, in the rebuilt later parts (Figs 7, 8, 12). The original building mortar is an off-white color, with coarse aggregates, while the joints are finished with the application of a thin, pressed, hydraulic jointing mortar which includes a large amount of crushed brick (Figs 16, 17).

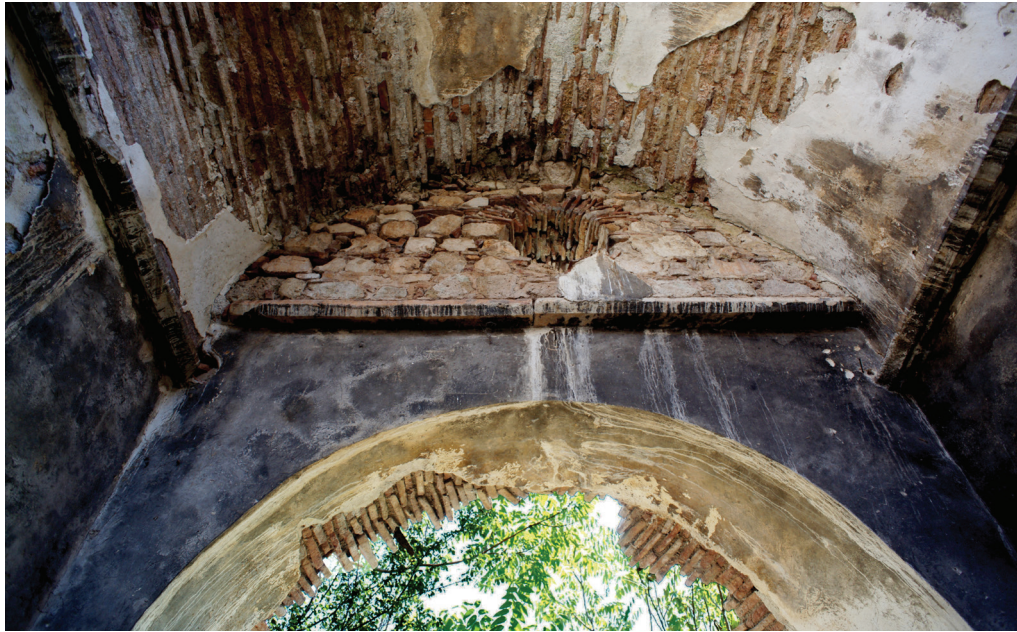
Fig. 12. Apollonia Lake. Monastery of St. Constantine. Katholikon. Interior view of the sanctuary towards the east.

Originally, a dome stood on the spot where the two cross-arms intersect; this dome had apparently already collapsed before the church's desertion in 1922 and subsequent ruination. The circular opening that was left behind after the dome's collapse was most probably covered with some wooden structure, no trace of which survives today (Figs 1, 8, 9). The circular base of the dome was outlined with a marble cornice, with a profile in the shape of a shallow concave moulding (cavetto) terminating with a rectangular recess at its lower end. The cornice was identical to the one that run around the cross-arm portion of the building at the level of the vaults' springing (Figs 7-9, 12-14).

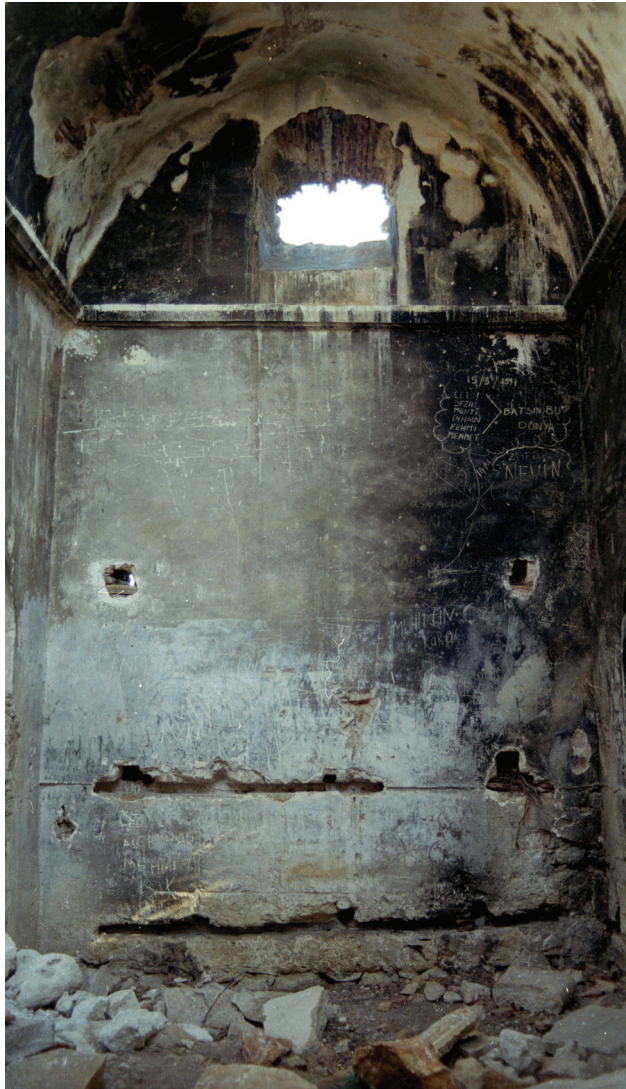
Fig. 13. Apollonia Lake. Monastery of St. Constantine. Katholikon. Interior view towards the south.

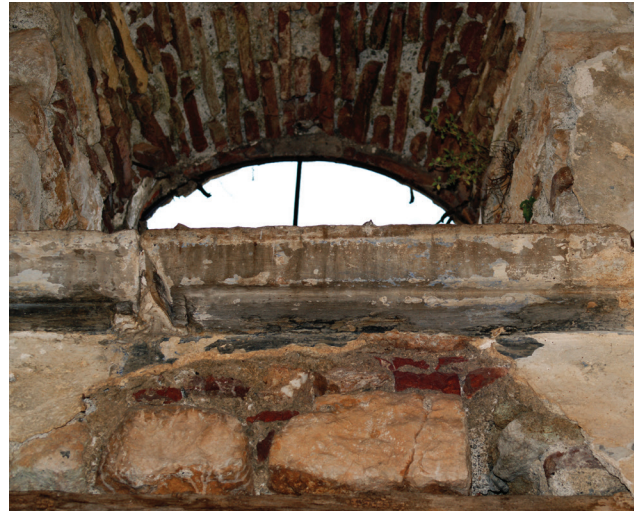
Fig. 14. Apollonia Lake. Monastery of St. Constantine. Katholikon. Cornice detail on the tympanum of the north cross-arm.

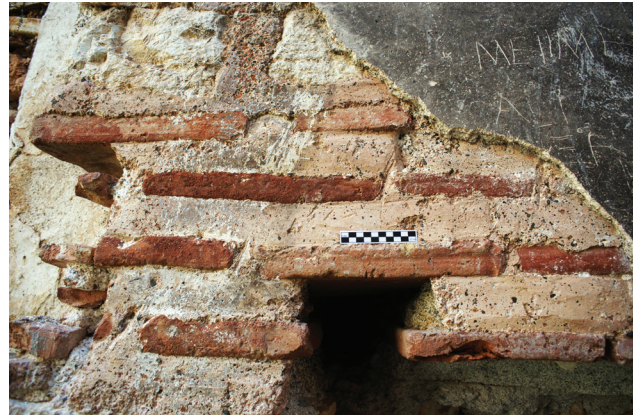
Fig. 16. Apollonia Lake. Monastery of St. Constantine. Katholikon. Masonry detail.

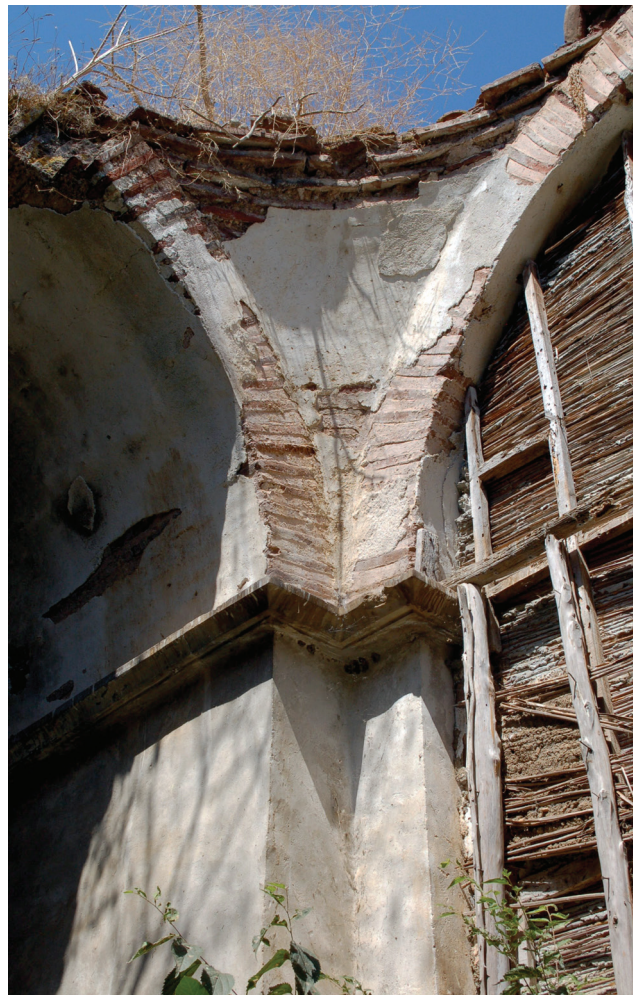
Fig. 17. Apollonia Lake. Monastery of St. Constantine. Katholikon. Interior view towards the northwest.
