Επανεξέταση του ναού του Αγίου Κωνσταντίνου στη λίμνη της Απολλωνίας στη Βιθυνία

Michalis Kappas – Stavros Mamaloukos

THE CHURCH OF ST. CONSTANTINE ON LAKE APOLLONIA, BITHYNIA, REVISITED

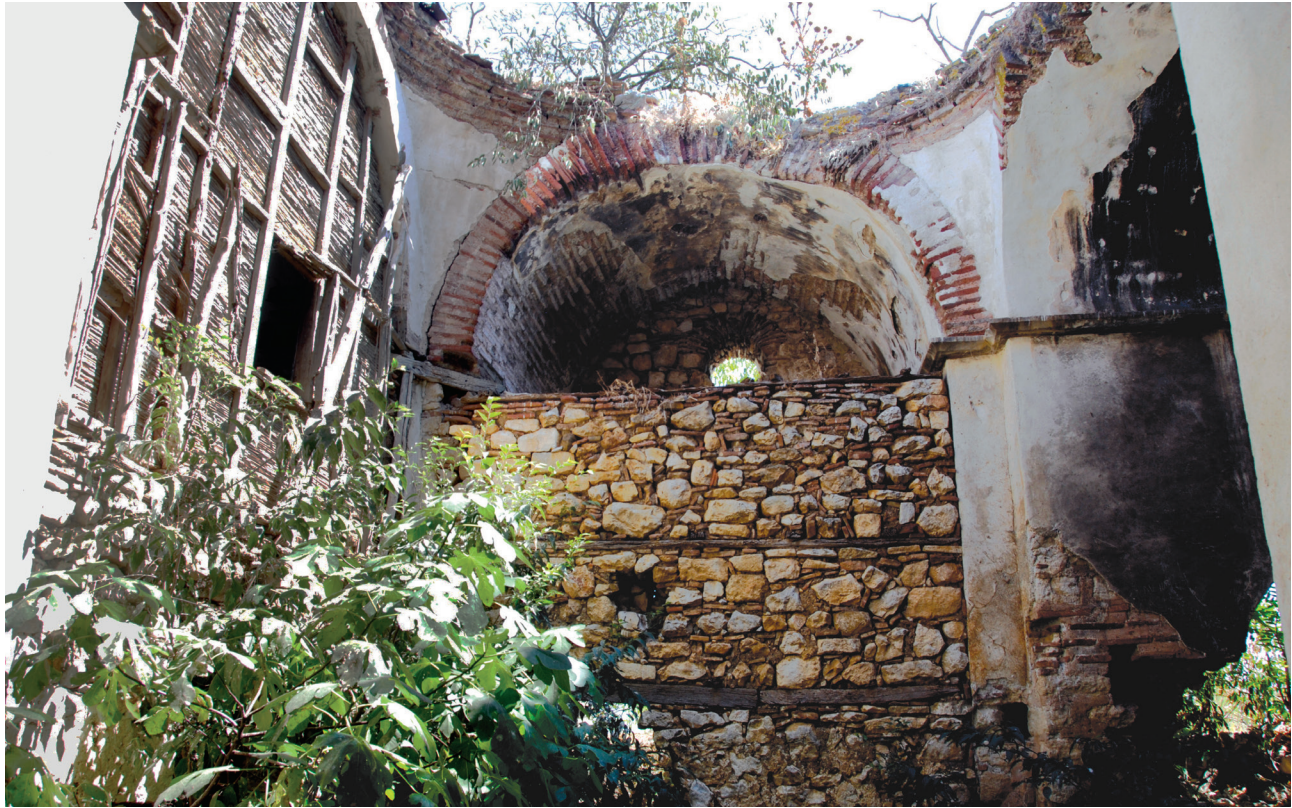
Fig. 9. Apollonia Lake. Monastery of St. Constantine. Katholikon. Interior view towards the east.

Originally, a dome stood on the spot where the two cross-arms intersect; this dome had apparently already collapsed before the church's desertion in 1922 and subsequent ruination. The circular opening that was left behind after the dome's collapse was most probably covered with some wooden structure, no trace of which survives today (Figs 1, 8, 9). The circular base of the dome was outlined with a marble cornice, with a profile in the shape of a shallow concave moulding (cavetto) terminating with a rectangular recess at its lower end. The cornice was identical to the one that run around the cross-arm portion of the building at the level of the vaults' springing (Figs 7-9, 12-14).

The square space underneath the dome was expanded via recesses on its four corners (Figs 1, 8, 9, 11). This practice of widening the central compartment of cruciform type buildings was widespread in the architecture of Late Antiquity, and survived in Byzantine architecture until the 10th and –on rare occasions– the 11th and 12th centuries or even later¹¹.

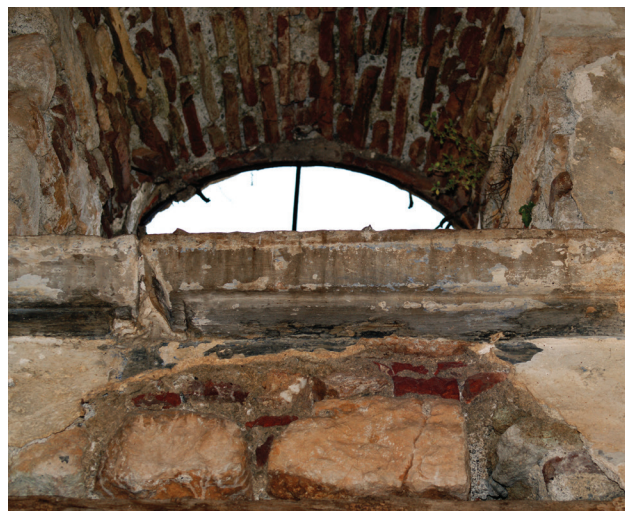
Fig. 14. Apollonia Lake. Monastery of St. Constantine. Katholikon. Cornice detail on the tympanum of the north cross-arm.

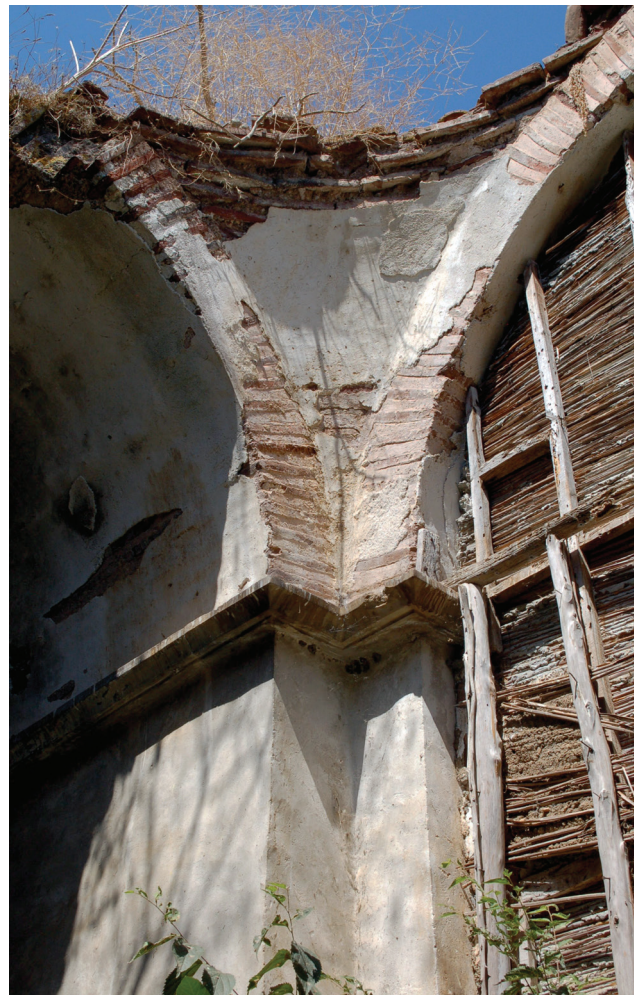
Fig. 17. Apollonia Lake. Monastery of St. Constantine. Katholikon. Interior view towards the northwest.

The original walls of the church of St. Constantine were constructed out of alternating bands of stone and brick masonry¹³ (Figs 4, 6, 7, 16). This construction system, also known as “opus mixtum” is the quintessential masonry building system encountered in the architecture of the capital throughout the Byzantine period¹⁴. The ratio of alternate material bands together with the thickness of bricks that does not exceed 4 cm. set the church of St. Constantine apart from early Constantinopolitan examples, such as the land walls of Theodosius, and rather associate it with later monuments in the capital¹⁵, or the areas within its immediate sphere of influence¹⁶. The arches and vaults of the surviving earlier parts of the monument are built entirely of bricks (Figs 8, 17), while bricks have also been used, albeit in a more haphazard manner, in the rebuilt later parts (Figs 7, 8, 12). The original building mortar is an off-white color, with coarse aggregates, while the joints are finished with the application of a thin, pressed, hydraulic jointing mortar which includes a large amount of crushed brick (Figs 16, 17).
