Δελτίον ΧΑΕ 38 (2017), Περίοδος Δ'

Επανεξέταση του ναού του Αγίου Κωνσταντίνου στη λίμνη της Απολλωνίας στη Βιθυνία

THE CHURCH OF ST. CONSTANTINE ON LAKE APOLLONIA, BITHYNIA, REVISITED

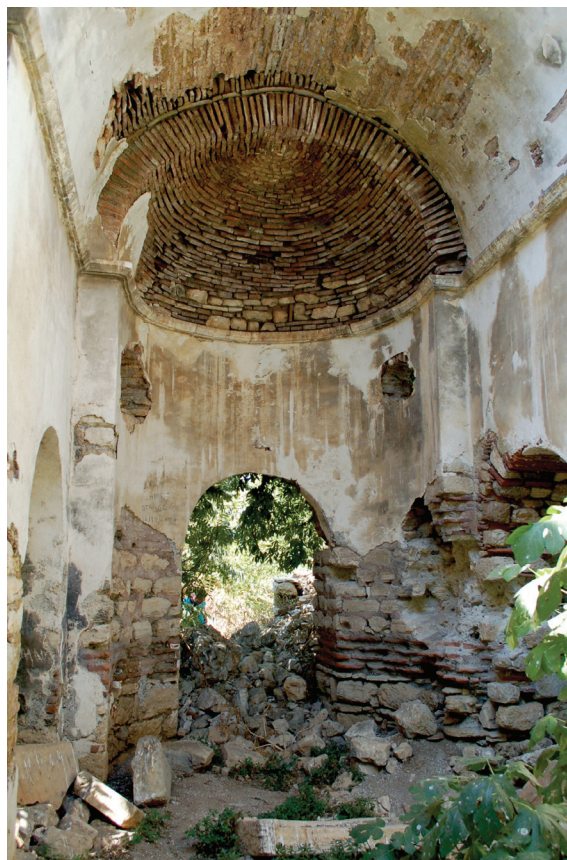
Fig. 7. Apollonia Lake. Monastery of St. Constantine. Katholikon. Interior view towards the west.

original phase. Another apse stood at the western end of the respective cross-arm, which survives almost intact today. Its lower part was inscribed into the western wall of the main church, while the upper part was semicircular on the exterior (Figs 1, 7, 8, 11).

Originally, a dome stood on the spot where the two cross-arms intersect; this dome had apparently already collapsed before the church's desertion in 1922 and subsequent ruination. The circular opening that was left behind after the dome's collapse was most probably covered with some wooden structure, no trace of which survives today (Figs 1, 8, 9). The circular base of the dome was outlined with a marble cornice, with a profile in the shape of a shallow concave moulding (cavetto) terminating with a rectangular recess at its lower end. The cornice was identical to the one that run around the cross-arm portion of the building at the level of the vaults' springing (Figs 7-9, 12-14).

The original walls of the church of St. Constantine were constructed out of alternating bands of stone and brick masonry¹³ (Figs 4, 6, 7, 16). This construction system, also known as “opus mixtum” is the quintessential masonry building system encountered in the architecture of the capital throughout the Byzantine period¹⁴. The ratio of alternate material bands together with the thickness of bricks that does not exceed 4 cm. set the church of St. Constantine apart from early Constantinopolitan examples, such as the land walls of Theodosius, and rather associate it with later monuments in the capital¹⁵, or the areas within its immediate sphere of influence¹⁶. The arches and vaults of the surviving earlier parts of the monument are built entirely of bricks (Figs 8, 17), while bricks have also been used, albeit in a more haphazard manner, in the rebuilt later parts (Figs 7, 8, 12). The original building mortar is an off-white color, with coarse aggregates, while the joints are finished with the application of a thin, pressed, hydraulic jointing mortar which includes a large amount of crushed brick (Figs 16, 17).
