Επανεξέταση του ναού του Αγίου Κωνσταντίνου στη λίμνη της Απολλωνίας στη Βιθυνία

Michalis Kappas – Stavros Mamaloukos

THE CHURCH OF ST. CONSTANTINE ON LAKE APOLLONIA, BITHYNIA, REVISITED

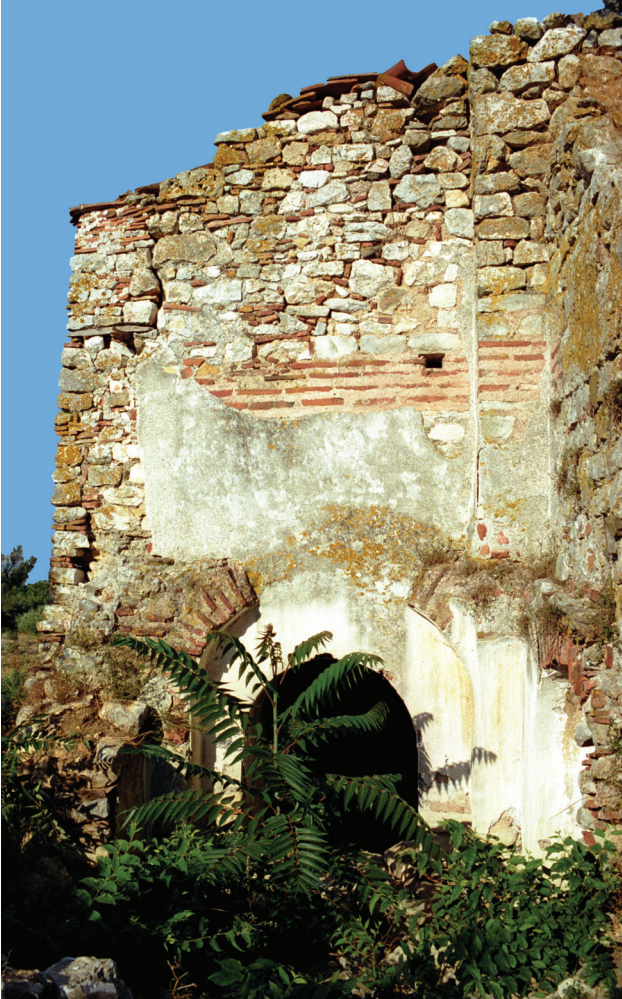
Fig. 6. Apollonia Lake. Monastery of St. Constantine. Katholikon. View of the northwest corner bay from the west.

The corner bays of the church were in the form of contracted cross-shaped rooms covered with calottes. The cross-arms took the form of arches 0.30 m. deep, except for the western cross-arms of the west compartments, which were about 1.80 m. deep (Figs 1, 6, 11).

The original walls of the church of St. Constantine were constructed out of alternating bands of stone and brick masonry¹³ (Figs 4, 6, 7, 16). This construction system, also known as “opus mixtum” is the quintessential masonry building system encountered in the architecture of the capital throughout the Byzantine period¹⁴. The ratio of alternate material bands together with the thickness of bricks that does not exceed 4 cm. set the church of St. Constantine apart from early Constantinopolitan examples, such as the land walls of Theodosius, and rather associate it with later monuments in the capital¹⁵, or the areas within its immediate sphere of influence¹⁶. The arches and vaults of the surviving earlier parts of the monument are built entirely of bricks (Figs 8, 17), while bricks have also been used, albeit in a more haphazard manner, in the rebuilt later parts (Figs 7, 8, 12). The original building mortar is an off-white color, with coarse aggregates, while the joints are finished with the application of a thin, pressed, hydraulic jointing mortar which includes a large amount of crushed brick (Figs 16, 17).

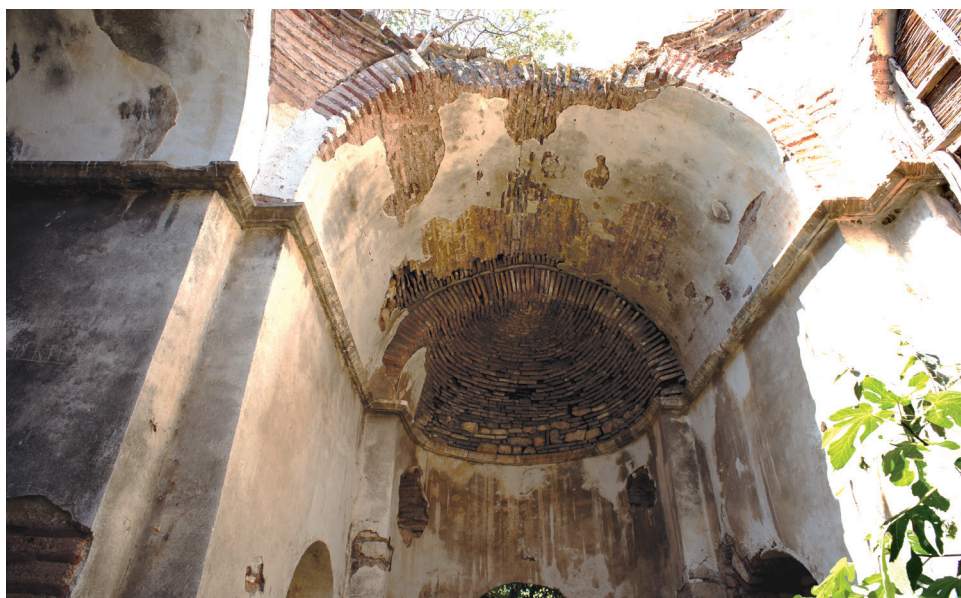
Fig. 8. Apollonia Lake. Monastery of St. Constantine. Katholikon. Interior view towards the west.

original phase. Another apse stood at the western end of the respective cross-arm, which survives almost intact today. Its lower part was inscribed into the western wall of the main church, while the upper part was semicircular on the exterior (Figs 1, 7, 8, 11).

Originally, a dome stood on the spot where the two cross-arms intersect; this dome had apparently already collapsed before the church's desertion in 1922 and subsequent ruination. The circular opening that was left behind after the dome's collapse was most probably covered with some wooden structure, no trace of which survives today (Figs 1, 8, 9). The circular base of the dome was outlined with a marble cornice, with a profile in the shape of a shallow concave moulding (cavetto) terminating with a rectangular recess at its lower end. The cornice was identical to the one that run around the cross-arm portion of the building at the level of the vaults' springing (Figs 7-9, 12-14).

The square space underneath the dome was expanded via recesses on its four corners (Figs 1, 8, 9, 11). This practice of widening the central compartment of cruciform type buildings was widespread in the architecture of Late Antiquity, and survived in Byzantine architecture until the 10th and –on rare occasions– the 11th and 12th centuries or even later¹¹.

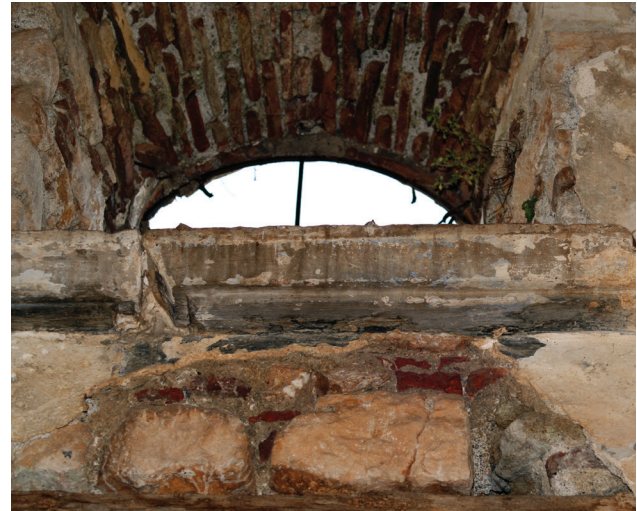
Fig. 14. Apollonia Lake. Monastery of St. Constantine. Katholikon. Cornice detail on the tympanum of the north cross-arm.
