Επανεξέταση του ναού του Αγίου Κωνσταντίνου στη λίμνη της Απολλωνίας στη Βιθυνία

Michalis Kappas – Stavros Mamaloukos

THE CHURCH OF ST. CONSTANTINE ON LAKE APOLLONIA, BITHYNIA, REVISITED

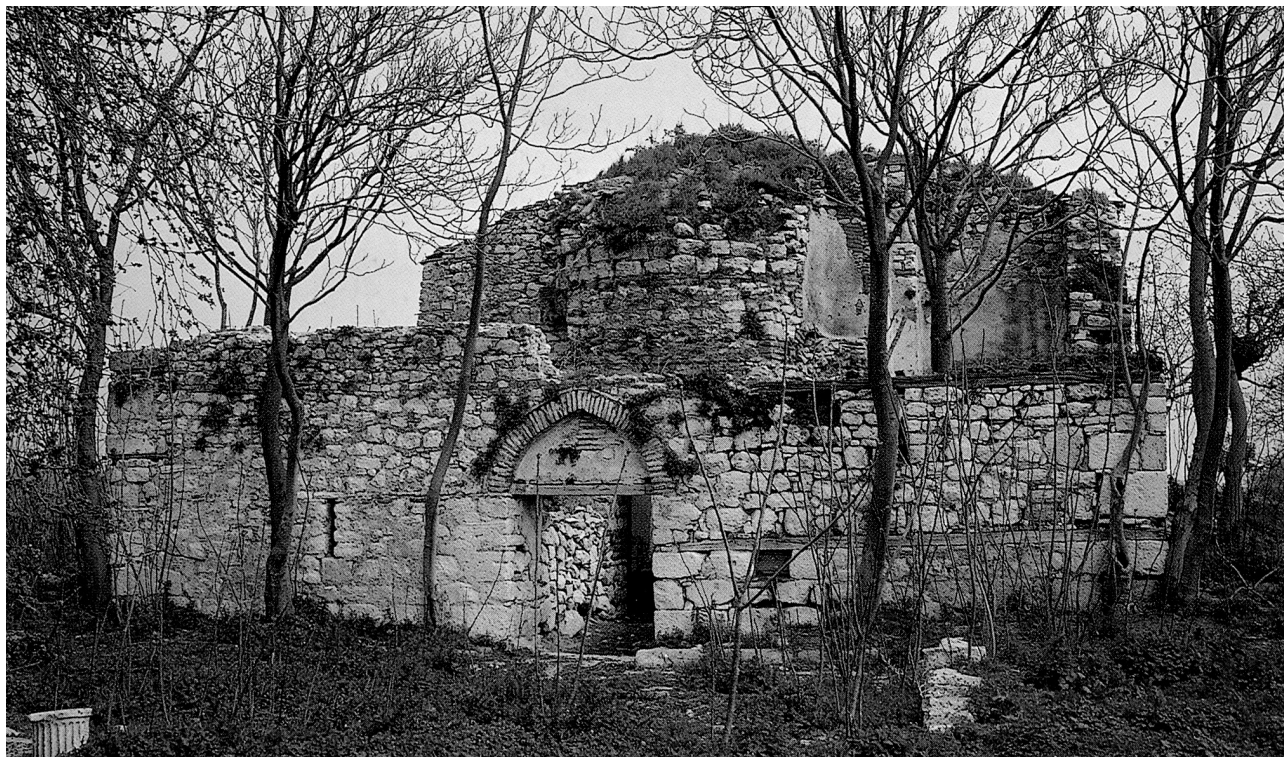
Fig. 2. Apollonia Lake. Monastery of St. Constantine. Katholikon. View from the southwest.

The sporadic accounts of the history of the monastic complex that can be garnered from medieval sources are known to us from Mango's publication. The earliest account dates back to the year 825, when Saint Ioannikios, a monk in one of the monasteries of Bithynian Olympus, inspired by divine passion, traveled to the monastery of Megas Agros to pay his respects to the relics of St. Theophanis Confessor. On his way back, Ioannikios was traveling on one of the main thoroughfares along the shores of Lake Apollonia, where he met one Daniel, abbot of the monastery of Thasios Island. The second account refers to Arsenios Autoreianos, who before being appointed patriarch in 1255 had been a monk in a monastery on one of the lake isles⁷. Identifying Thasios Island as the island of St. Constantine seems logical, though it is not corroborated by the two brief medieval sources. The earliest account of the dedication of the church to St. Constantine dates back to the 16th century, a time when a total of seven monks resided in the monastery⁸. Upon studying the monument's form it becomes evident that it has undergone extensive subsequent interventions (it has literally been partly rebuilt) (Fig. 1). At least one part of these interventions could be probably dated to the 19th century, possibly after the severe earthquake of 1855, based on its morphological and construction features⁹ (Figs 2-5). It is not possible

A narthex that as wide as the main church was attached on the west side; a large portion of this narthex had been rebuilt in later years (Figs 1, 2, 11), while its later roofing is completely destroyed. The vaulting of the original narthex must have consisted of a barrel vault placed on the transverse axis of the building. Two small vaulted spaces were formed over the passageways between the narthex and the west corner bays; these spaces were accessible through small arched openings on the semicylindrical wall of the west conch. The exact shape of the roofing over the narthex cannot be safely reconstructed. It may have been a lean-to roof inclined towards the west. The existence of galleries over the narthex, and probably even over the west corner bays cannot be excluded either. In any case, the confirmation or dismissal of this hypothesis will require a more detailed archaeological documentation of the monument.

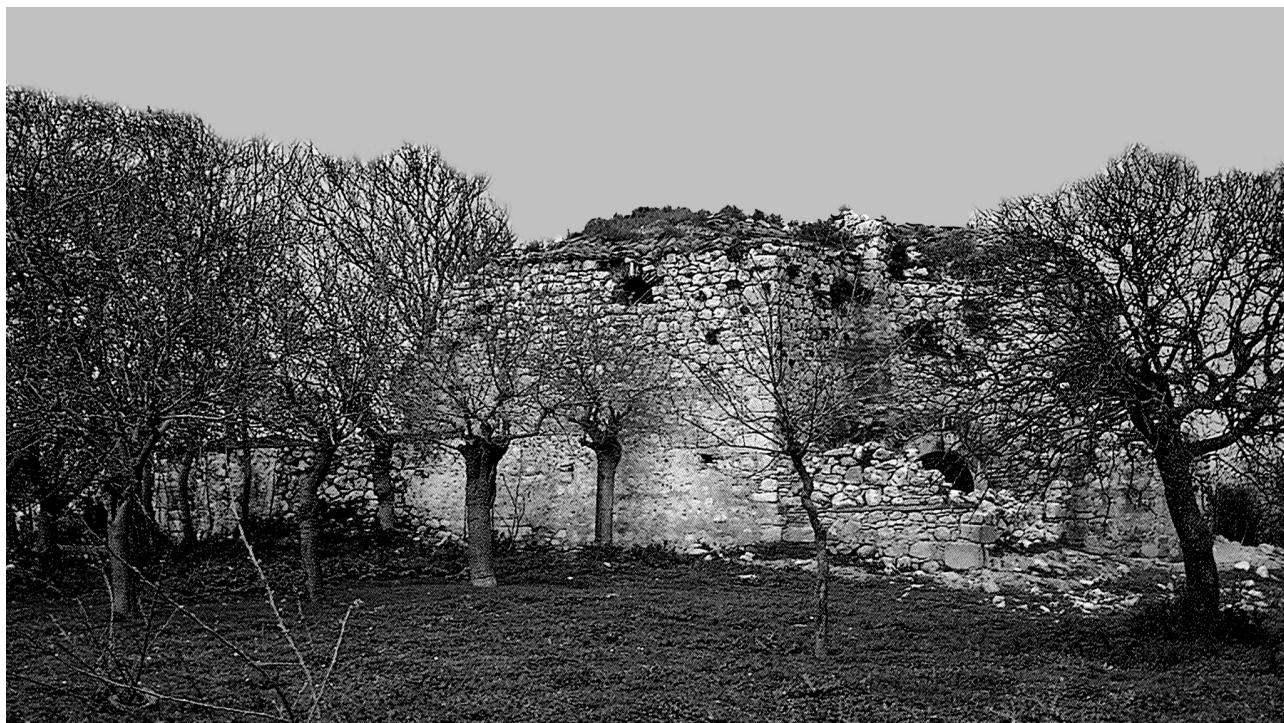
Fig. 3. Apollonia Lake. Monastery of St. Constantine Katholikon. View from the southeast.

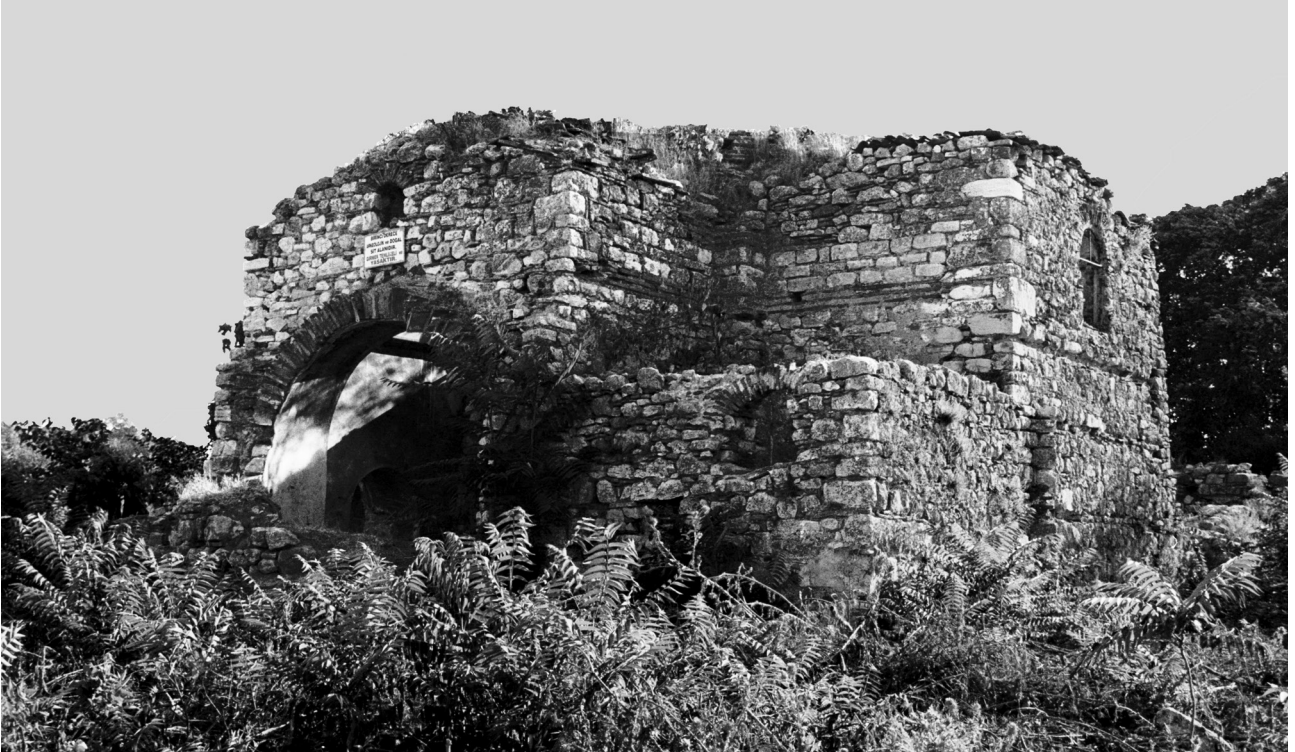
Fig. 4. Apollonia Lake. Monastery of St. Constantine. Katholikon. View from the northeast.

The original walls of the church of St. Constantine were constructed out of alternating bands of stone and brick masonry¹³ (Figs 4, 6, 7, 16). This construction system, also known as “opus mixtum” is the quintessential masonry building system encountered in the architecture of the capital throughout the Byzantine period¹⁴. The ratio of alternate material bands together with the thickness of bricks that does not exceed 4 cm. set the church of St. Constantine apart from early Constantinopolitan examples, such as the land walls of Theodosius, and rather associate it with later monuments in the capital¹⁵, or the areas within its immediate sphere of influence¹⁶. The arches and vaults of the surviving earlier parts of the monument are built entirely of bricks (Figs 8, 17), while bricks have also been used, albeit in a more haphazard manner, in the rebuilt later parts (Figs 7, 8, 12). The original building mortar is an off-white color, with coarse aggregates, while the joints are finished with the application of a thin, pressed, hydraulic jointing mortar which includes a large amount of crushed brick (Figs 16, 17).

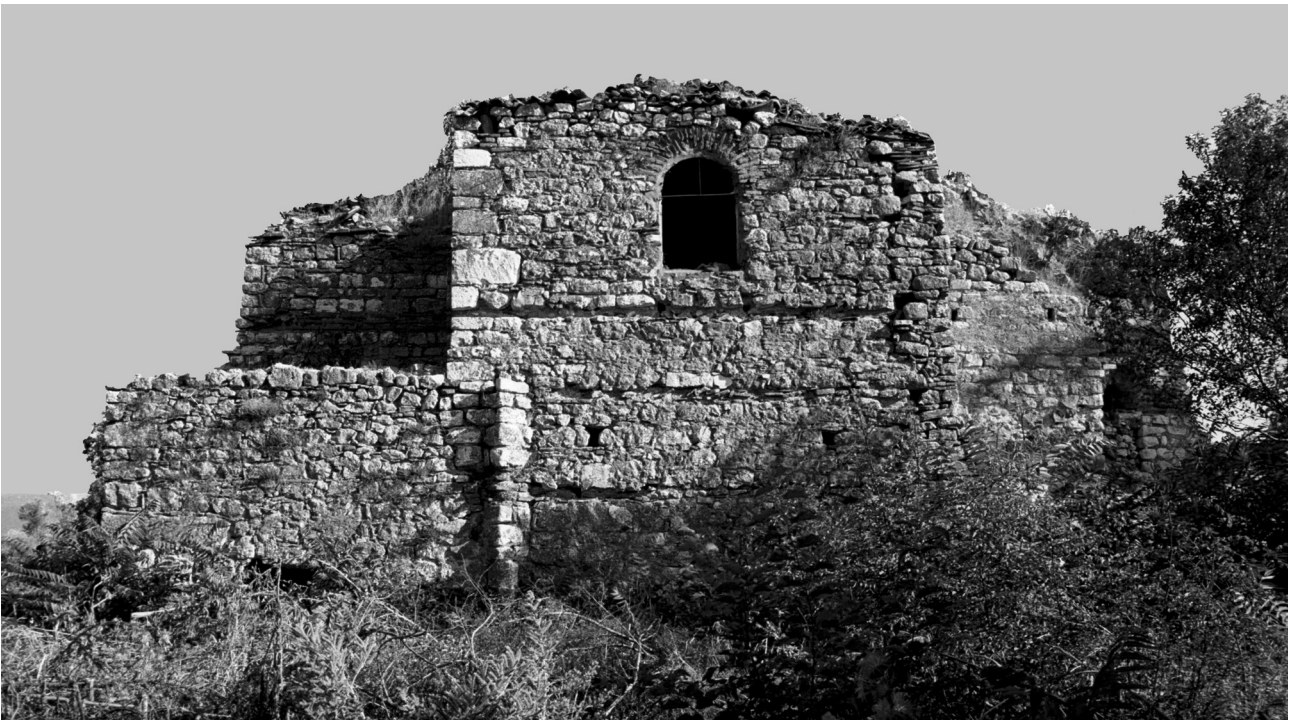
Fig. 5. Apollonia Lake. Monastery of St. Constantine. Katholikon. View from the north.

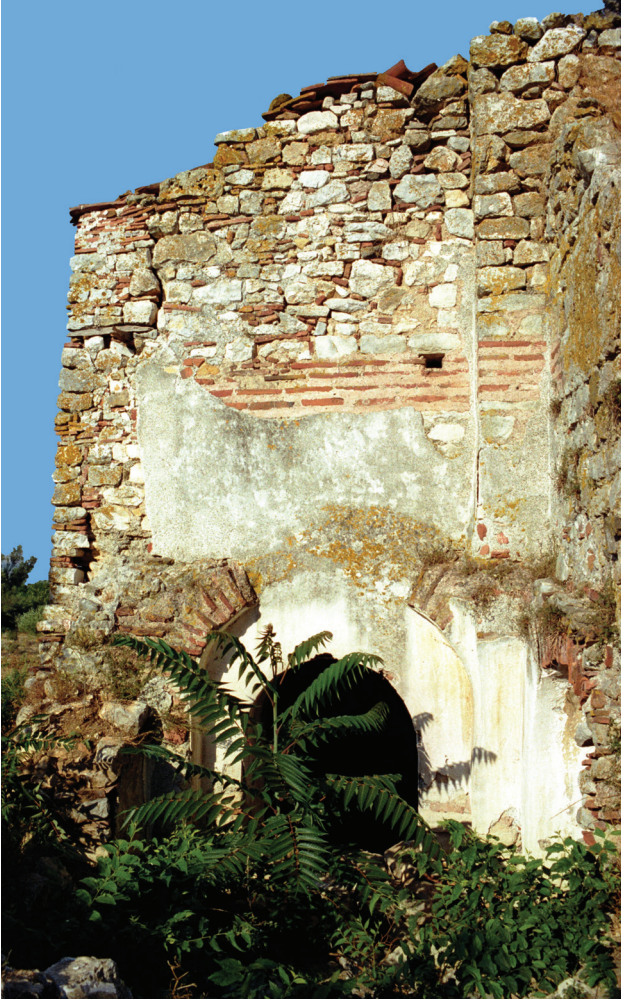
Fig. 6. Apollonia Lake. Monastery of St. Constantine. Katholikon. View of the northwest corner bay from the west.

The corner bays of the church were in the form of contracted cross-shaped rooms covered with calottes. The cross-arms took the form of arches 0.30 m. deep, except for the western cross-arms of the west compartments, which were about 1.80 m. deep (Figs 1, 6, 11).

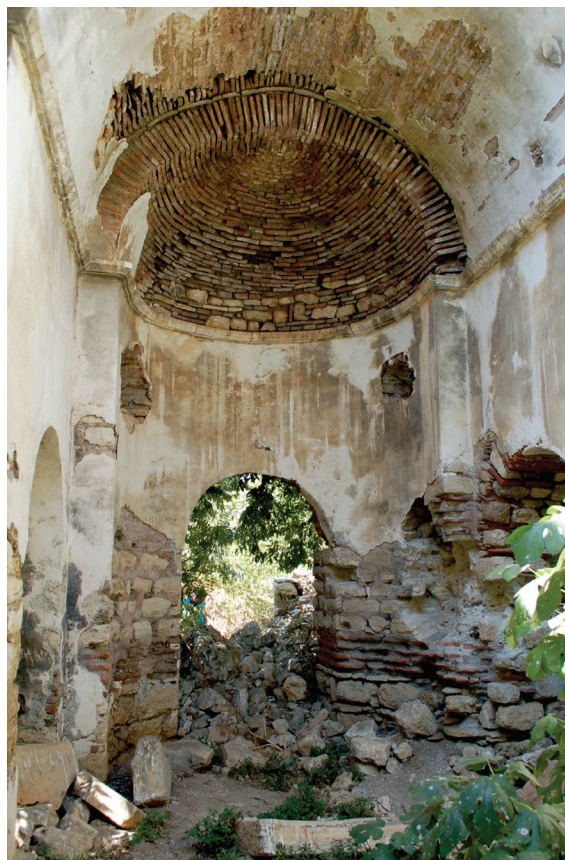
Fig. 7. Apollonia Lake. Monastery of St. Constantine. Katholikon. Interior view towards the west.

original phase. Another apse stood at the western end of the respective cross-arm, which survives almost intact today. Its lower part was inscribed into the western wall of the main church, while the upper part was semicircular on the exterior (Figs 1, 7, 8, 11).

Originally, a dome stood on the spot where the two cross-arms intersect; this dome had apparently already collapsed before the church's desertion in 1922 and subsequent ruination. The circular opening that was left behind after the dome's collapse was most probably covered with some wooden structure, no trace of which survives today (Figs 1, 8, 9). The circular base of the dome was outlined with a marble cornice, with a profile in the shape of a shallow concave moulding (cavetto) terminating with a rectangular recess at its lower end. The cornice was identical to the one that run around the cross-arm portion of the building at the level of the vaults' springing (Figs 7-9, 12-14).

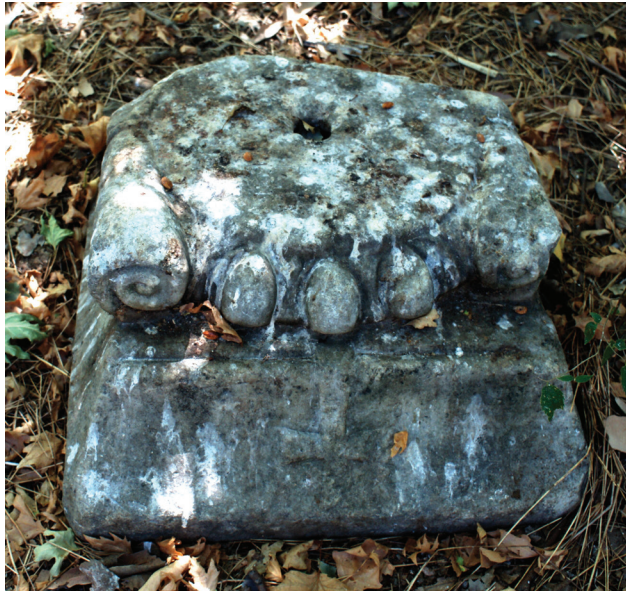
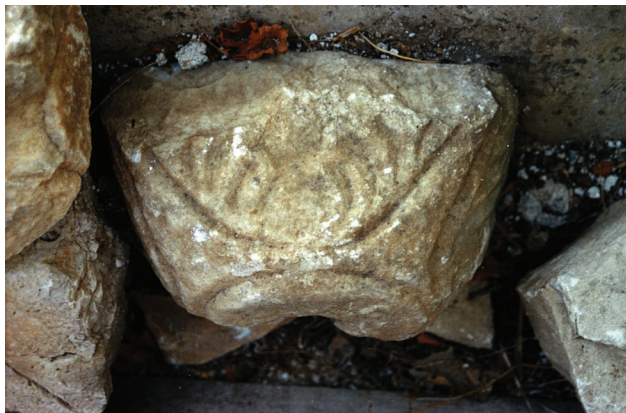
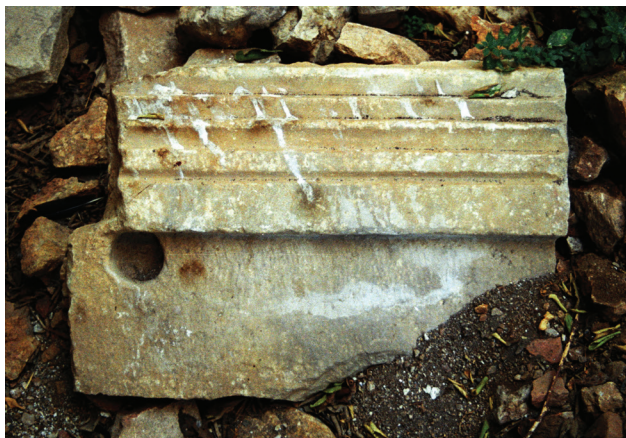
Fig. 10 (a, b, c). Apollonia Lake. Monastery of St. Constantine. Katholikon. Architectural members.

The church of St. Constantine, initially the Katholikon of a small male monastery until the population exchange of 1922, survives today in a derelict state, enveloped by overgrown vegetation, exposed to the elements and to the whims of treasure-hunters (Figs 2-5). After it was deserted, the church appears to have been used for storage. The edifice's several compartments were separated by rudimentary stone-masonry and timber-framed walls that still stand, obstructing all efforts to study the building's history. Recently a large portion of the west façade collapsed, while other parts of the monument are in a state of imminent collapse as well. Only a few of the architectural members mentioned in Mango's publication⁶ still remain

in the area (see below Fig. 10). No trace of the rest of the monastic buildings can be discerned.

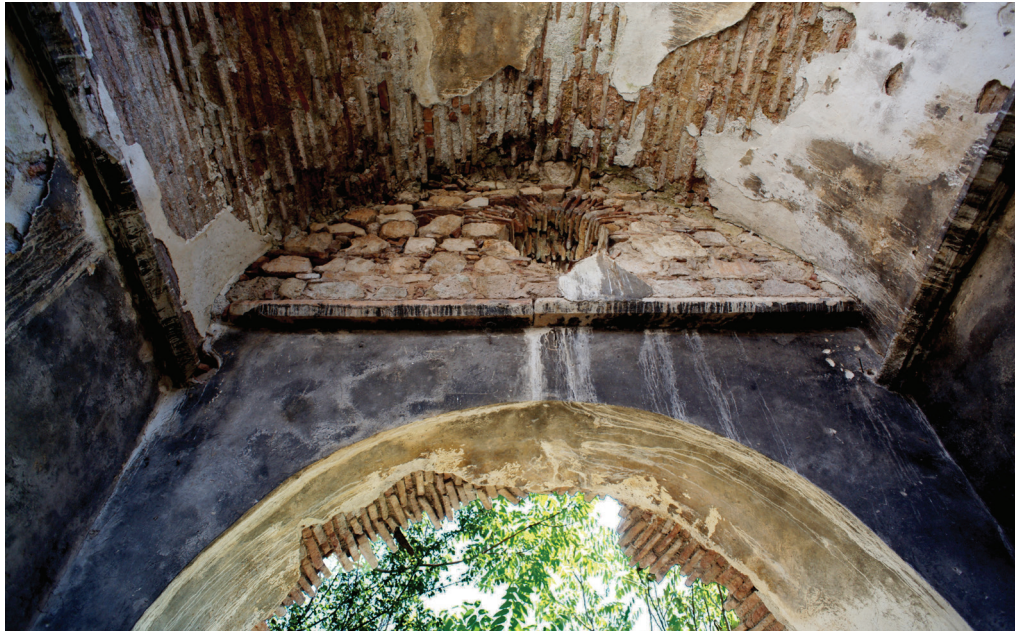
Fig. 12. Apollonia Lake. Monastery of St. Constantine. Katholikon. Interior view of the sanctuary towards the east.

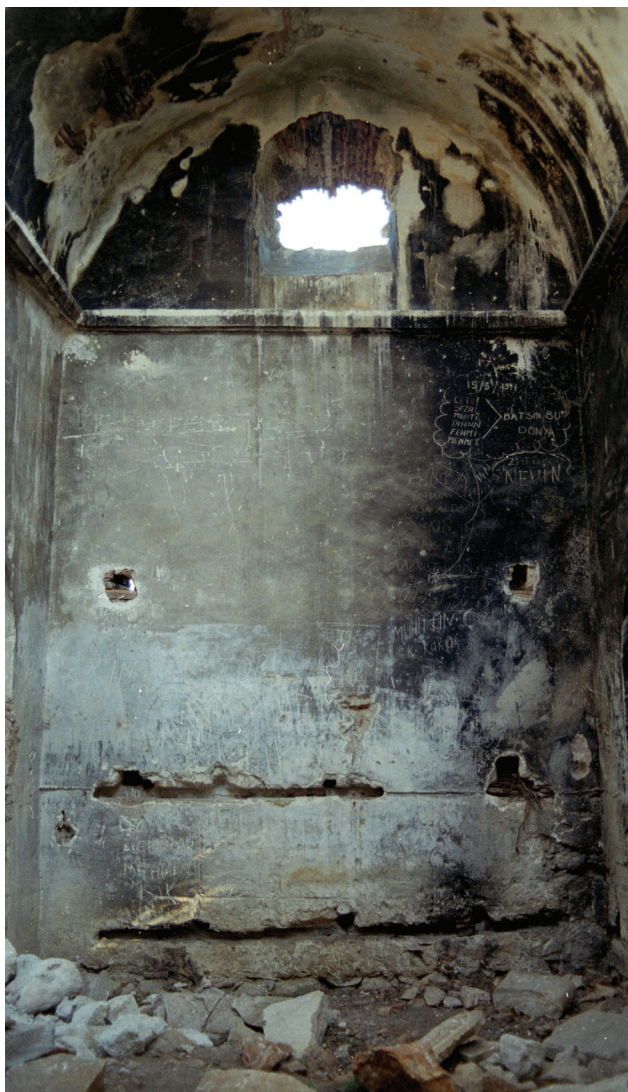
Fig. 13. Apollonia Lake. Monastery of St. Constantine. Katholikon. Interior view towards the south.

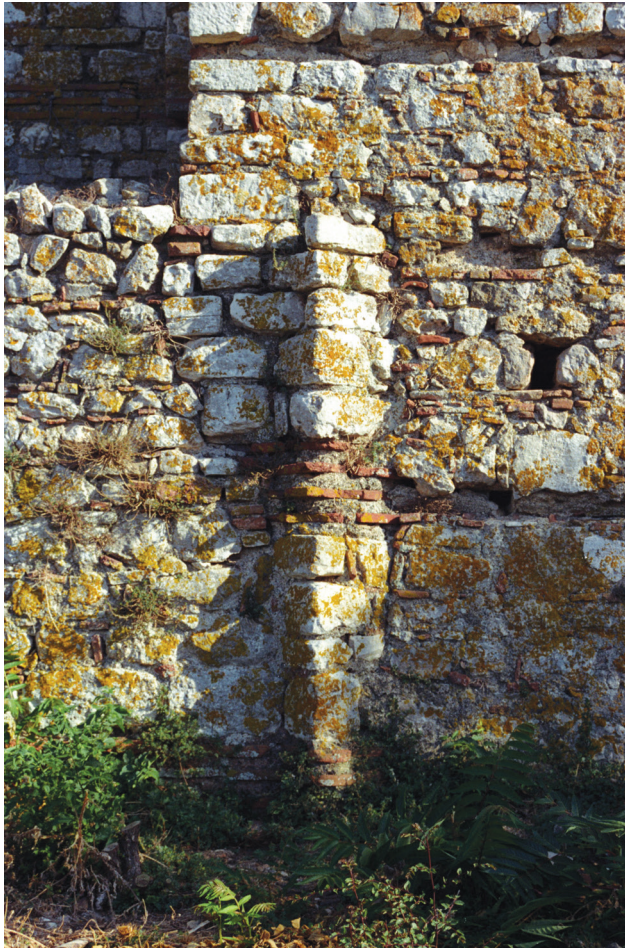
Fig. 15. Apollonia Lake. Monastery of St. Constantine. Katholikon. North elevation detail.

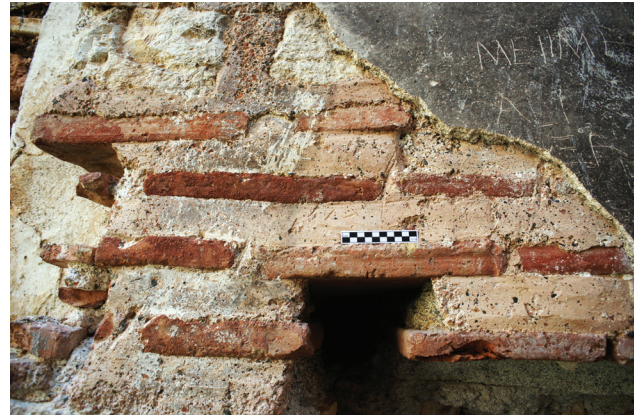
Fig. 16. Apollonia Lake. Monastery of St. Constantine. Katholikon. Masonry detail.
