Δελτίον ΧΑΕ 38 (2017), Περίοδος Δ'

Επανεξέταση του ναού του Αγίου Κωνσταντίνου στη λίμνη της Απολλωνίας στη Βιθυνία

THE CHURCH OF ST. CONSTANTINE ON LAKE APOLLONIA, BITHYNIA, REVISITED

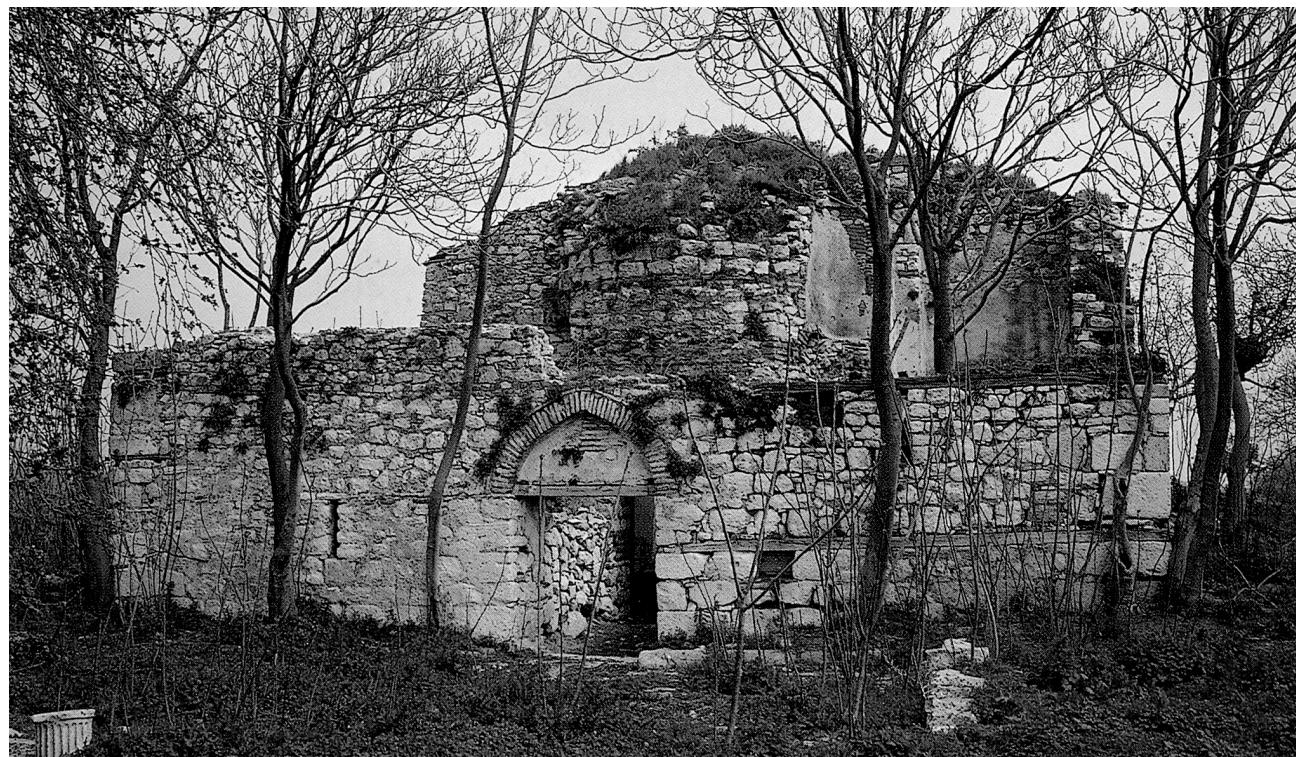
Fig. 2. Apollonia Lake. Monastery of St. Constantine. Katholikon. View from the southwest.

A narthex that as wide as the main church was attached on the west side; a large portion of this narthex had been rebuilt in later years (Figs 1, 2, 11), while its later roofing is completely destroyed. The vaulting of the original narthex must have consisted of a barrel vault placed on the transverse axis of the building. Two small vaulted spaces were formed over the passageways between the narthex and the west corner bays; these spaces were accessible through small arched openings on the semicylindrical wall of the west conch. The exact shape of the roofing over the narthex cannot be safely reconstructed. It may have been a lean-to roof inclined towards the west. The existence of galleries over the narthex, and probably even over the west corner bays cannot be excluded either. In any case, the confirmation or dismissal of this hypothesis will require a more detailed archaeological documentation of the monument.

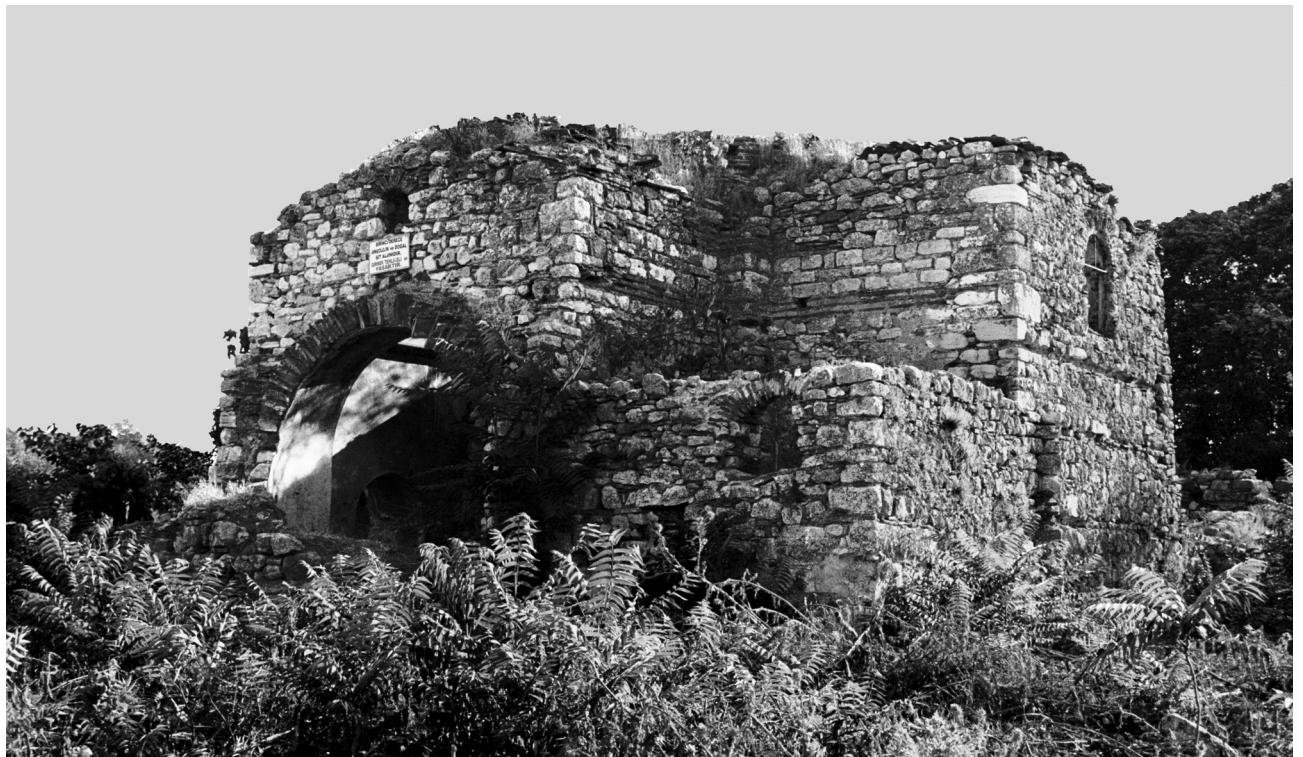
Fig. 4. Apollonia Lake. Monastery of St. Constantine. Katholikon. View from the northeast.

The original walls of the church of St. Constantine were constructed out of alternating bands of stone and brick masonry¹³ (Figs 4, 6, 7, 16). This construction system, also known as “opus mixtum” is the quintessential masonry building system encountered in the architecture of the capital throughout the Byzantine period¹⁴. The ratio of alternate material bands together with the thickness of bricks that does not exceed 4 cm. set the church of St. Constantine apart from early Constantinopolitan examples, such as the land walls of Theodosius, and rather associate it with later monuments in the capital¹⁵, or the areas within its immediate sphere of influence¹⁶. The arches and vaults of the surviving earlier parts of the monument are built entirely of bricks (Figs 8, 17), while bricks have also been used, albeit in a more haphazard manner, in the rebuilt later parts (Figs 7, 8, 12). The original building mortar is an off-white color, with coarse aggregates, while the joints are finished with the application of a thin, pressed, hydraulic jointing mortar which includes a large amount of crushed brick (Figs 16, 17).

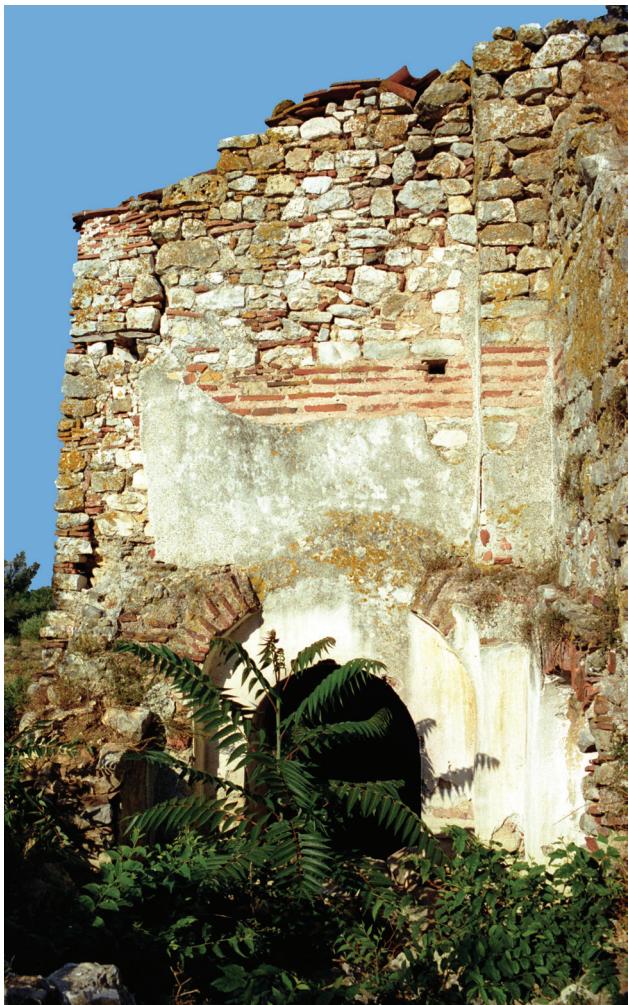
Fig. 6. Apollonia Lake. Monastery of St. Constantine. Katholikon. View of the northwest corner bay from the west.

The corner bays of the church were in the form of contracted cross-shaped rooms covered with calottes. The cross-arms took the form of arches 0.30 m. deep, except for the western cross-arms of the west compartments, which were about 1.80 m. deep (Figs 1, 6, 11).

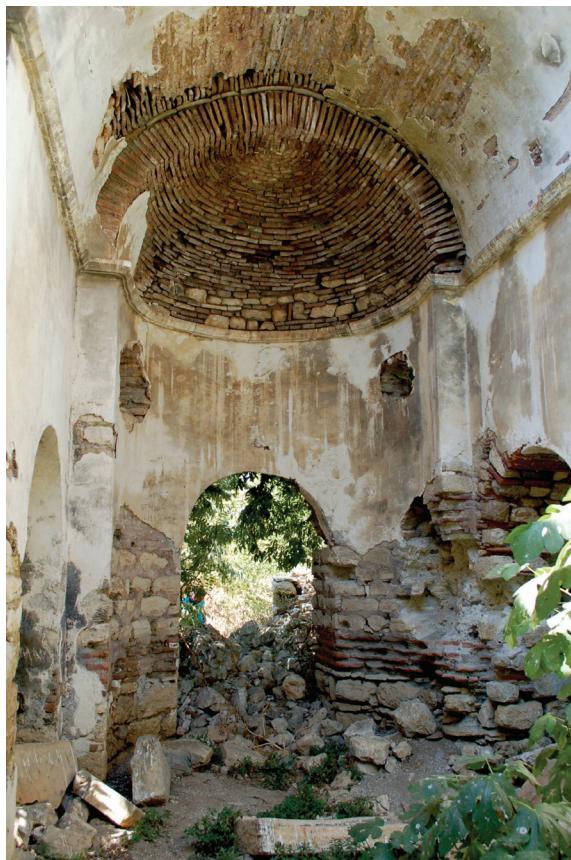
Fig. 7. Apollonia Lake. Monastery of St. Constantine. Katholikon. Interior view towards the west.

original phase. Another apse stood at the western end of the respective cross-arm, which survives almost intact today. Its lower part was inscribed into the western wall of the main church, while the upper part was semicircular on the exterior (Figs 1, 7, 8, 11).

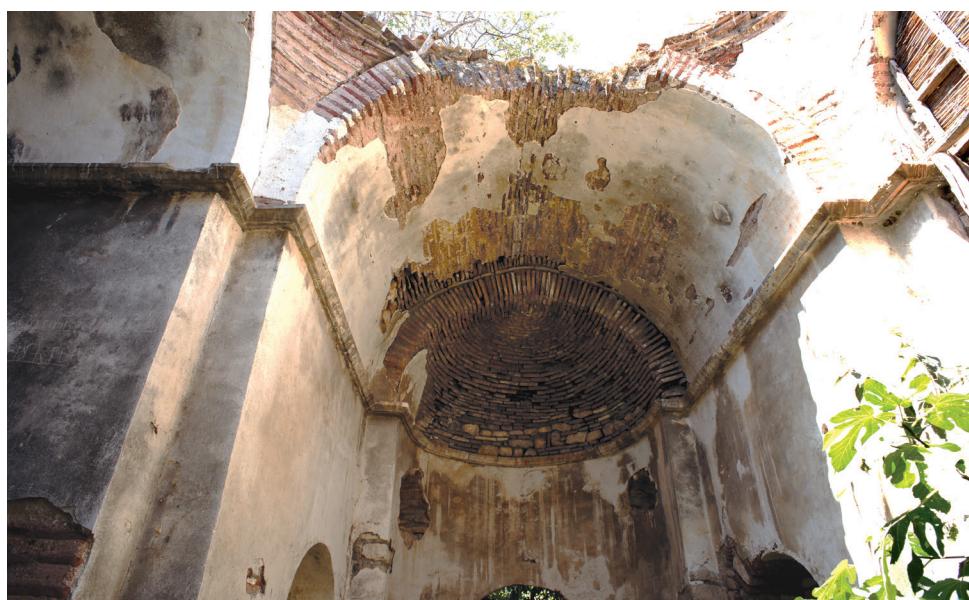
Fig. 8. Apollonia Lake. Monastery of St. Constantine. Katholikon. Interior view towards the west.

The square space underneath the dome was expanded via recesses on its four corners (Figs 1, 8, 9, 11). This practice of widening the central compartment of cruciform type buildings was widespread in the architecture of Late Antiquity, and survived in Byzantine architecture until the 10th and –on rare occasions– the 11th and 12th centuries or even later¹¹.

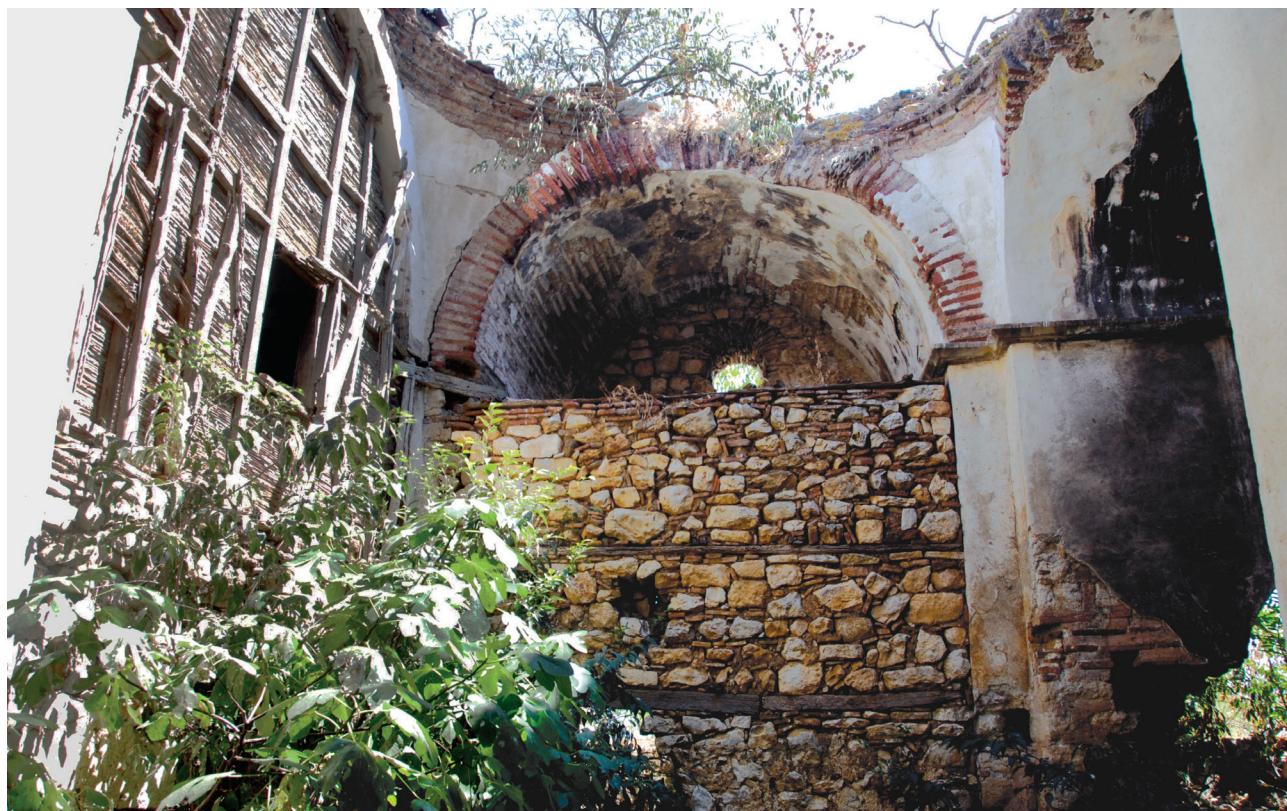
Fig. 9. Apollonia Lake. Monastery of St. Constantine. Katholikon. Interior view towards the east.

Originally, a dome stood on the spot where the two cross-arms intersect; this dome had apparently already collapsed before the church's desertion in 1922 and subsequent ruination. The circular opening that was left behind after the dome's collapse was most probably covered with some wooden structure, no trace of which survives today (Figs 1, 8, 9). The circular base of the dome was outlined with a marble cornice, with a profile in the shape of a shallow concave moulding (cavetto) terminating with a rectangular recess at its lower end. The cornice was identical to the one that run around the cross-arm portion of the building at the level of the vaults' springing (Figs 7-9, 12-14).

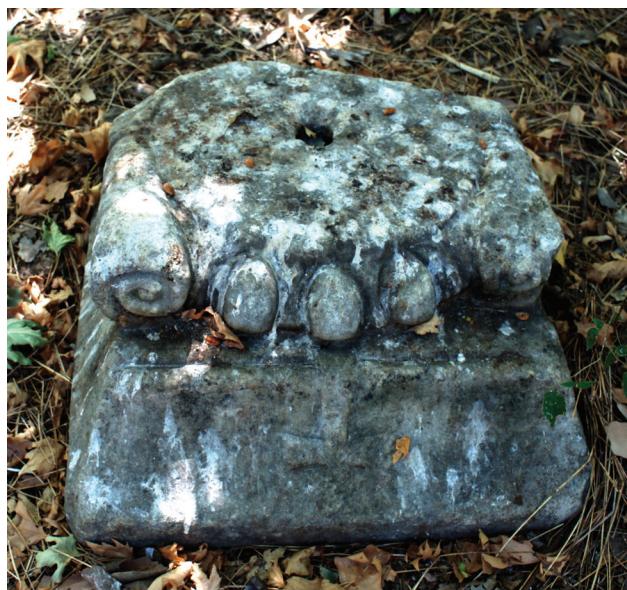
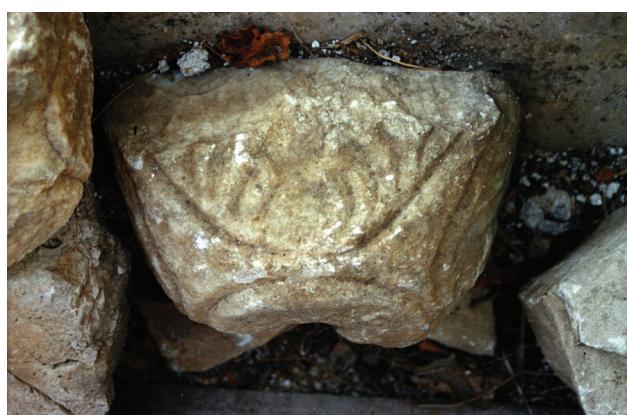
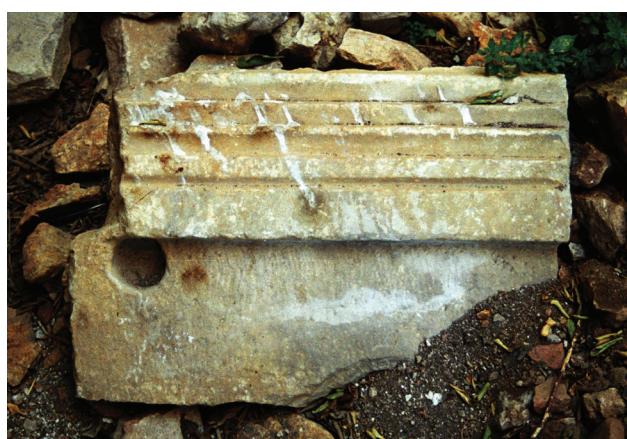
Fig. 10 (a, b, c). Apollonia Lake. Monastery of St. Constantine. Katholikon. Architectural members.

in the area (see below Fig. 10). No trace of the rest of the monastic buildings can be discerned.

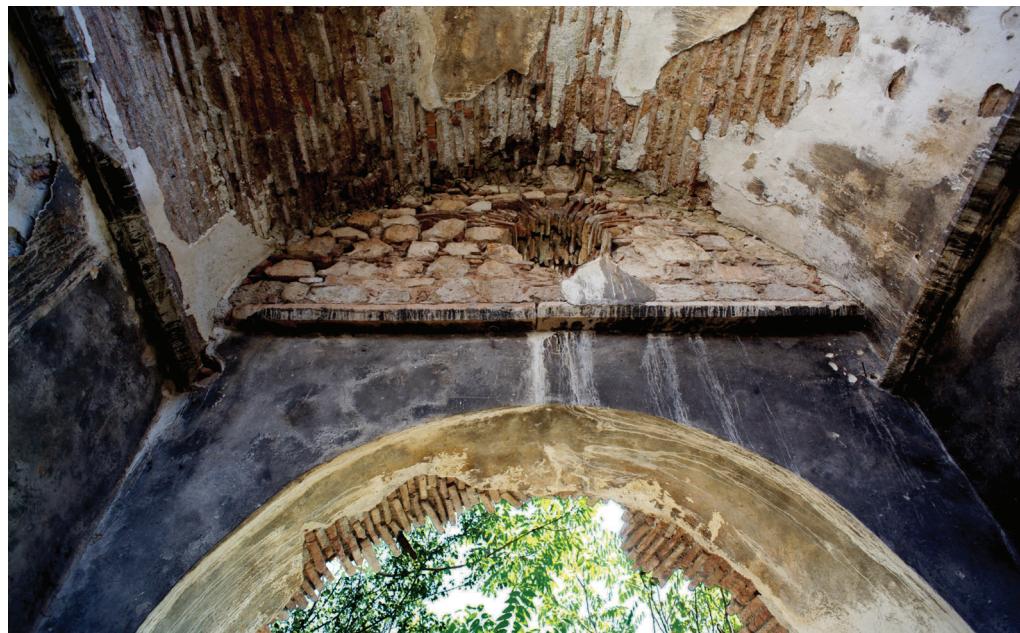
Fig. 12. Apollonia Lake. Monastery of St. Constantine. Katholikon. Interior view of the sanctuary towards the east.

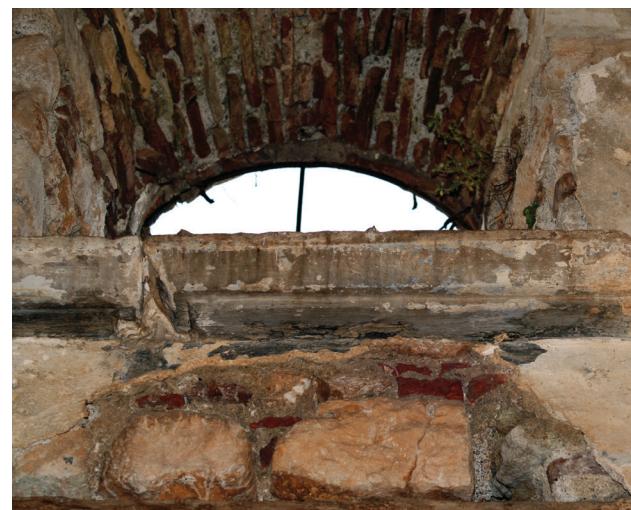
Fig. 14. Apollonia Lake. Monastery of St. Constantine. Katholikon. Cornice detail on the tympanum of the north cross-arm.

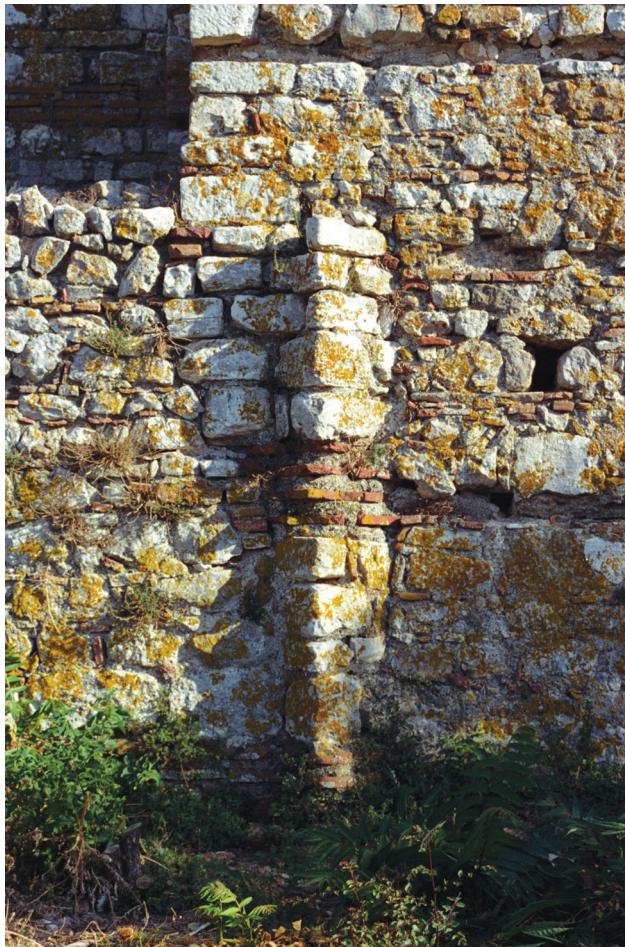
Fig. 15. Apollonia Lake. Monastery of St. Constantine. Katholikon. North elevation detail.

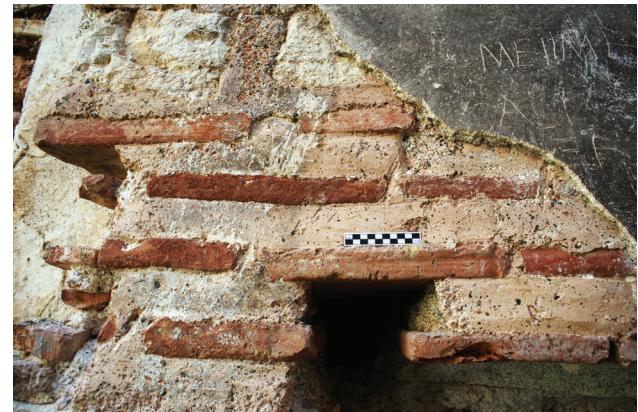
Fig. 16. Apollonia Lake. Monastery of St. Constantine. Katholikon. Masonry detail.

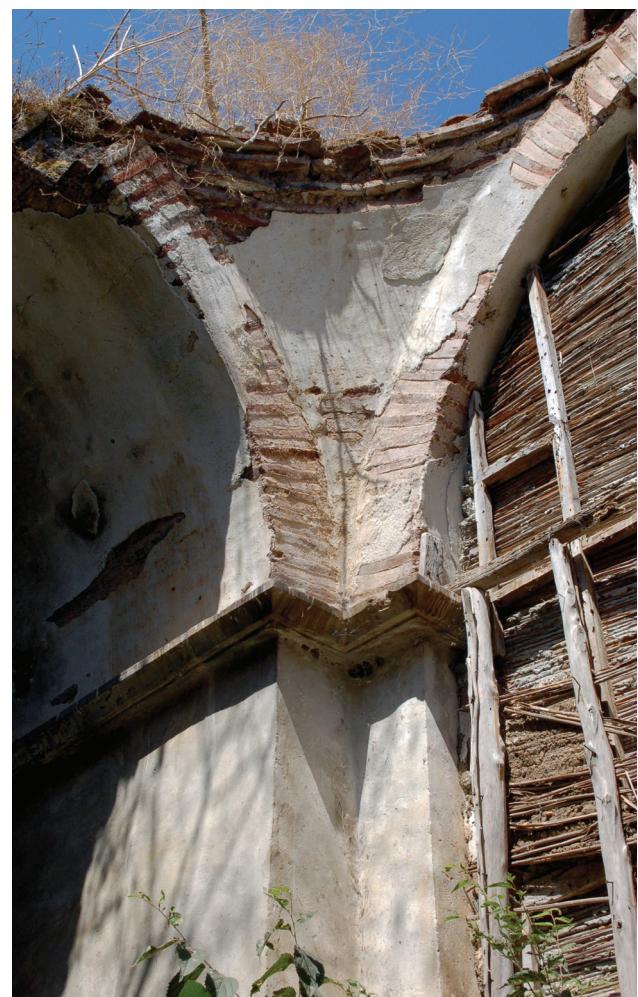
Fig. 17. Apollonia Lake. Monastery of St. Constantine. Katholikon. Interior view towards the northwest.
