COMPARATIVE SURFACE DAMAGE DETERMINATION AT A JEWISH GRAVE USING TWO DIFFERENT MOBILE ULTRASONIC VELOCITY DEVICES

Christaras B.¹, Moropoulou An.², Chatziangelou M.¹, Dimitraki L.¹ and
Devlioti K.¹

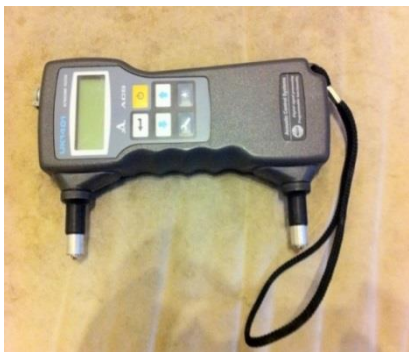
Figure 3 - The SURFER ultrasonic detector.

For evaluating the weathering degree of the monument surfaces were used two ultrasonic devices, the SURFER ultrasonic detector (Figure 3) and the PUNDIT ultrasonic non-destructive digital tester (Figure 4), (Bruneau *et al.*, 1995). The SURFER detector is applicable for measurement of ultrasound velocity and time of longitudinal ultrasound waves propagation in solid materials at surface sounding testing method for estimating the quality of the materials. This estimation is based on the correlation of ultrasound waves velocity in material to its physic and mechanical characteristics and physical statement. The SURFER gives the chance of estimating the depth of the crack (mm) on the surface by calculating the time of ultrasonic waves propagation. This device maintains a stable distance between the two ultrasonic probes (15cm) which gives the ability of mapping and allocating the weathering of specific surfaces.

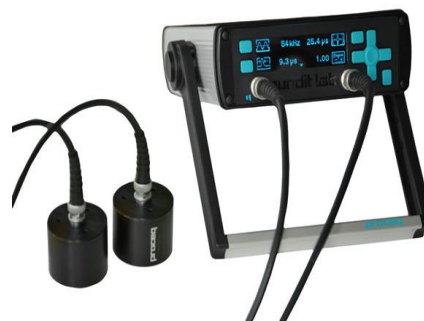
Figure 4 - The PUNDIT ultrasonic device.

On the other hand, the PUNDIT ultrasonic non-destructive digital tester is a good index characteristic for determining the physic-mechanical behavior and evaluating the weathering degree

of the rocks. For the measurements a pair of small edge transducers was used for estimating the P-wave velocity for the determination of the depth. The tests held out by using the indirect method referring to arrangement of the transducers (transmitter and receiver) on the same surface of the stone. The transmitter was stable along a calibrated line and the receiver was reinstalling at every 5cm. The final result was the travel time in correlation with the distance in each place. Each pair (travel time-distance) is displayed on a diagram. Given the fact, that the most weathered surface demands longer travel time propagation, the change of slope in the plot indicates the quality of the material.

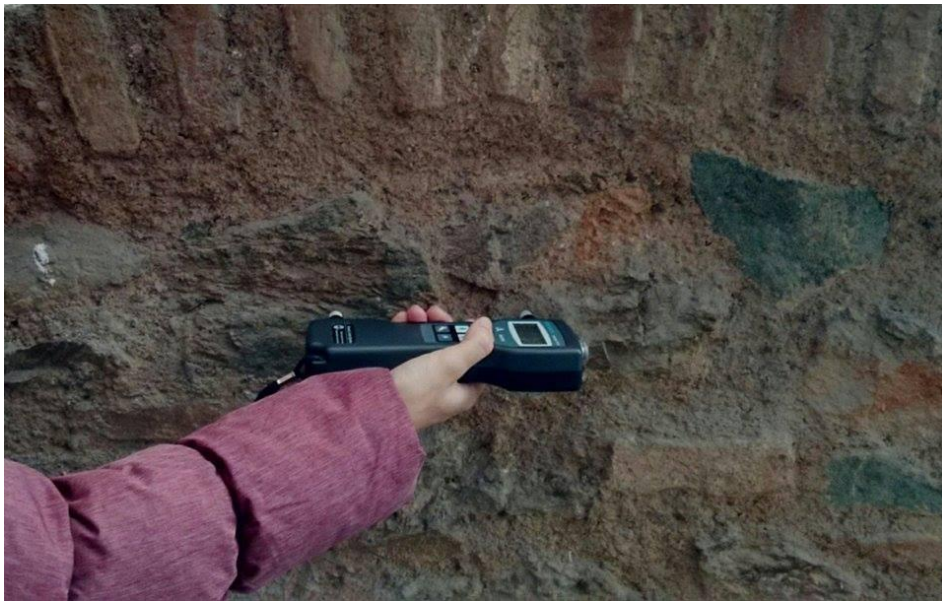
Figure 5 - The use of SURFER device on the monument.

First of all, the SURFER device was used for mapping 4 specific surfaces of the monument (the back surface, the convex one upon the back surface, the dome and the entrance of the tomb), by taking a big amount of measurements, approximately 459, (Figure 5).

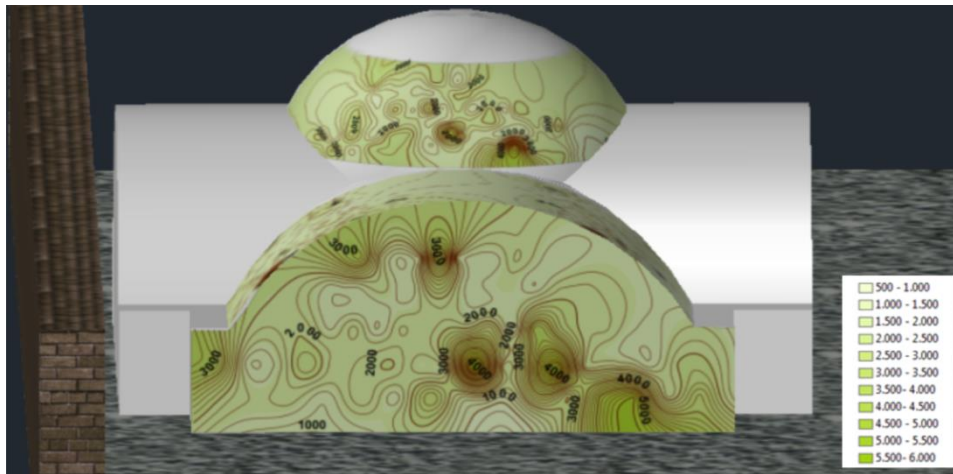
The application of this method was implemented for the allocation of the weathering along these surfaces, by the construction of 4 maps. Each map depicts the ultrasonic velocities Vp (m/sec) and the way they are distributed depending on the weathering conditions of each surface. The most weathered parts take lower values (longer travel time propagation), so in Figure 6 (back surface), it is obvious that the biggest part (in the right part and left half part of the tomb) is displayed with the lightest colors, assigning the most weathered areas, with Vp= 1200-2000 m/sec in the first most weathered part and Vp= 800-2000 m/sec in the second most weathered part of the back surface.

Figure 6 - The back surface of the monument (the maps were made with ARC GIS 2010, on the model by the use of the AutoCAD 2012). The legend shows the ultrasound velocities V_p (m/sec).

According to the Equation 1 was estimated the depth of each weathered zone of the surfaces of the monument. In detail, the back surface was devised in two areas: in the first area the depth was calculated in $D=66$ mm, while in the second one was $D=92.4$ mm. At the same way, the depth of the weathering at the convex part upon the back surface is about $D=83$ mm and at the dome as it is shown in the following plot Figure 11, the travel time of P- waves is constant in depth higher than $D= 35$ mm. Furthermore, the entrance of the tomb consists of the right side with weathering depth $D=79$ mm and the left one with the same weathering depth.

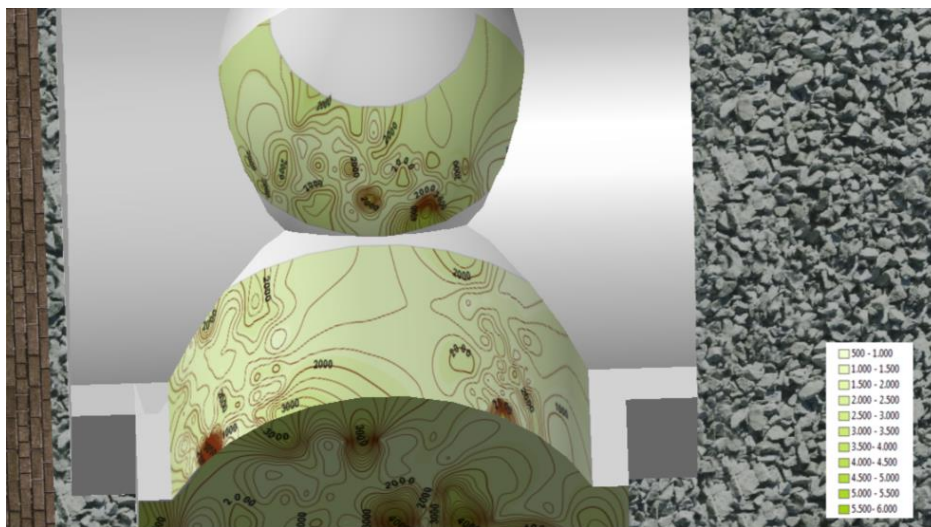
At the same way, along the convex part, upon the back surface appears clearly the weathered part, the values of which range in lower levels than those in the back surface, with $V_p=500-2000$ m/sec (Figure 7).

Figure 7 - The convex part upon the back surface, (the maps were made with ARC GIS 2010 on the model, by the use of the AutoCAD 2012). The legend shows the ultrasound velocities V_p (m/sec).

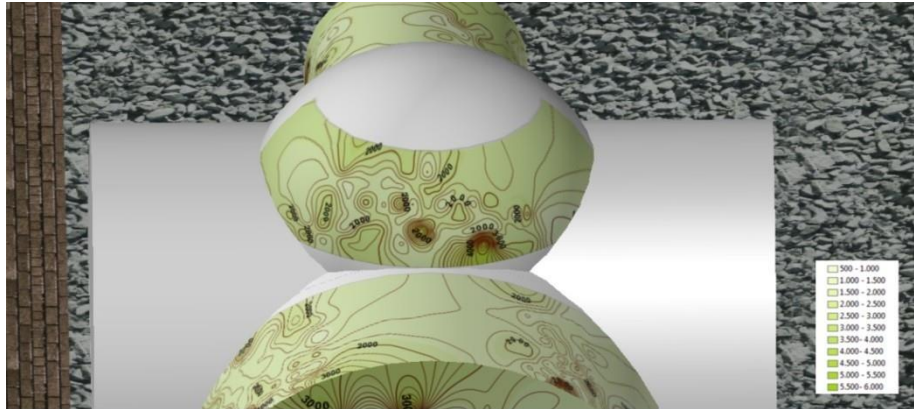
In Figure 8, the dome of the monument appears to have a wide weathered area which ranges between 1000- 2000 m/sec.

Figure 8 - The dome of the monument, (the maps were made with ARC GIS 2010 on the model, by the use of the AutoCAD 2012). The legend shows the ultrasound velocities V_p (m/sec).

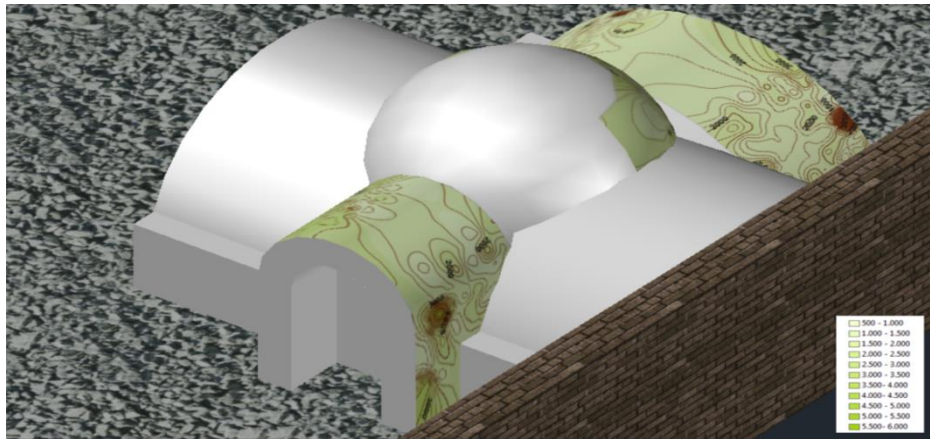
Finally, at the entrance of the tomb, there are distinguished 2 weathered areas that appear to have the same values both in the right and in the left semicircular part. The values of the velocity range at a width of 1800-2000 m/sec, (Figure 9 and 10).

Figure 9 - The right part of the entrance, (the maps were made with ARC GIS 2010 on the model, by the use of the AutoCAD 2012). The legend shows the ultrasound velocities V_p (m/sec).

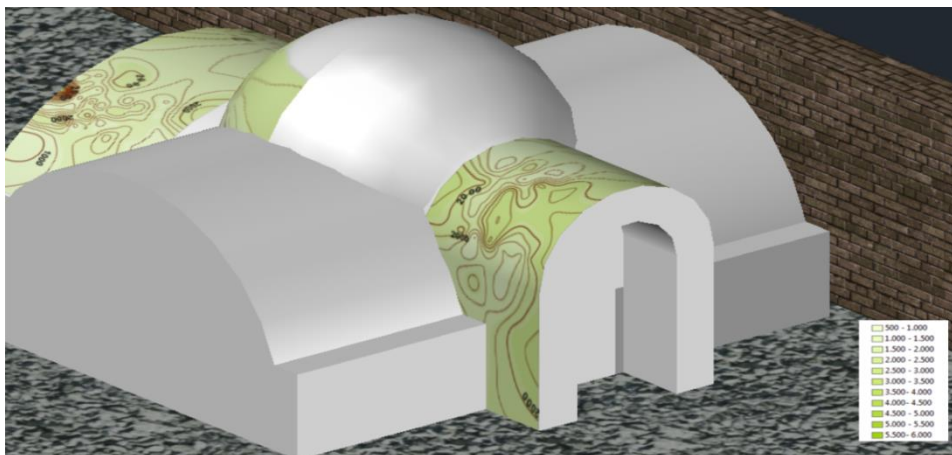
Figure 10- The left part of the entrance, (the maps were made with ARC GIS 2010 on the model, by the use of the AutoCAD 2012). The legend shows the ultrasound velocities V_p (m/sec).

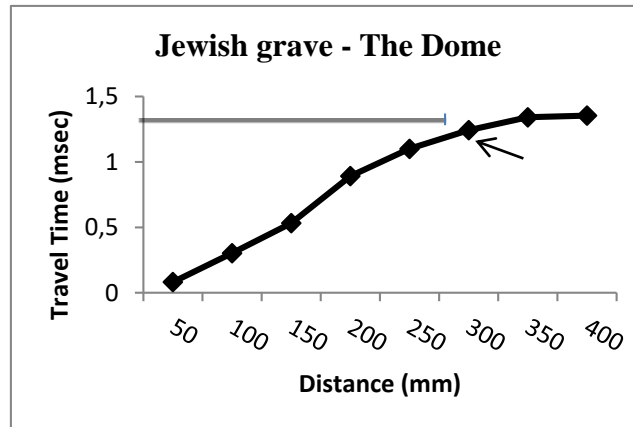
Except for the SURFER device, PUNDIT Ultrasonic non-destructive digital tester also was used for determining the physic and mechanical characteristics and evaluating the weathering depth. For the purposes of the measurements, the indirect method was used. The final result was the travel time in correlation with the distance in each place. As it is known in Figure 11, the most weathered surface needs longer travel time propagation, so the change of slope in the plot indicates the quality of the material.

Figure 11 - Estimation of the weathering depth on the surface of the dome in the Jewish grave.

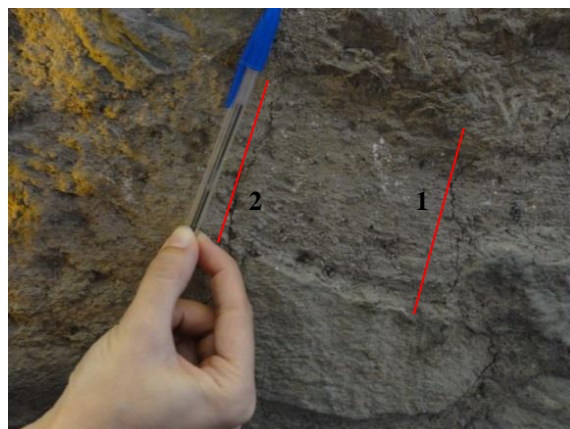
As it was mentioned before, the SURFER device gives the opportunity of determining the depth of the cracks of the surfaces. On the back surface of the monument are distinguished two cracks Figure 12, the depths of which were measured as follows: for the first crack the depth is $D=88$ mm, while for the second one is $D=45$ mm.

Figure 12 - The two cracks on the back surface.

First of all, held out the mapping of specific surfaces on the monument by allocating the ultrasonic velocities (V_p m/sec), using the SURFER device detector. It is observed a wide range of values of the velocities between 500 and 6000 m/sec depending on the case. On the other hand, the depth of the weathered zones of the tomb, were estimated by using the PUNDIT ultrasonic non-destructive digital tester. The weathering depth has a minimum value, $D=35$ mm and a maximum one, $D=92,4$ mm with corresponding minimum velocities 800-1000 m/sec. Finally, two cracks were located and measured on the back surface of the monument, with the SURFER device and the depth of which was determined in $D=88$ mm and $D=45$ mm.
