COMPARATIVE SURFACE DAMAGE DETERMINATION AT A JEWISH GRAVE USING TWO DIFFERENT MOBILE ULTRASONIC VELOCITY DEVICES

Christaras B.¹, Moropoulou An.², Chatziangelou M.¹, Dimitraki L.¹ and
Devlioti K.¹

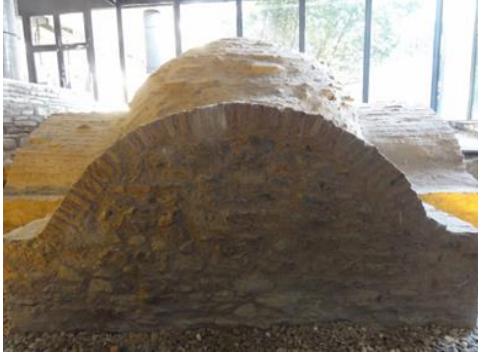
Figure 1 - A general option of the monument.

This tomb dates in the first quarter of 4th century and belongs to a member of Israelite community in Thessaloniki and was founded in university campus between the central administration building and the building of Law and Economic Sciences. It is about a well-preserved historical monument with favorable position for taking the ultrasonic measurements (Marki, 2001).

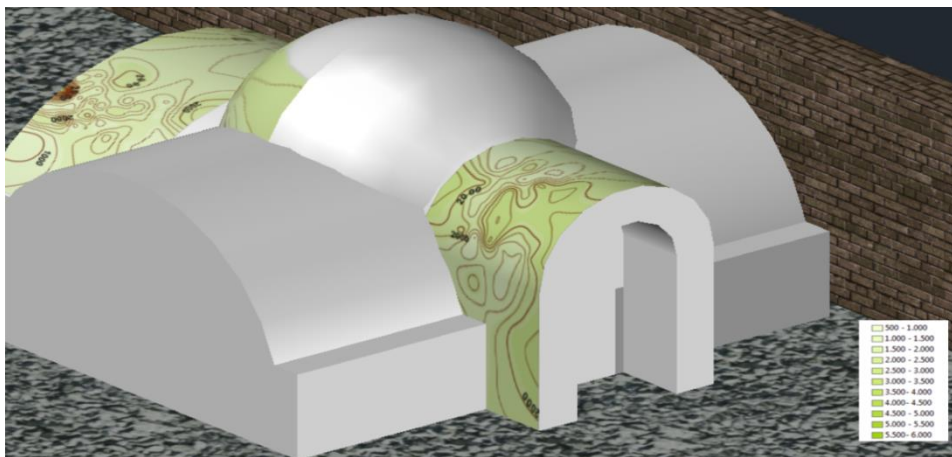
Finally, at the entrance of the tomb, there are distinguished 2 weathered areas that appear to have the same values both in the right and in the left semicircular part. The values of the velocity range at a width of 1800-2000 m/sec, (Figure 9 and 10).

Figure 9 - The right part of the entrance, (the maps were made with ARC GIS 2010 on the model, by the use of the AutoCAD 2012). The legend shows the ultrasound velocities V_p (m/sec).

Figure 10- The left part of the entrance, (the maps were made with ARC GIS 2010 on the model, by the use of the AutoCAD 2012). The legend shows the ultrasound velocities V_p (m/sec).

According to the Equation 1 was estimated the depth of each weathered zone of the surfaces of the monument. In detail, the back surface was devised in two areas: in the first area the depth was calculated in $D=66$ mm, while in the second one was $D=92.4$ mm. At the same way, the depth of the weathering at the convex part upon the back surface is about $D=83$ mm and at the dome as it is shown in the following plot Figure 11, the travel time of P- waves is constant in depth higher than $D= 35$ mm. Furthermore, the entrance of the tomb consists of the right side with weathering depth $D=79$ mm and the left one with the same weathering depth.
