Damage and economic impact of wood-borers (Bivalvia, Teredinidae) on artisanal fishing in Morocco: a case study

Damage and economic impact of wood-borers (*Bivalvia*, *Teredinidae*) on artisanal fishing in Morocco: a case study

This study presents the first comprehensive assessment of the economic impact of wood-boring bivalves from the family *Teredinidae* on artisanal fishing in Tangier, Morocco, following the establishment of a new fishing port that has seen a marked increase in infestations since its opening in 2018. We conducted a questionnaire survey with over 40 artisanal shipowners to evaluate the extent of damage and repair costs associated with teredinids. The results indicated that 77.5% of the fleet was affected, with a significant proportion reporting moderate damage. Analysis of wood samples revealed two dominant teredinid species: *Lyrodus* cf. *pedicellatus*, and *Teredo bartschi*, both recorded for the first time in Morocco, marking them as alien invasive species in the region. The vulnerability of wooden boats, particularly those constructed from softwoods (e.g., *Picea* sp. and *Pinus* sp.), was evident, while polyester boats remained unaffected. Annual repair

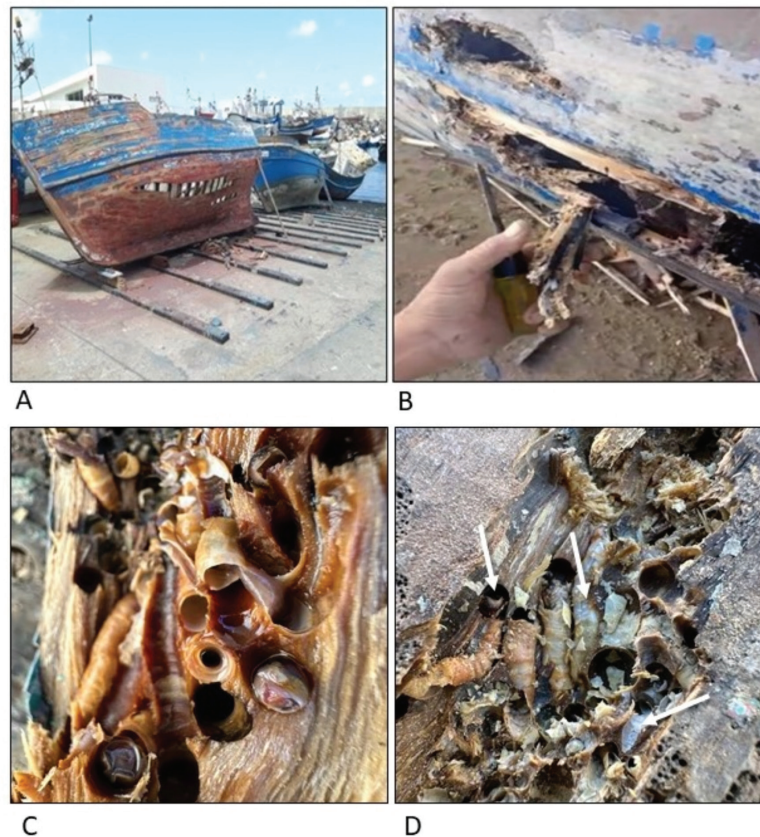
A large majority (74%) of shipowners reported that shipworm damage reappeared within six months of each repair, with only polyester boats remaining untouched. Wooden boats, especially those made of *Picea* sp. (white wood) and *Pinus* sp. (red wood), were particularly vulnerable to extensive damage to their submerged areas (Fig. 2A and B), evidenced by numerous calcareous-lined tunnels typical of shipworms (Fig. 2C and D).

Fig. 2: Teredinid damage to artisanal fishing boats; a- Damaged boats queueing at the shipyard, 2023; b- The magnitude of damage observed on boat hulls; c- Teredinids in a damaged wooden piece from a boat in the new fishing port of Tangier, 2023. d- Shipworm tunnels in the wooden hull of a boat showing the typical calcareous lining (arrows).

including the replacement of significant sections of the boat hull, which can be particularly expensive. Overall, there was no significant difference between the two years, only a slightly higher percentage of repairs in 2023 (17% more than the average in 2022).

The average annual repair costs per boat were estimated at MAD 10,000 per boat (US\$ 1,000). While expenses include also the cost of raising and lowering the boat into the sea with a crane, as well as the cost of mooring it at the ‘Baradero’ (Fig. 2A), this figure varies significantly depending on the severity of the damage. For boats requiring multiple repairs per year, or extensive work involving the replacement of major structural elements such as the keel (Fig. 2B), the costs could exceed MAD 20,000 (US\$ 2,000). Furthermore, the operational disruptions caused by repairs – ranging from one week to a month – also add indirect costs through lost fishing time and income.
