Vol 26, No 1 (2025)

Damage and economic impact of wood-borers (Bivalvia, Teredinidae) on artisanal fishing in Morocco: a case study

JAZILA EL JAMAAI, AHMED TAHERI, BILAL EL AJJOURI, MOHAMMED SAID ADLAN MERINI, LUÍSA M. S. BORGES

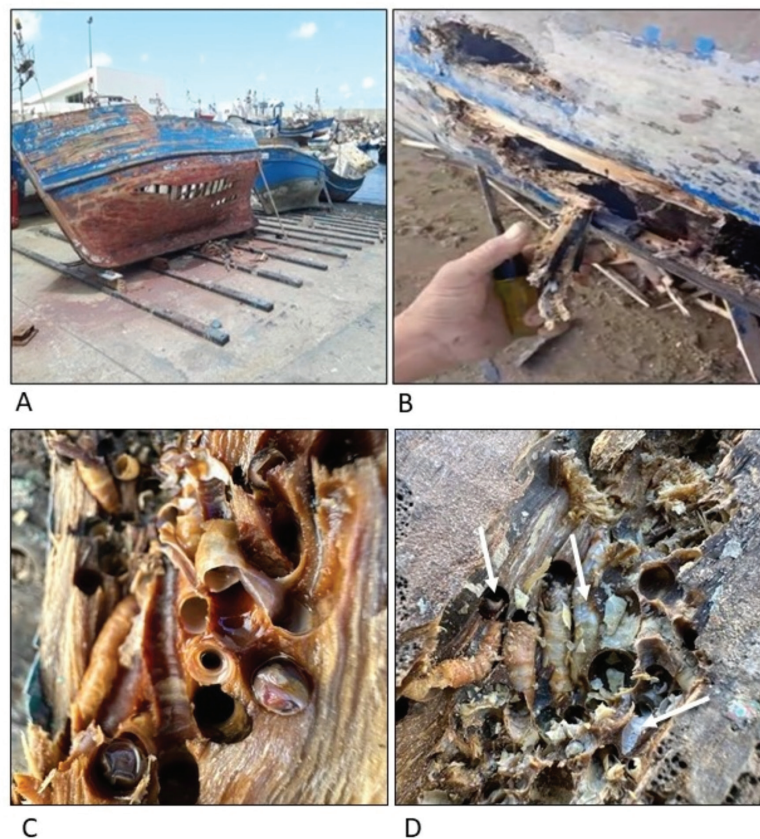
Fig. 2: Teredinid damage to artisanal fishing boats; a- Damaged boats queuing at the shipyard, 2023; b- The magnitude of damage observed on boat hulls; c- Teredinids in a damaged wooden piece from a boat in the new fishing port of Tangier, 2023. d- Shipworm tunnels in the wooden hull of a boat showing the typical calcareous lining (arrows).

A large majority (74%) of shipowners reported that shipworm damage reappeared within six months of each repair, with only polyester boats remaining untouched. Wooden boats, especially those made of *Picea* sp. (white wood) and *Pinus* sp. (red wood), were particularly vulnerable to extensive damage to their submerged areas (Fig. 2A and B), evidenced by numerous calcareous-lined tunnels typical of shipworms (Fig. 2C and D).

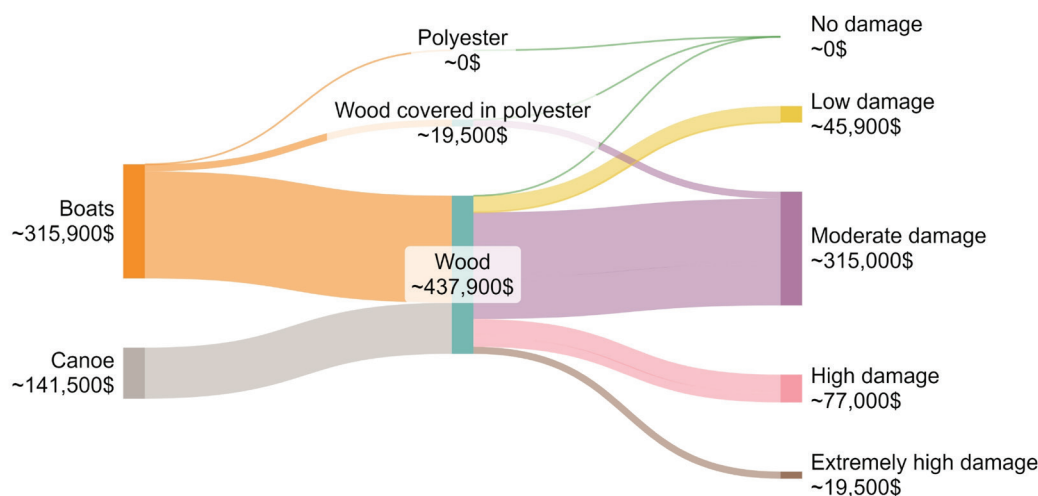
Fig. 5: Distribution of estimated annual costs caused by shipworms to the artisanal fishing sector at the new fishing port of Tangier (in MAD) by type of boat, hull material and average damage.

The severity of damage was closely linked to the type of hull material used. Polyester boats showed no damage, while wooden boats and those with mixed materials (wood covered in polyester) displayed varying degrees of infestation. Boats constructed with “white” wood (e.g., *Picea* sp.) and “red” wood (e.g., *Pinus* sp.) suffered the most extensive damage. Mixed hull materials (wood and polyester) did show some moderate damage, indicating that while the polyester layer offers some protection, it is not entirely effective in preventing shipworm infestation (Fig. 5).
