Vol 1, No 3 (2023)

**Protection and enhancement of the historical and architectural heritage in times of peace on apparently distant war wounds. Some cases in Cagliari (Italy) between restorations, current problems and future prospects**

*Maria Dessi, Emanuela Fara, Piervanna Piredda*

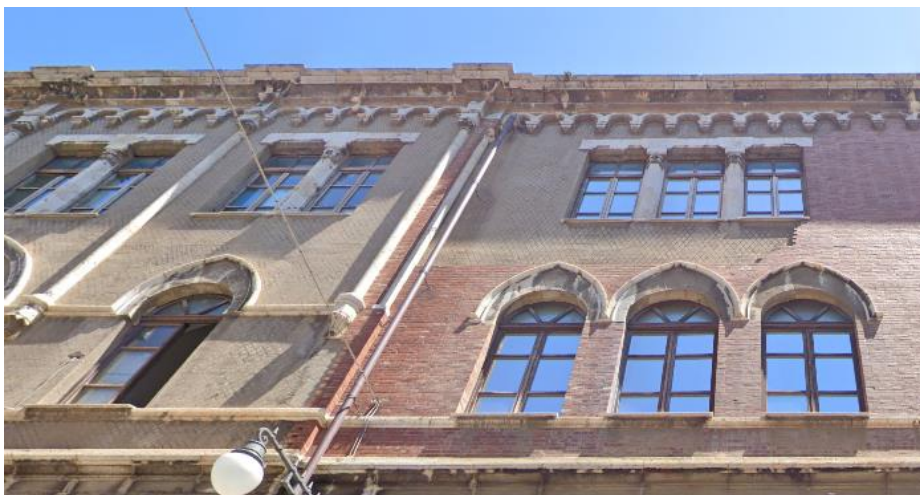
**Fig. 3.** Scuola Satta [[www.sardegnaeoportale.it](http://www.sardegnaeoportale.it)]

Only in a few cases we can see an interesting attention for restoration: for example the intervention on "Palazzo Vivanet" and the "Scuola Satta", on the facades of these buildings the reconstruction of damaged parts using different materials is clearly visible, in full compliance with the criterion of recognizability of the intervention.

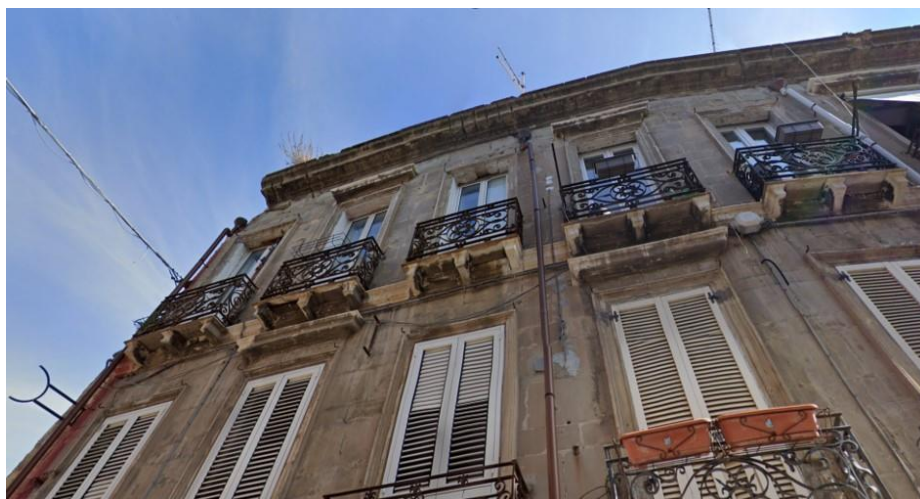
**Fig. 6.** A building in front of empty urban

The result is the presence of an urban emptiness, a vulnerability for other buildings, which has not found a total resolution with the adopted measures: it is observed in fact that the buttress appears here not to be sufficient to ensure the balance to the architectural building that was not thought to constitute the head of the block. Obviously, there is a correlation between the fissuring framework that is present today and the damage caused by the bombings occurred 80 years ago: we can call this the “indirect damage”. The buttress in the facade in front of the urban void has a lower height than the building itself, and this generates a particular criticality on the upper floor, where clearly there is a disconnection of the joints with hinge on the interfloor. It is not a coincidence that the lintel of the upper door, close to the cantonal, is propped up while, with further distance from the cantonal, the instability appears to be less and less worrying. (fig. 6)

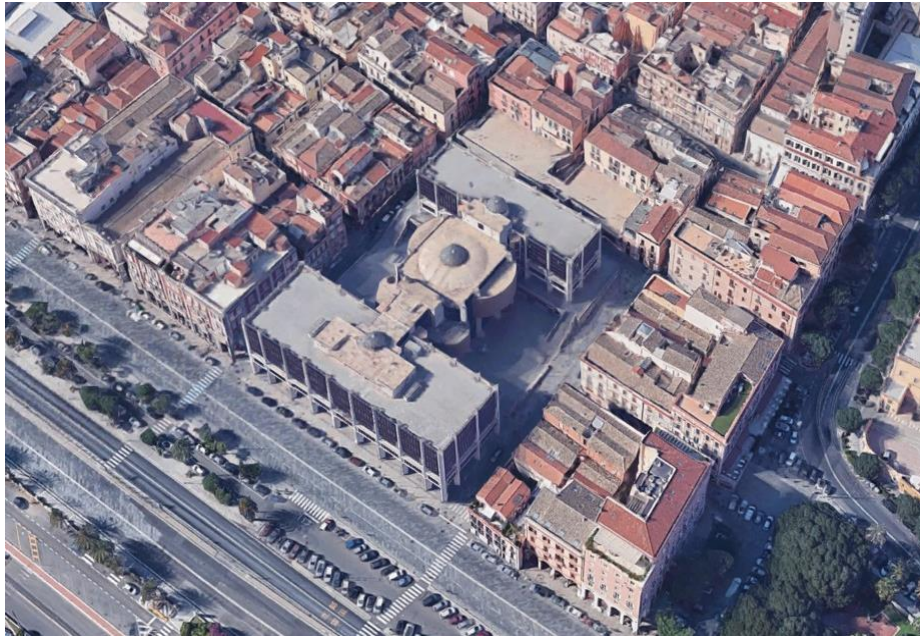
**Fig. 7.** Palazzo della Regione ([www.sardegnaeoportale.it](http://www.sardegnaeoportale.it))

damaged ones are sacrificed: this is, for example, the case of the “Regional Palace” (“Palazzo della Regione”), built in this area because was partly affected by urban voids caused by the bombs (Fig.5, n.6 and Fig. 7). In 1963 the process for the rebuilding began, and its first solution was rejected by the municipality due to the limitation the view of the Castle, until the end of the 1988, when the present building was inaugurated. The block behind, also affected by damage classified partially as high and medium, will give space to a volume which, once again, hosts parking spaces.

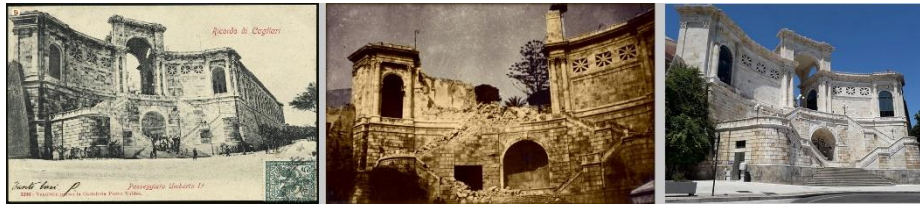
**Fig. 9.** Bastioni San Remy: before 1943, after damage, today (1th photo by <https://www.sardegнадigitallibrary.it/> and 2th by <http://www.sardegناسotterranea.org/>)

The case of Bastioni San Remy (fig.9) is emblematic, considering the monumentality of this architecture. The structure, built between 1896 and 1902, was classified as highly damaged by war bombing. Observing the historical images, the main elevation on Viale Regina Margherita was affected by a partial collapse: we can see the total loss of the central arch and part of the stairs on its right side. After the inevitable debate on the method of reconstruction, the gap was compensated, and without any distinction, the missing part was rebuilt in the years 1946-1948.
