### Restoration and highlight of Agioi Theodoroi church in Nafplio with the use of CAD technologies

# Restoration and highlight of Agioi Theodoroi church in Nafplio with the use of CAD technologies

**Abstract.** The church of Agioi Theodoroi is located north of the new city of Nafplion in Greece. It is not proclaimed monument, but it constitutes important historical evidence of recent history of the city and of Greece in general, given that it is documented to be associated with one of the protagonists of the Revolution of 1821 Theodoros Kolokotronis and therefore it is inextricably linked to the collective historical memory.

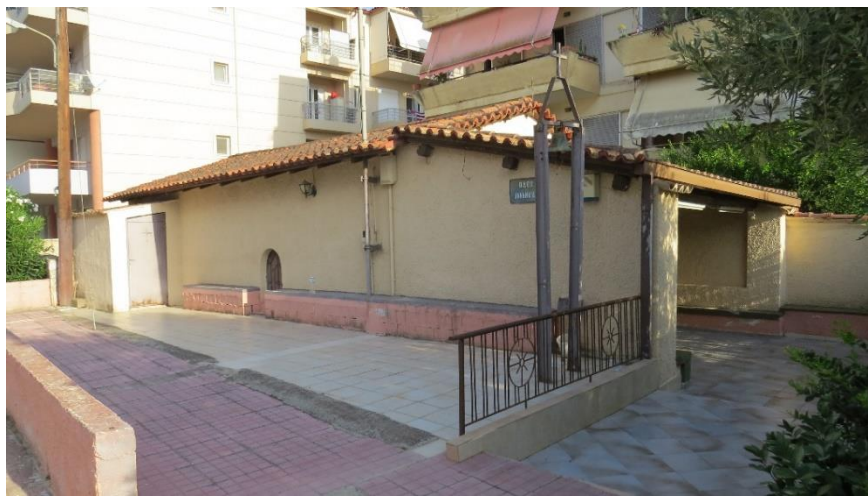
**Fig. 1.** North–West view of the church before the building works. (7/9/2021)

identified as a problem. Also, the newer coatings had altered the image of the monument and its historical and artistic value was not highlighted. Finally, it was found that there was a lack of design in the surrounding area and no information signs that would allow the visitor to understand the historical value of the church (see Fig.1).

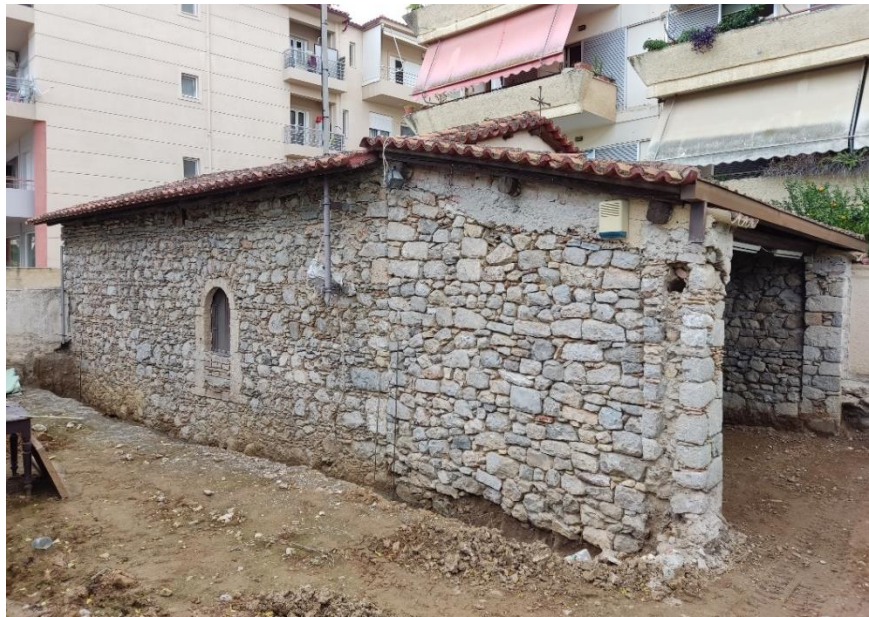
**Fig. 2.** North–West view of the church. Removal of plaster on the exterior masonry. Excavation of the northern part of the surrounding area. (24/9/2022)

To date, the removal of plaster on the exterior masonry, the test cuts on the interior masonry, the excavation of the northern part of the surrounding area, the removal of interior floors and the detachment of the newest part of the iconostasis have been carried out (see Fig.2, Fig.3, Fig.4, Fig.5)

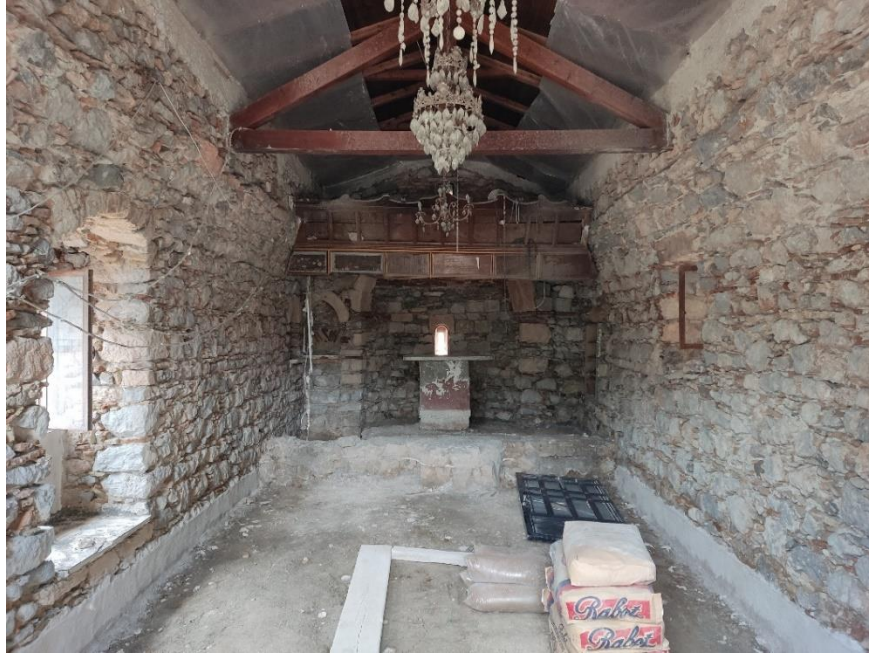
**Fig. 5.** Interior. Removal of plaster on the interior masonry. (23/6/2023)

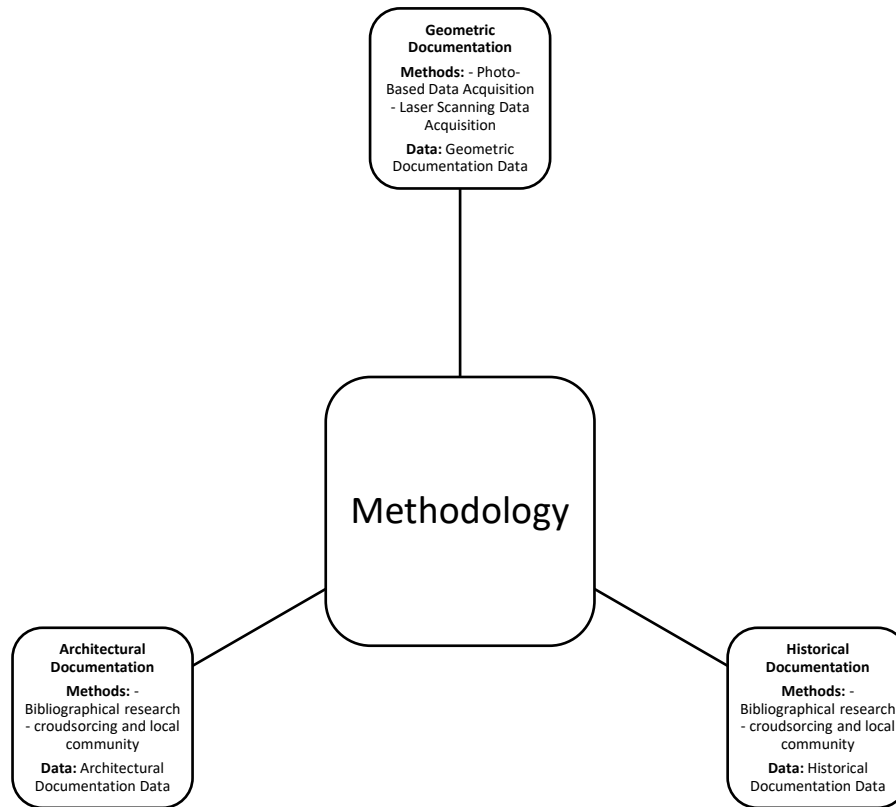
Fig. 7. Diagram of the process

In order to make use of all the data and information obtained from the above actions, the methodology shown in the following diagram was followed (see Fig.7). This includes Geometric, Architectural and Historical Documentation. To date, the first three steps have been largely completed.

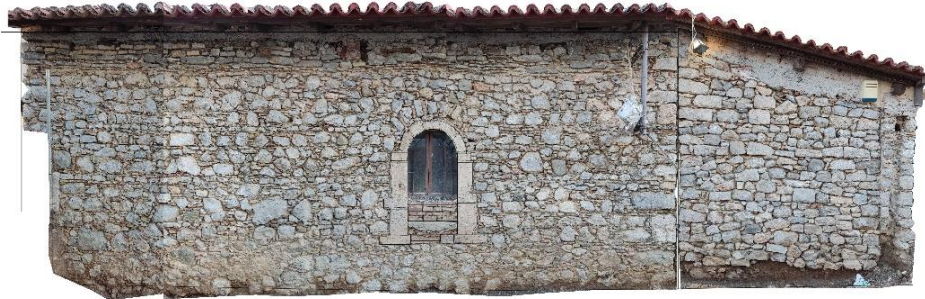
**Fig. 11.** Orthoimage of the north façade.

The next step was to process the sketches and photographs of each facade and convert them into drawings using CAD technologies. Initially, each façade was worked out as a different project using masks of edited images. After processing the data for all facades, a 3D model of the Catholic Church was constructed. Selected images were used to process the orthoimages of each facade to ensure quality texture. To advance the interdisciplinary process, four orthoimages were created, one for each facade of the church. These orthoimages served as blueprints for further processing of thematic maps incorporating not only qualitative information but also quantitative data. (See Fig.11, Fig.12)

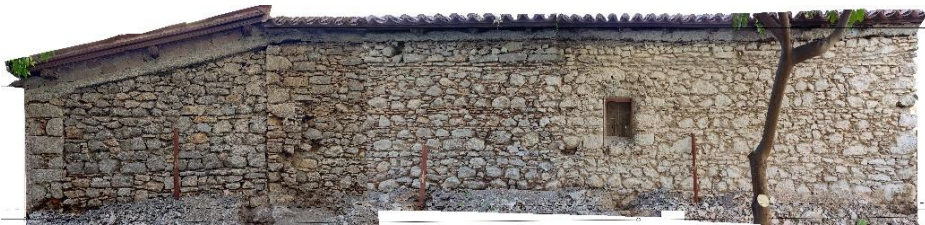
**Fig. 12.** Orthoimage of the south façade.
