### Restoration and highlight of Agioi Theodoroi church in Nafplio with the use of CAD technologies

# Restoration and highlight of Agioi Theodoroi church in Nafplio with the use of CAD technologies

**Abstract.** The church of Agioi Theodoroi is located north of the new city of Nafplion in Greece. It is not proclaimed monument, but it constitutes important historical evidence of recent history of the city and of Greece in general, given that it is documented to be associated with one of the protagonists of the Revolution of 1821 Theodoros Kolokotronis and therefore it is inextricably linked to the collective historical memory.

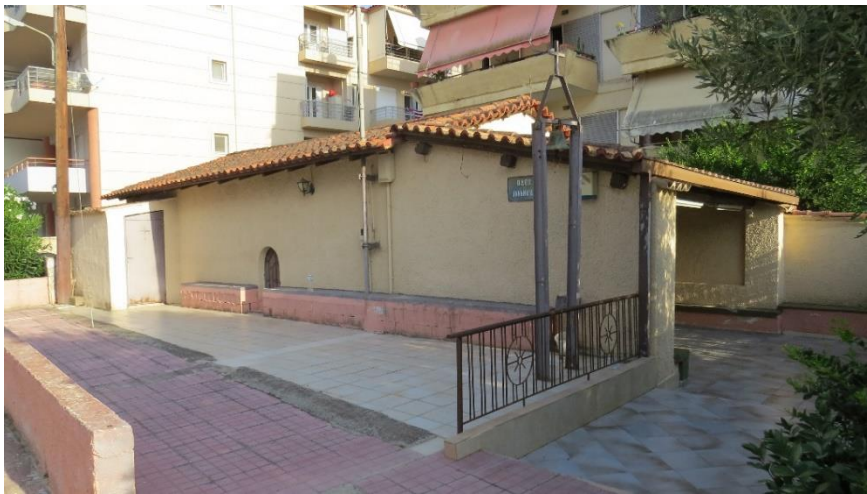
**Fig. 1.** North–West view of the church before the building works. (7/9/2021)

identified as a problem. Also, the newer coatings had altered the image of the monument and its historical and artistic value was not highlighted. Finally, it was found that there was a lack of design in the surrounding area and no information signs that would allow the visitor to understand the historical value of the church (see Fig.1).

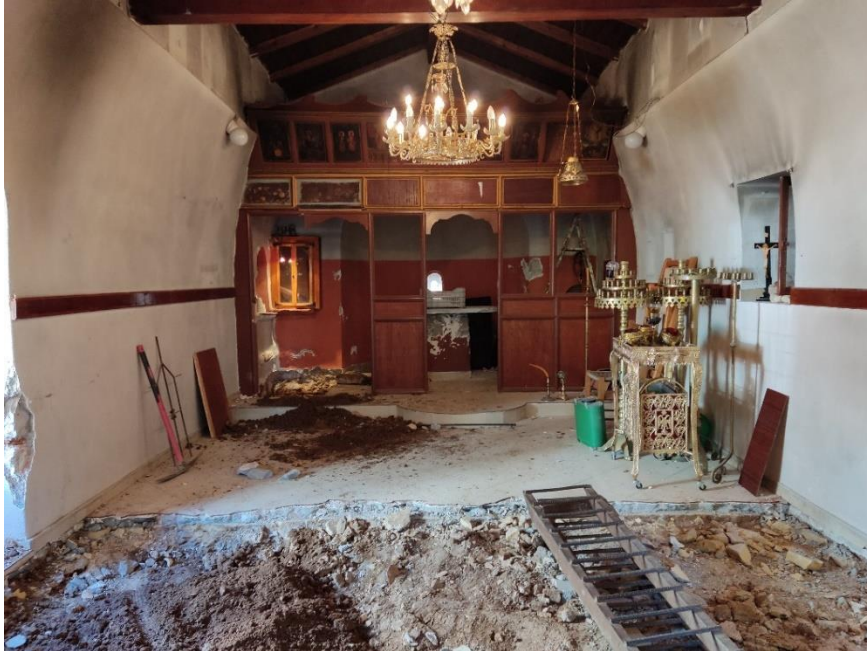
**Fig. 4.** Interior of the church. Test cuts on the interior masonry. Removal of interior floors  
Detachment of the newest part of the iconostasis.

To date, the removal of plaster on the exterior masonry, the test cuts on the interior masonry, the excavation of the northern part of the surrounding area, the removal of interior floors and the detachment of the newest part of the iconostasis have been carried out (see Fig.2, Fig.3, Fig.4, Fig.5)

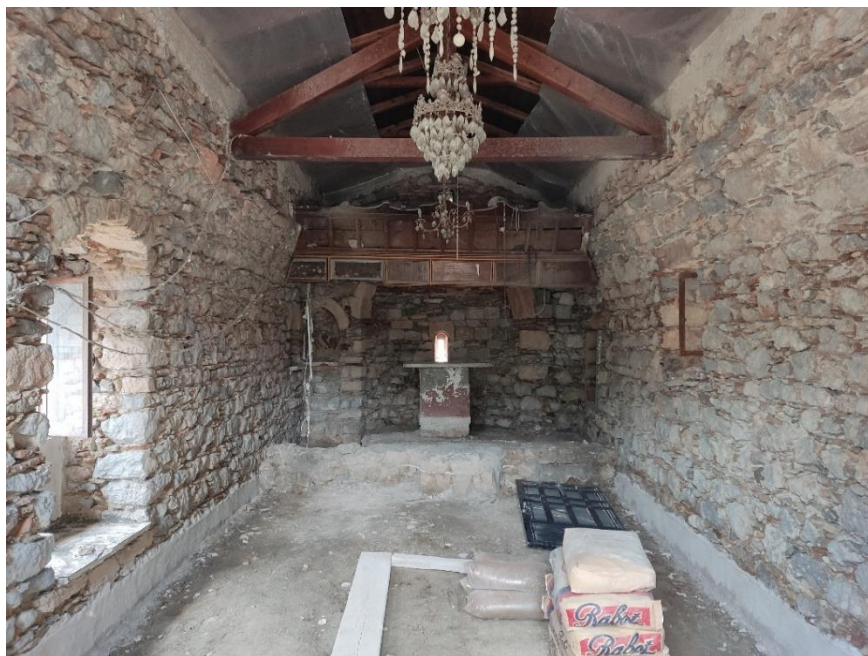
**Fig. 5.** Interior. Removal of plaster on the interior masonry. (23/6/2023)

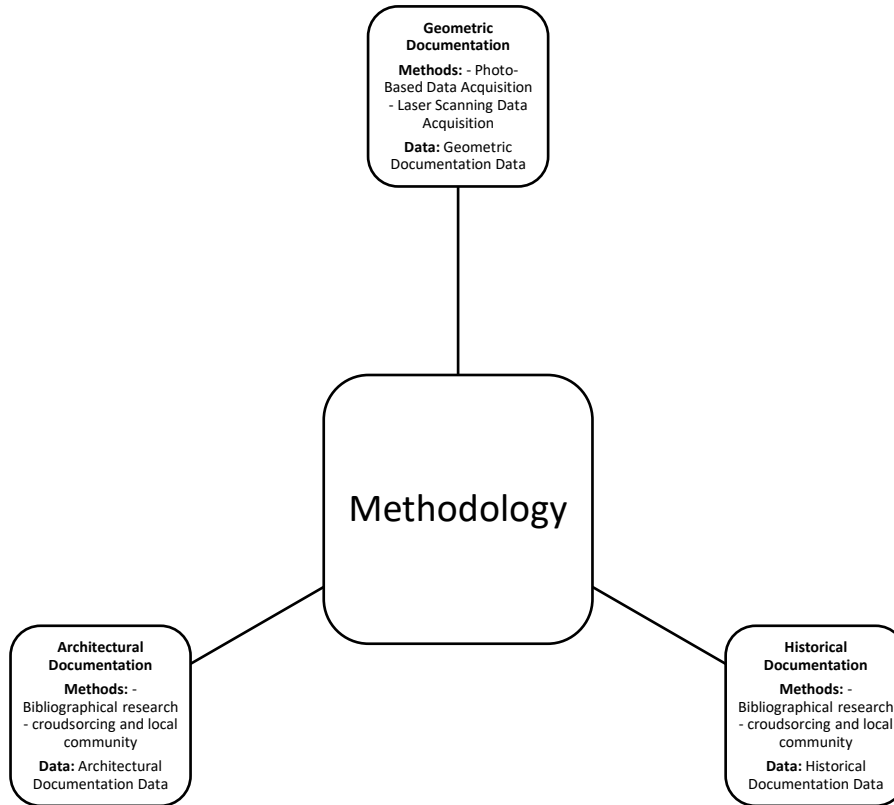
Fig. 7. Diagram of the process

In order to make use of all the data and information obtained from the above actions, the methodology shown in the following diagram was followed (see Fig.7). This includes Geometric, Architectural and Historical Documentation. To date, the first three steps have been largely completed.

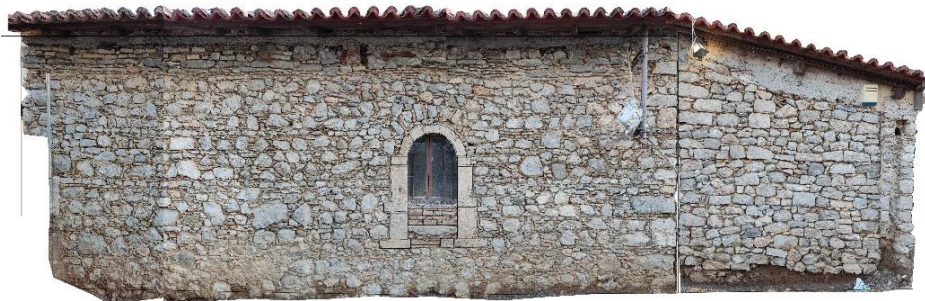
**Fig. 11.** Orthoimage of the north façade.

The next step was to process the sketches and photographs of each facade and convert them into drawings using CAD technologies. Initially, each façade was worked out as a different project using masks of edited images. After processing the data for all facades, a 3D model of the Catholic Church was constructed. Selected images were used to process the orthoimages of each facade to ensure quality texture. To advance the interdisciplinary process, four orthoimages were created, one for each facade of the church. These orthoimages served as blueprints for further processing of thematic maps incorporating not only qualitative information but also quantitative data. (See Fig.11, Fig.12)

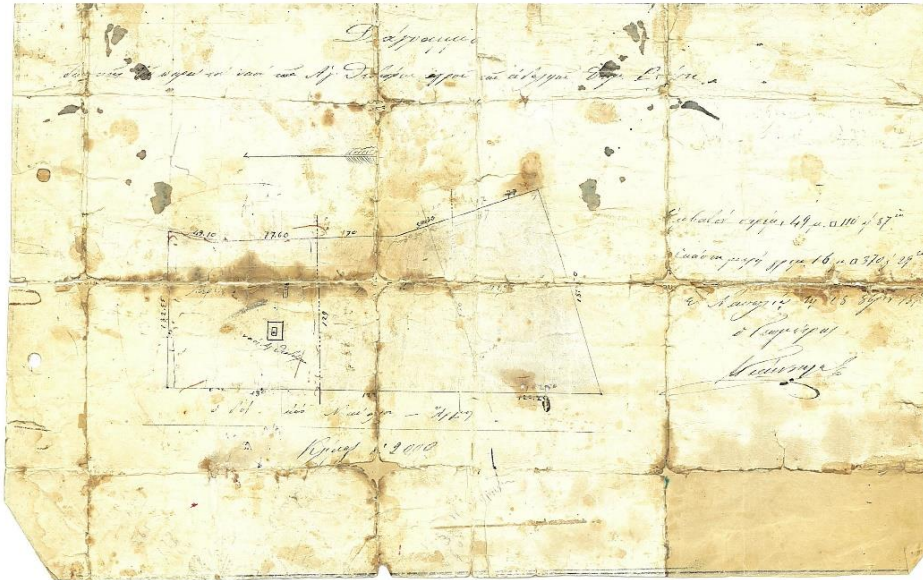
**Fig. 15.** Documentation of the attached drawings of the contract number 15.987 / 02-08-1871 of the notary of Athens Vasileios Lambroulis (Adopted from [14]).

Based on the above and on the evidence that has emerged so far from the external plaster removals in the project, the church of Agioi Theodoroi represents a typical example of post-Byzantine church architecture in Argolida, following the type of the single-aisle basilica with a gabled roof with a tiled roof that we find in Lygourio and Asini. The masonry is for the most part with rough or semi-worked stones, bonded with mortar and is differentiated on the eastern side where the niche of the sanctuary is located. The sanctuary consists of a three-sided niche and is one of the places where the masonry layers are built of many large, squared stones, with very small joints and almost no mortar. Most of the interventions are on the west side of the church and around the upper layers of the masonry, which proves the multiple interventions on the roof. Of particular interest is the corner connecting the eastern and western sides of the church. Before the work was started, all the walls were plastered and painted. During the external plaster removal of the walls, different building phases gradually appear. Inside, the temple is single aisled (mono-spatial) and there seems to have been a large arch supporting the roof, starting from the floor, and forming a semicircle. Today there is only part of the arch as shown in the section AA drawing (see Fig. 15).
