Restoration and highlight of Agioi Theodoroi church in Nafplio with the use of CAD technologies

Dimitris Psychogyios^{1[0009-0009-5568-9064]} and Katerina Leptidou¹

¹Department of Architecture, University of Thessaly, Pedion Areos, 38334, Volos, Greece
dps@uth.gr

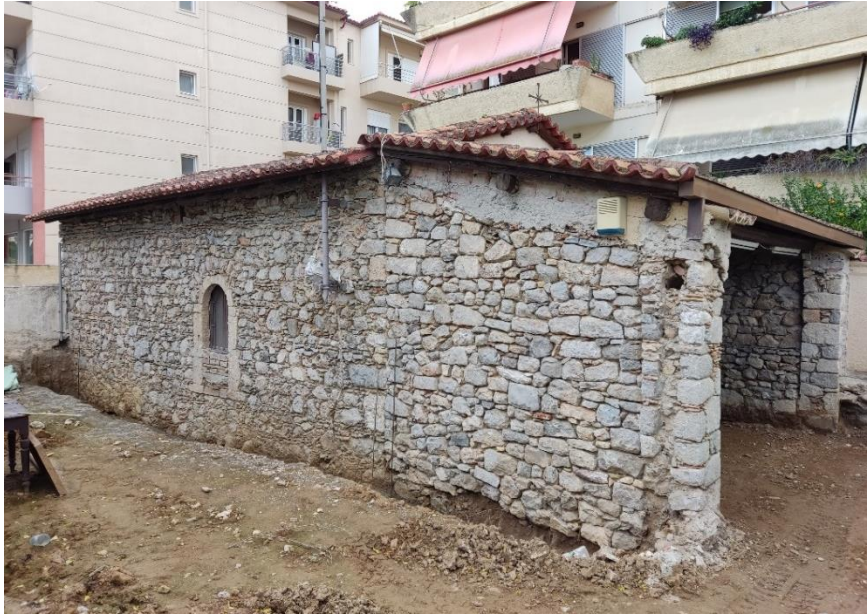
Fig. 2. North–West view of the church. Removal of plaster on the exterior masonry. Excavation of the northern part of the surrounding area. (24/9/2022)

To date, the removal of plaster on the exterior masonry, the test cuts on the interior masonry, the excavation of the northern part of the surrounding area, the removal of interior floors and the detachment of the newest part of the iconostasis have been carried out (see Fig.2, Fig.3, Fig.4, Fig.5)

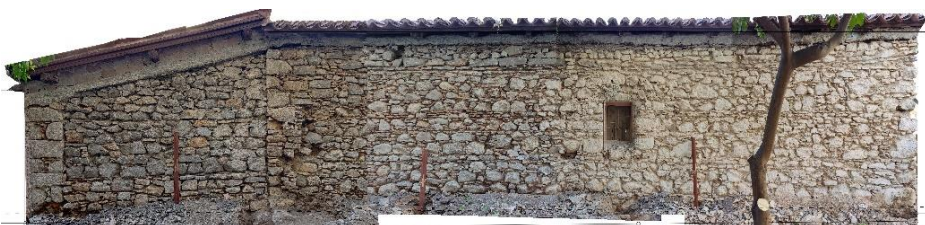
Fig. 12. Orthoimage of the south façade.

The next step was to process the sketches and photographs of each facade and convert them into drawings using CAD technologies. Initially, each façade was worked out as a different project using masks of edited images. After processing the data for all facades, a 3D model of the Catholic Church was constructed. Selected images were used to process the orthoimages of each facade to ensure quality texture. To advance the interdisciplinary process, four orthoimages were created, one for each facade of the church. These orthoimages served as blueprints for further processing of thematic maps incorporating not only qualitative information but also quantitative data. (See Fig.11, Fig.12)

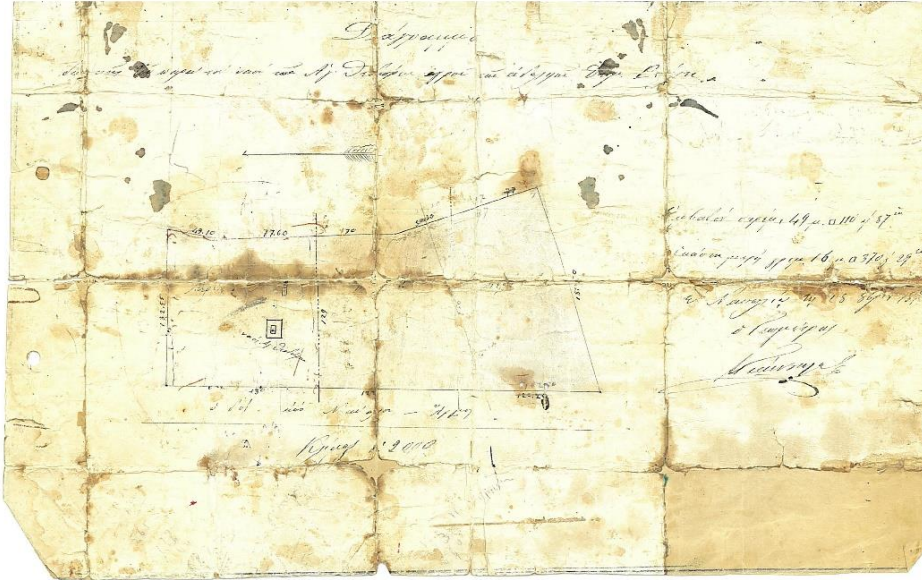
Fig. 15. Documentation of the attached drawings of the contract number 15.987 / 02-08-1871 of the notary of Athens Vasileios Lambroulis (Adopted from [14]).

Based on the above and on the evidence that has emerged so far from the external plaster removals in the project, the church of Agioi Theodoroi represents a typical example of post-Byzantine church architecture in Argolida, following the type of the single-aisle basilica with a gabled roof with a tiled roof that we find in Lygourio and Asini. The masonry is for the most part with rough or semi-worked stones, bonded with mortar and is differentiated on the eastern side where the niche of the sanctuary is located. The sanctuary consists of a three-sided niche and is one of the places where the masonry layers are built of many large, squared stones, with very small joints and almost no mortar. Most of the interventions are on the west side of the church and around the upper layers of the masonry, which proves the multiple interventions on the roof. Of particular interest is the corner connecting the eastern and western sides of the church. Before the work was started, all the walls were plastered and painted. During the external plaster removal of the walls, different building phases gradually appear. Inside, the temple is single aisled (mono-spatial) and there seems to have been a large arch supporting the roof, starting from the floor, and forming a semicircle. Today there is only part of the arch as shown in the section AA drawing (see Fig. 15).
